Safety Notice  
Side-on collision with a freight train  
by a runaway packing machine  
Gent-Sint-Pieters  
14 April 2019

Side-on collision with a freight train by a runaway packing machine of type Unimat 08.

Station Gent-Sint-Pieters at point switch AW61BK.

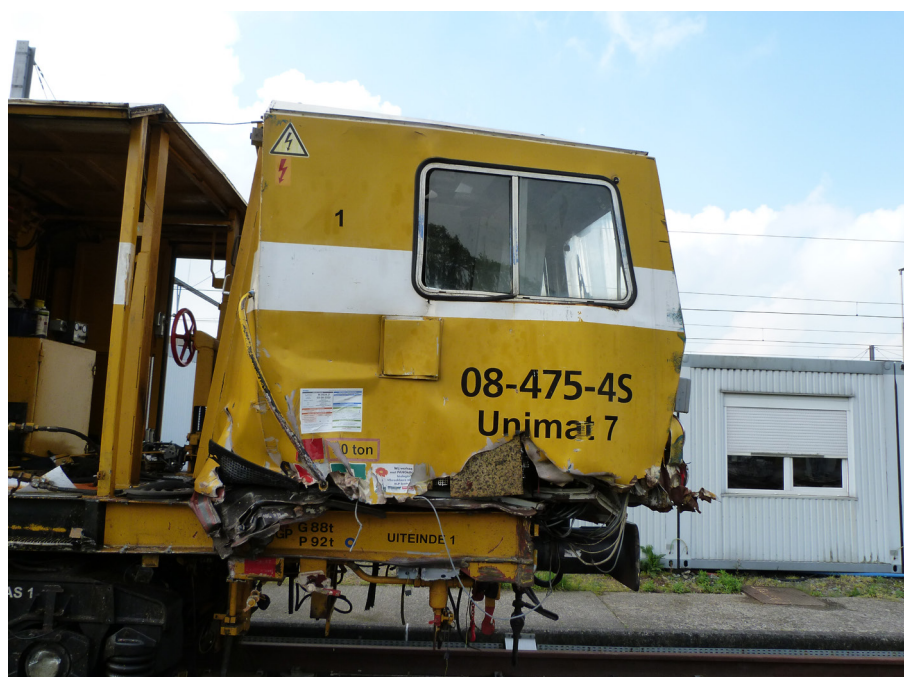
The runaway packing machine reaches point switch AW61BK at the moment freight train Z65902 is coming past and collides with it side-on. There are no casualties, but there is material damage to the infrastructure, 5 wagons and the packing machine. 1 wagon and the packing machine derail and are damaged.

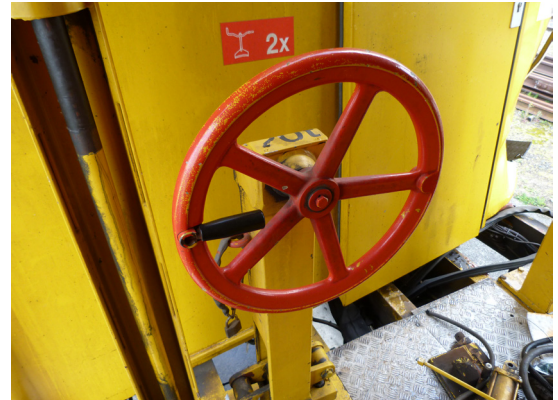
The packing machine's braking system was visually inspected a few hours after the accident: a pressure reservoir was torn off during the collision such that it was not possible to control the automatic braking system function in-situ. The handbrakes in driver's cab 1 and 2 were working normally, but the packing machine was not immobilised. The rear brake lever was open when visually inspected.

After the inspection, the pressure reservoir was checked and tested at the workshop: the pressure reservoir showed no leaks. The braking system was also checked and tested at the workshop: aside from the consequential damage from the derailing and the collision, the packing machine's braking system was working normally.
