Bulletin of General Information

Derailment followed by a side collision

Walenhoek

6 February 2020

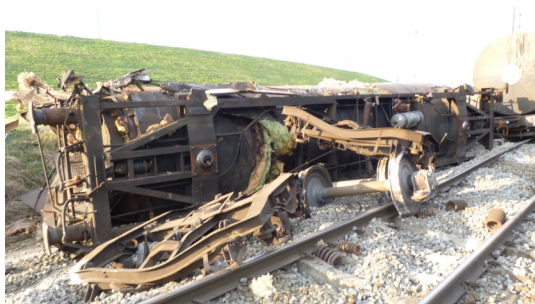
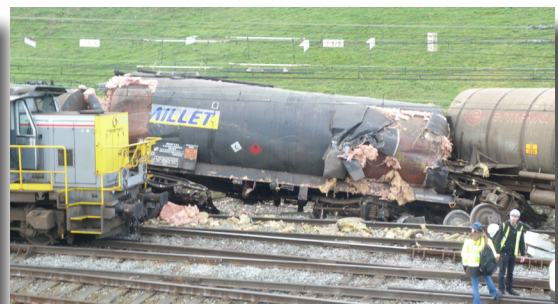
- 2 derailed engines with considerable damage to the driver's cab and a leaked diesel tank.
- 6 derailed wagons of which 1 wagon overturned and began to leak and 2 wagons ended up in the verge.
- Damage to railroad infrastructure:
 - Damage to overhead wires;
 - Damage to rails;
 - Damage to point switches.
- Freight transport suspended for several days on L.10 and L.11.

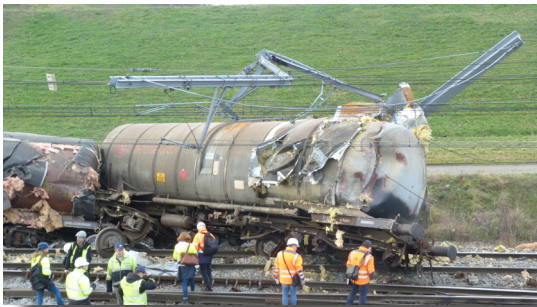
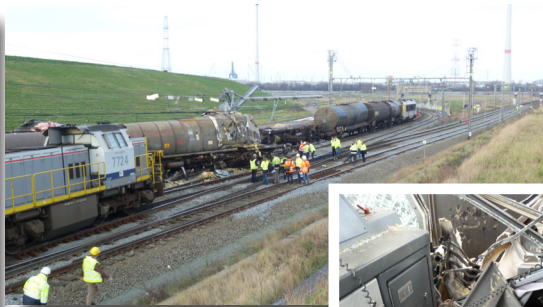
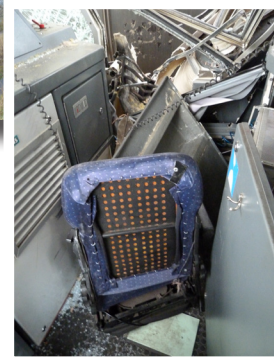
Upon impact, six wagons of the E49826 train derail. Wagon number four separates and overturns completely. The residue inside the wagon leaks out. There is no immediate fire risk. Wagons number five and six partially overturn, derail towards the verge and start jack-knifing. Upon impact, the LZ70080 train's diesel tank also starts to leak. The first engine's driver's cab is severely damaged.
