Bulletin of General Information
Derailment of a Lineas freight train
Aubange - 19th May 2017

Derailment of a freight train on regular track.

Freight train from LINEAS
Derailed wagon : Type Sggmrs - Vehicule n° 3368495200729
Registered in Germany
Manufacturing Year : 2003
Owner : VTG Deutschland GMBH
Keeper : VTG Schweiz GmbH

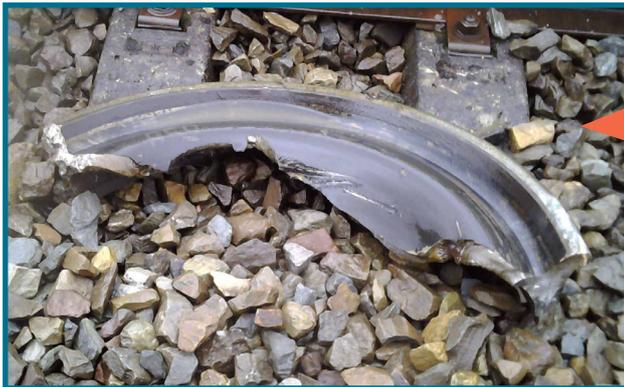
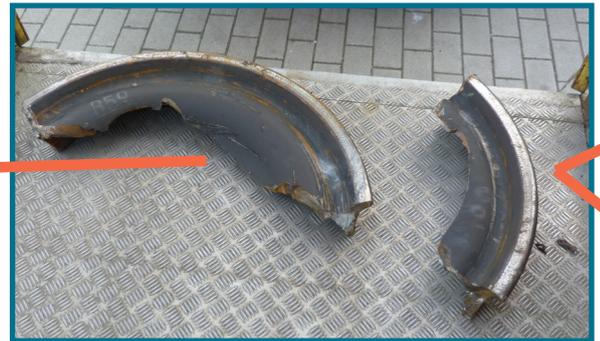
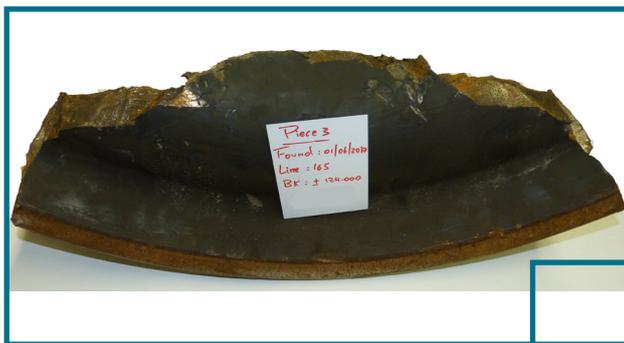
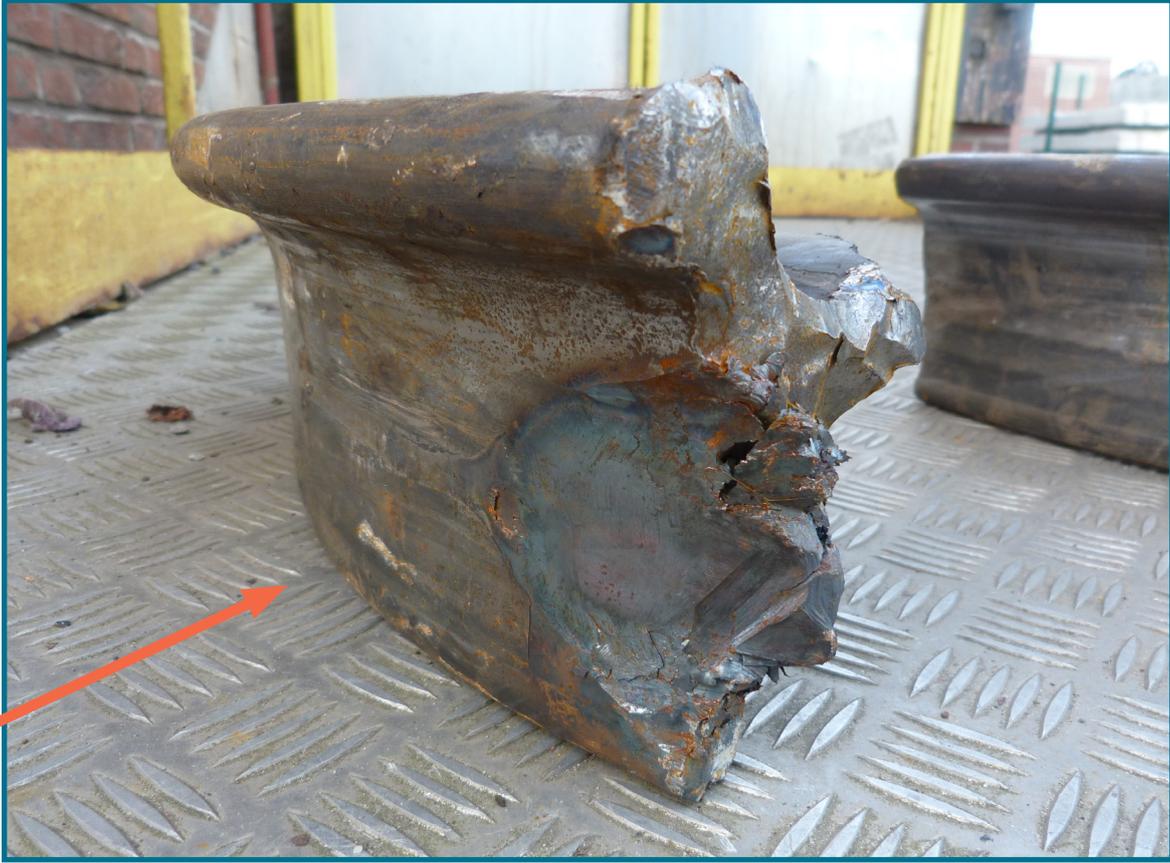
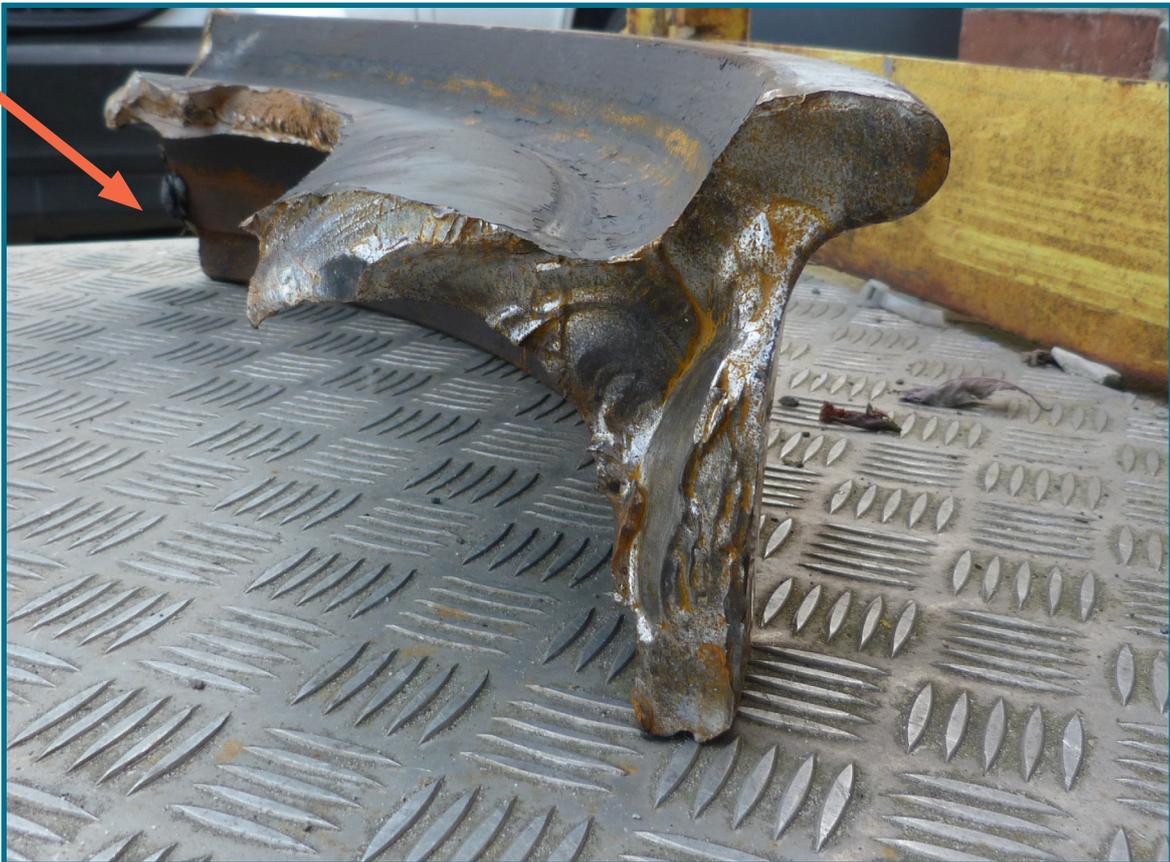
According to first elements in our possession, the derailment has most probably been caused by the fracture of the wheel.

Four pieces of the broken wheel were found back during the on-site investigation : these pieces and other wheelsets are transferred to a laboratory to perform several tests and analyses.

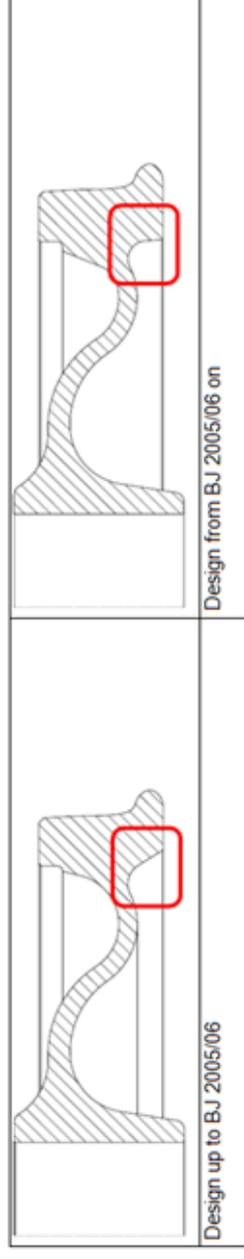
ZDB 29 Designs

Wheelset type 314 / ZDB 29 with a slope under the wheel flange (probably produced until 2005/2006)

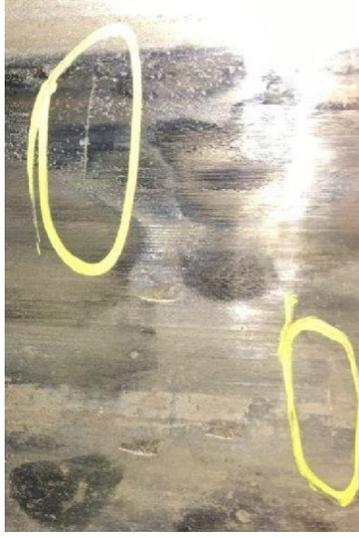
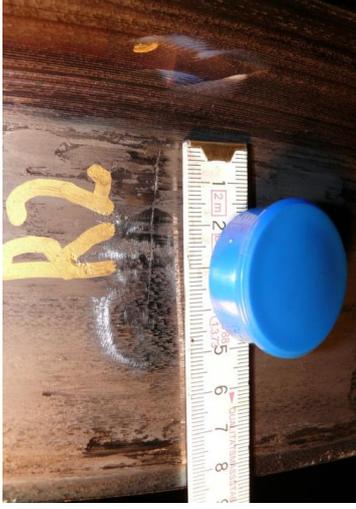
Description: The tread exhibits cracks at an angle of approximately 90° to the circumference of the wheel and have a typical length of 30mm or more. Transverse cracks generally develop at the surface in either straight or slightly crooked lines and can penetrate radially (usually of thermal origin in these cases) or branch out in a circumferential direction (usually of mechanical origin in this case). They occur individually and can be distributed at several points around the circumference. [EN 15313, §C.2.6]

Transverse crack revealed by magnetic particle testing [EN 15313, §C.2.6]

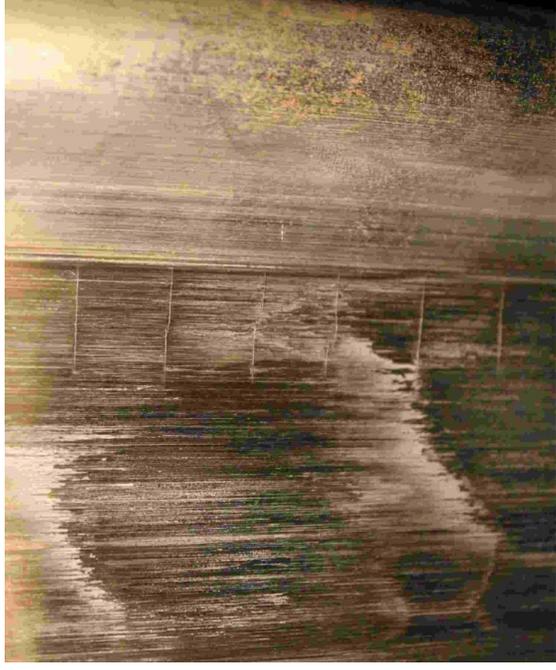
Example for single cracks on the wheel tread by visual inspection

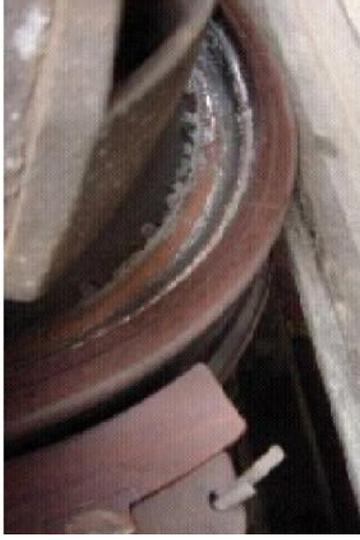
Description: This type of defect occurs only in tread-braked wheels. When suitable coatings are used, the paint becomes clearly burnt in the rib/web transition radius when the temperature exceeds approximately 300 °C. The paint in this area then becomes cracked and peeling. The brake blocks are often melted to some extent. Build-up of metal and characteristic colouring can be seen on the tread. The rim may also become a bluish colour.

Overheating affecting the wheel rim/web transition [EN 15313, §C.3.2.2]

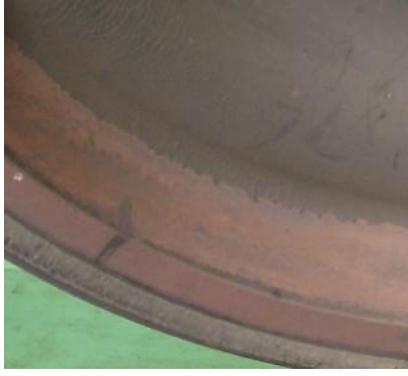
Old and fresh burnt paint

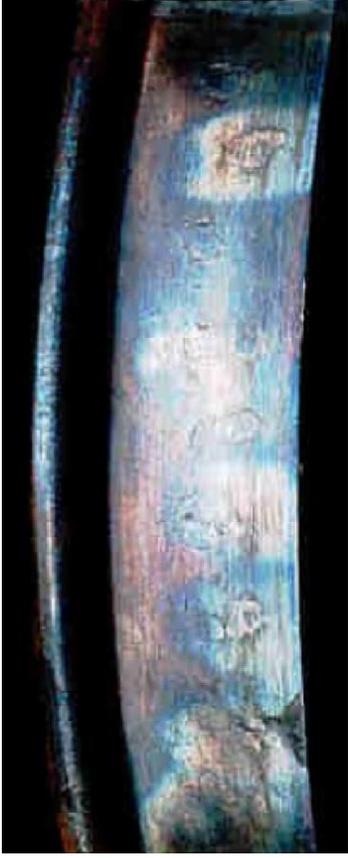
colouring on the tread

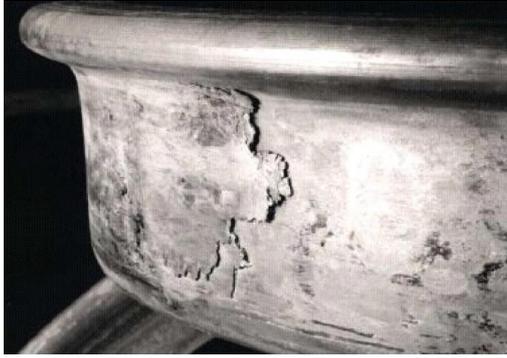
Metal build up on the tread

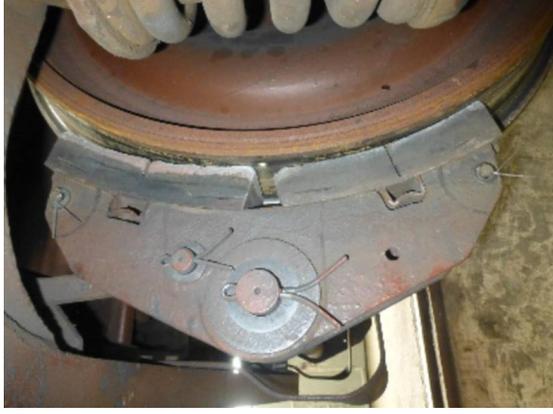
Melted brake block
