### **GENERAL INFORMATION**

Derailment of a bogie of the 9th wagon of a freight train of the railway undertaking LINEAS.

Thursday 9 May 2019, around 08:45 am.

Line 59 between Belsele and Sinaai.

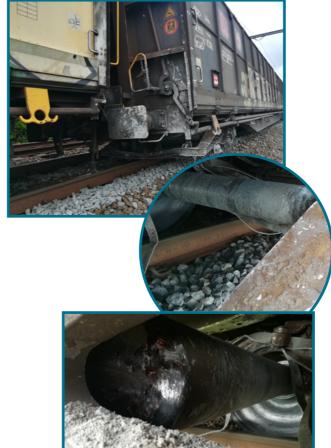
On Thursday, 9 May 2019, freight train E52903 of the railway undertaking LINEAS is riding between Antwerpen-Noord and Gent-Zeehaven: it is composed of an electric locomotive and 18 wagons. Around 8:43 am, on line 59, near the town of Belsele, the first axle of the first bogie of the 9<sup>th</sup> wagon breaks.

As a result of this breakage, parts of the wagon are dragged, and various elements of the infrastructure are damaged (sleepers, level crossings, signalling elements).

According to the first analyses, the direct cause of the derailment is the breakage of the axle. The investigation is ongoing to determine the indirect factors, including the causes of this breakage.

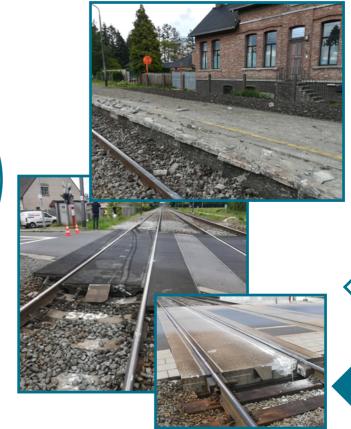
At Sinaai station, the 9<sup>th</sup> wagon - which is crabbing - scrapes elements of the structure of the platforms, causing significant damages.
