Summary of the Safety Investigation Report

COLLISION OF A PASSENGER TRAIN WITH AN EXCAVATOR

DUFFEL - 14 JUNE 2012

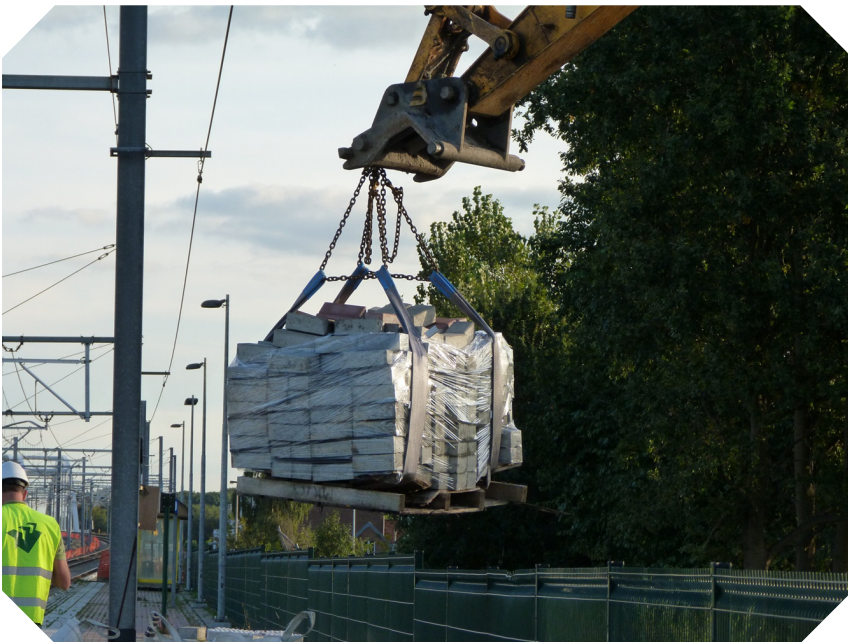
The workers considered that the pallets were unstable, and that a fork-lifting system would be more efficient and give better support to the pallets being moved.

The excavator operator did not have a good view of the position of the arm in relation to the structure gauge, nor did he have a good view of the possible arrival of trains on track A.

The arm of the excavator obscured the assistant's view of any approaching

trains but the assistant retained visual contact with the excavator operator.
