Safety Investigation Report Switch run-through Noorderkempen - 11 February 2019

1. SUMMARY

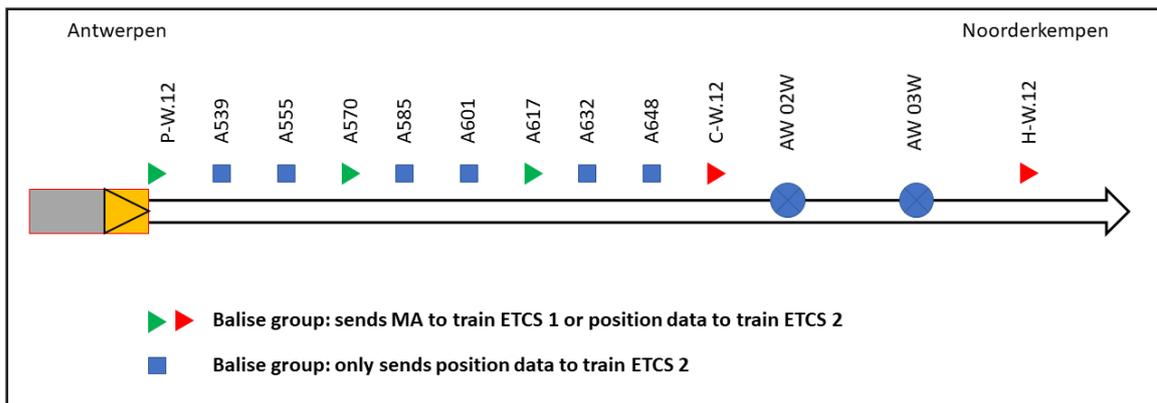
Figure: sequence of the signals between Antwerpen and Noorderkempen.

When the empty passenger train (E15214) is approaching stop marker board A617, the train driver receives a telephone call from the signal box (Block 12 HSL) asking him whether the signal in advance of him (signal C-W.12) may be closed. The train driver replies in the affirmative, and the movement agent of the signal box (Block 12 HSL) confirms that he will close the signal. The route of the empty passenger train (E15214) crosses that of another passenger train E7226 waiting at Noorderkempen station for permission to depart. Because the route of the empty passenger train (E15214) was actuated first, the departure of the other passenger train (E7226) is automatically stopped.

During the telephone call, the empty passenger train (E15214) crosses the balise group of stop marker board A617. Stop marker board A617 is the last location, in rear of signal C-W.12, equipped with an ETCS 1 balise where the MA² of the empty passenger train (E15214) can still be adapted. The conversation between the train driver and the signal box (Block 12 HSL) comes to an end, and the movement agent of signal box Block 12 HSL operates the help function SDG³ to close signal C-W.12.

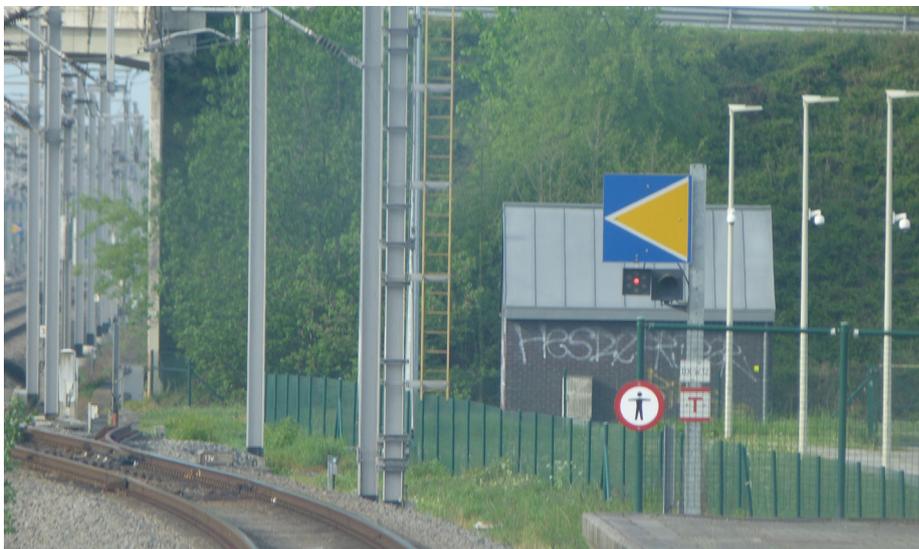
The occupation of switch 02W is detected, and the EBP system automatically closes signal DX-W.12 and turns off light of the stop marker board at Noorderkempen station.

The driver of train E7226 notices in time that the permissive signal is turned off, and he initiates a service braking to bring his train to a standstill a few metres in rear of the stop marker board. Without this intervention, the train would have passed the light, resulting in an emergency braking.

The train driver follows the instructions on his DMI screen, as learnt during the training courses. There are no light signals on HSL 4. There are stop marker boards.

Picture: exit signal DX-W.12 in Noorderkempen station.

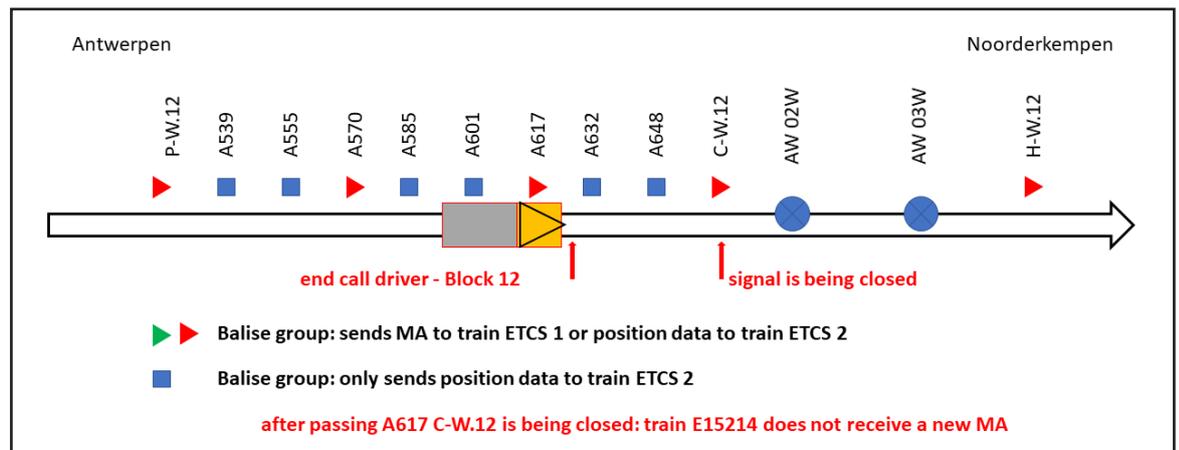
During the GSM conversation with the agent, the empty passenger train passes stop marker board A617 without the movement agent and the train driver noticing it. Signal A617 is the signal where the MA (Movement Authority) could be modified, instructing the train driver to stop in rear of the closed signal C-W.12.

For ETCS 1 equipment, balises are only placed at certain identification points which are approximately 4 to 5 km apart for Line 4. The distance between the balises of stop marker board level 1 A617 and stop marker board level 1 C-W.12 is 4,627 m. As a result, the train E15214 runs to the closed stop marker board C-W.12 without slowing down.

When crossing the closed signal (C-W.12), the train runs at a speed of approx. 129 km/h. The ETCS system intervenes and activates an automatic emergency braking. The actual stopping distance is approx. 480 m and the train comes to a standstill in advance of the closed signal (C-W.12) on switch 02W. In other words, the train reached the dangerous point.

The DRSI is recommended to ensure that the Infrastructure Manager makes sure that the early signal closing procedure is made compatible with ETCS Level 1, taking into account the location of the balises (safe integration procedures in the ETCS system).
