Safety Investigation Report
Infrabel agents hit in Morlanwelz, followed by a
collision with an SNCB/NMBS-train in Bracquegnies
caused by a runaway towed damaged railcar
27 November 2017

SUMMARY

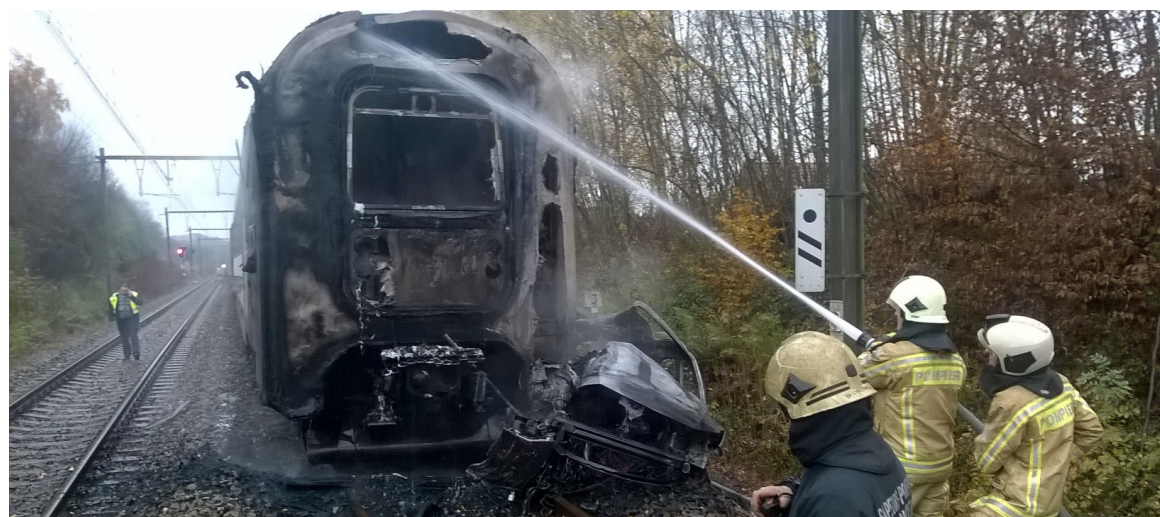
The driver's cabin of the first railcar (n° 449) was badly damaged and various elements of the infrastructure were also damaged by the fire.

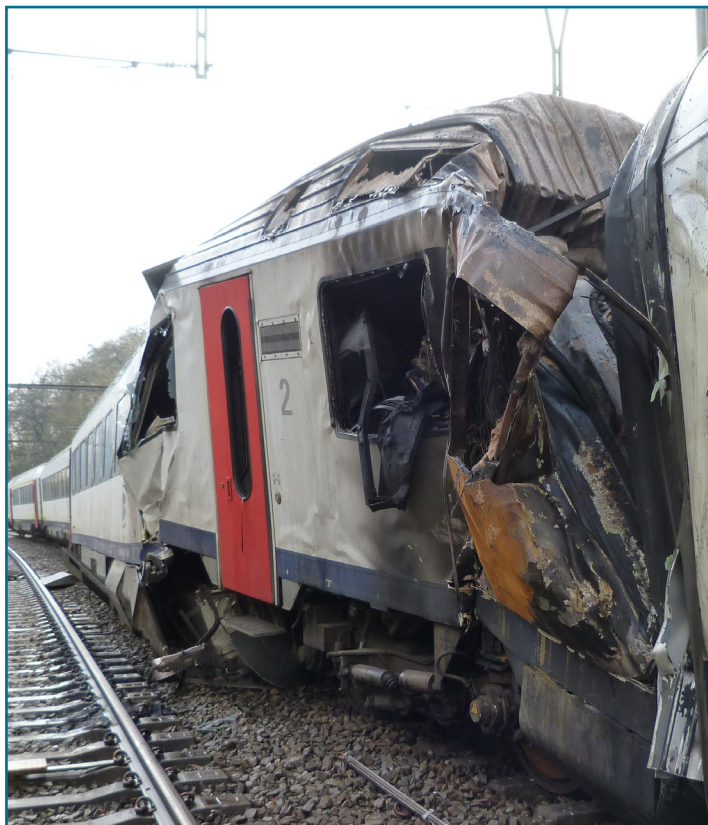
In Bracquegnies, on line 118, at around 8:00pm, the damaged railcar (n°449) collided with the train E940, injuring at various degrees three passengers and two SNCB/NMBS members of staff.

The front of the first railcar of the AM449, with the traces of the fire, collided with the train E940 in Bracquegnies.

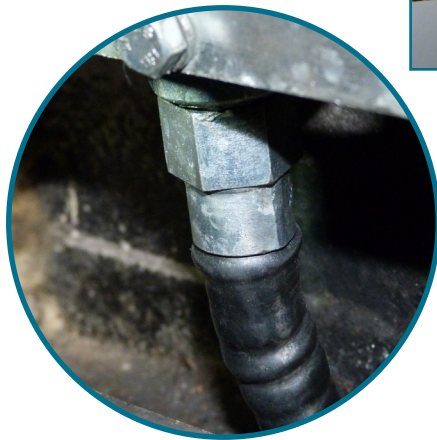
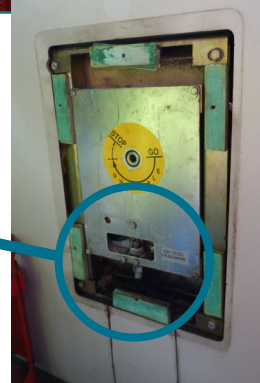
Inappropriate use of the crank causes irreversible damage to the sheath of the cable connecting the crank to the manual uncoupling system when a foot is used to apply greater force on the crank.

The damage caused to the cable sheath is only visible during workshop maintenance operations.

Once the “sheath + cable” system is damaged, rotating the crank no longer drives the correct motion of the internal parts of the coupler, bringing them to an intermediary and unstable position.

Based on these elements, the IB recommends that SNCB/NMBS analyses its training procedure so as to raise awareness of staff in terms of the risks identified.

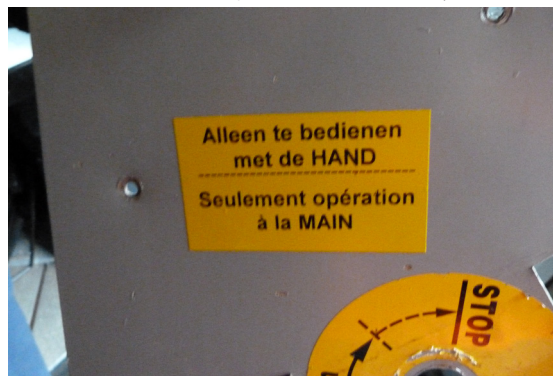
A sticker next to the crank in the driver's cabin informs that the crank should only be used manually. This sticker was not sufficient to prevent a foot from being used.

In the driver's cabin, there is no warning to inform that the operation must be conducted simultaneously in both drivers' cabins. This procedure is specific to this type of railcar.
