Summary of Security Investigation Report

DERAILMENT OF A FREIGHT TRAIN WETTEREN - 4 MAY 2013

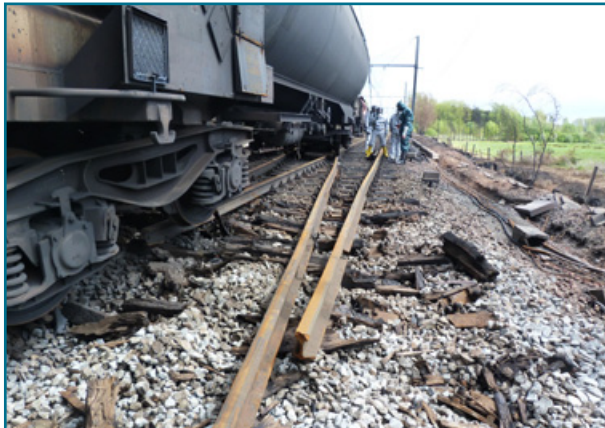
According to our scenario, the direct cause of derailment is the toppling of the first three wagons when they passed over the switches. The toppling of the wagons was made possible by the combination of the following factors:

- a non-adapted speed;
- two successive small curves of switches, radius $\pm 215\text{m}$, in a S-shape and designed for a maximum speed of 40km/h when placed in deviating position;
- the high centre of gravity of the fully (correctly) loaded wagons;
- the initiated emergency brake.
