Safety Notice

Incident with numerous vehicles on a level crossing
Moelingen - 3 March 2020

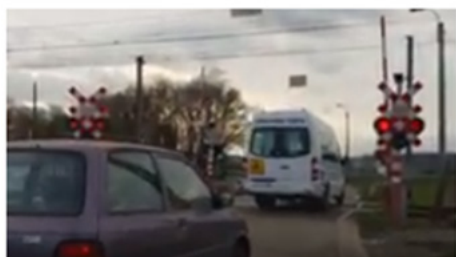
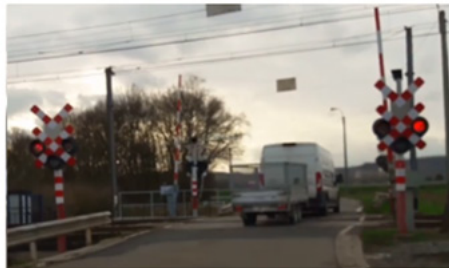
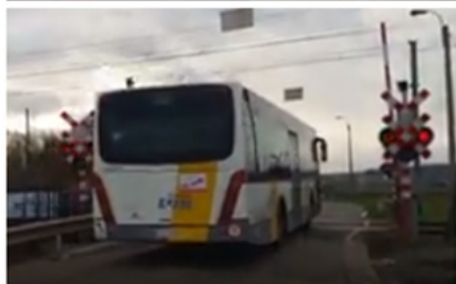
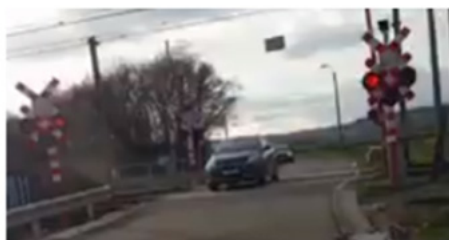
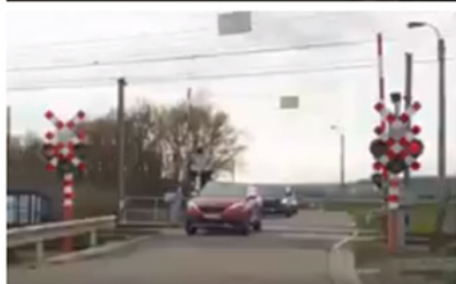
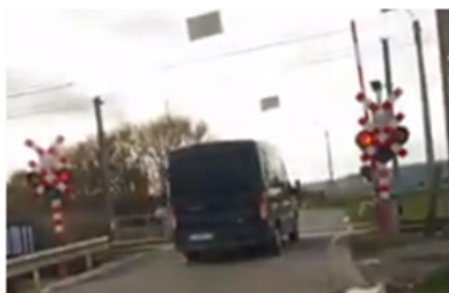
On 3 March around 4:23 pm, the operation of level crossing 28 on line 40 is disrupted: the red lights flash on and off alternately but the barriers on both sides of the level crossing are not closed. Despite the red flashing traffic lights, numerous road users cross the level crossing in both directions.

The road users showing such inadequate driving behaviour at the level crossing are drivers of both cars, vans, a school bus and a bus.

Screenshots as seen on RTL from an anonymous source

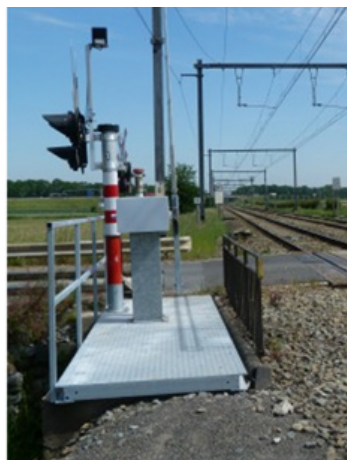
The newly built pedestrian bridge to reduce the number of major alerts on level crossing 28. (Photo taken on 19 May 2020)

The year before the incident, there was a noticeable increase in the amount of major alerts. The cause was attributed to the outdated pedestrian crossing. This has since been renewed.

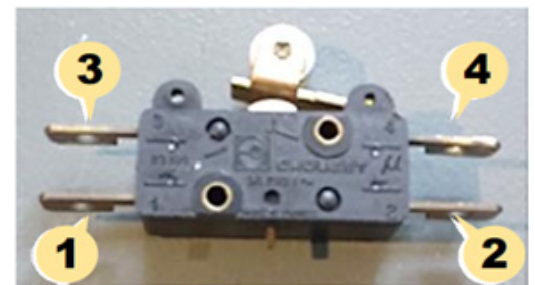
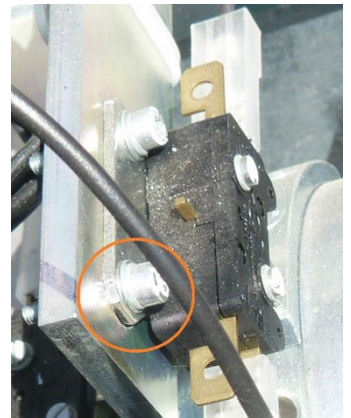
Consequently, the barriers were completely raised but the red traffic lights did not receive this information and kept flashing in alternation. When the major alert was triggered, the signal box was informed of the hitherto unknown position of the barrier. The signal box was alerted by the changing colour of the level crossing on the EBP screen to red inverse, the fact that a safety table was implemented on the stricken level crossing, as well as by an alert message in the message box and an audible signal.

The infrastructure manager generally does not have many issues with these types of microswitch, and this kind of malfunction rarely occurs.³⁹ In their experience, these microswitches need to be replaced approximately every three years, if one of the following elements is identified during preventive maintenance: a) abnormally high contact resistance and b) a worn out swivel castor that activates the contact of the microswitch.

The registered RIOCALL, no. 17753226, was created on 3 March 2020 at 5:51 pm. In the RIOCALL, the engineers noted the cause as *"Microswitch [...]" with the description "Batis [...] switch bouge au niveau de la fixation"*, i.e. the microswitch had shifted at the attachment screw.

After the technical intervention, the engineers tested whether the barrier functioned correctly. Having done this, RACOR was informed of the cause of the major alert, and the repair work carried out. They also recorded this in the register of events, instructions and orders of the level crossing, also referred to as the 'logbook S 477'.
