Derailment of a work train (ballast regulator) of the infrastructure manager.

Tuesday 14 April 2020 around 4:40 am.

Line 96, at Tubize station on switch 02C.

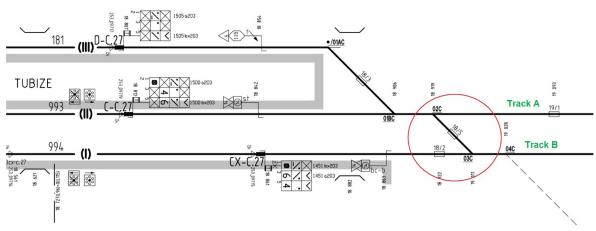
The track change is made through switch 02C, which is manually operated by a technician. Once the switch is operated, the ballast regulator leaves the Tubize station platforms and crosses switch 02C from track A to track B.

While crossing this switch, the first axle of the ballast regulator derails at low speed. The driver, having felt the shocks, brakes immediately. The ballast regulator stops on the switch, encroaching on the loading gauge of both tracks.
