Safety Investigation Report

Derailment of an SNCB/NMBS passenger train

Weerde - 28 January 2021

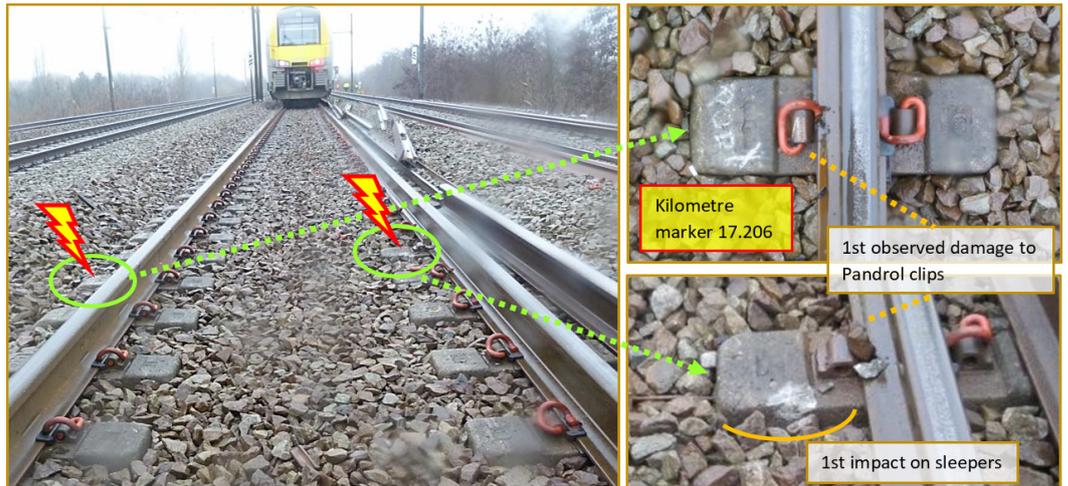
The investigation of the tracks at the place of the incident reveals the location of the derailment at kilometre marker 17.206: on the outer side of the left rail of the track (the direction of travel being in normal track regime) on the basis of the first detached Pandrol clip; on the inner side of the right rail of the track on the basis of the impact on a concrete sleeper as well as a first detached Pandrol clip.

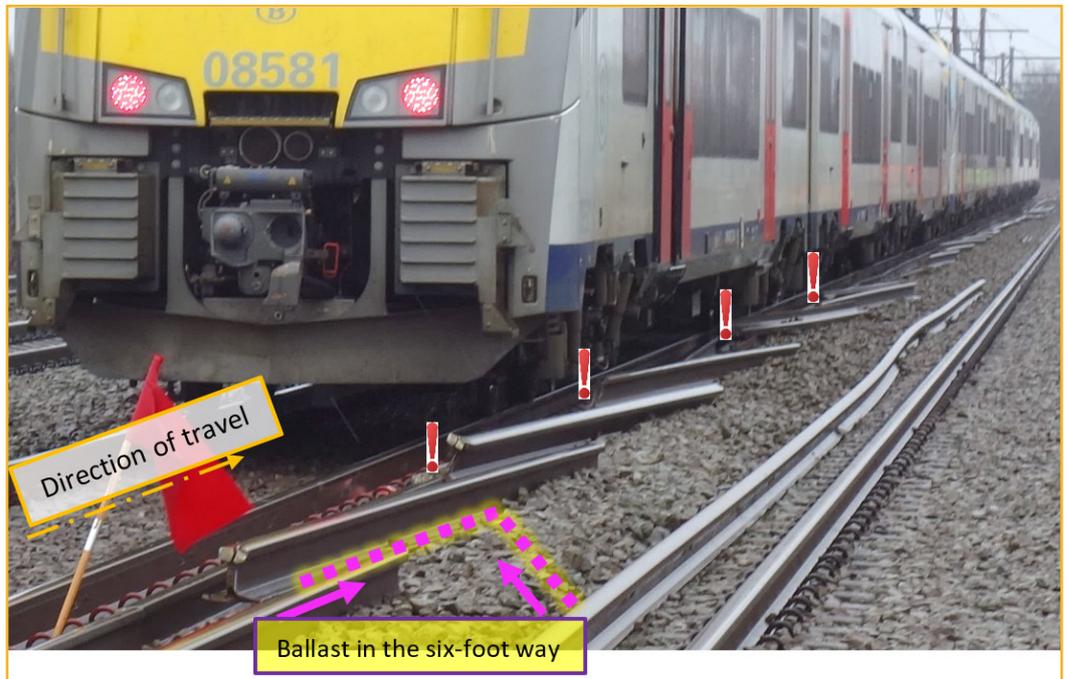
Then, at the location of the accident, a gauge measurement reveals that four cut rails, which lie diagonally on the top of the ballast in the six-foot way, encroach on the clearance gauge.

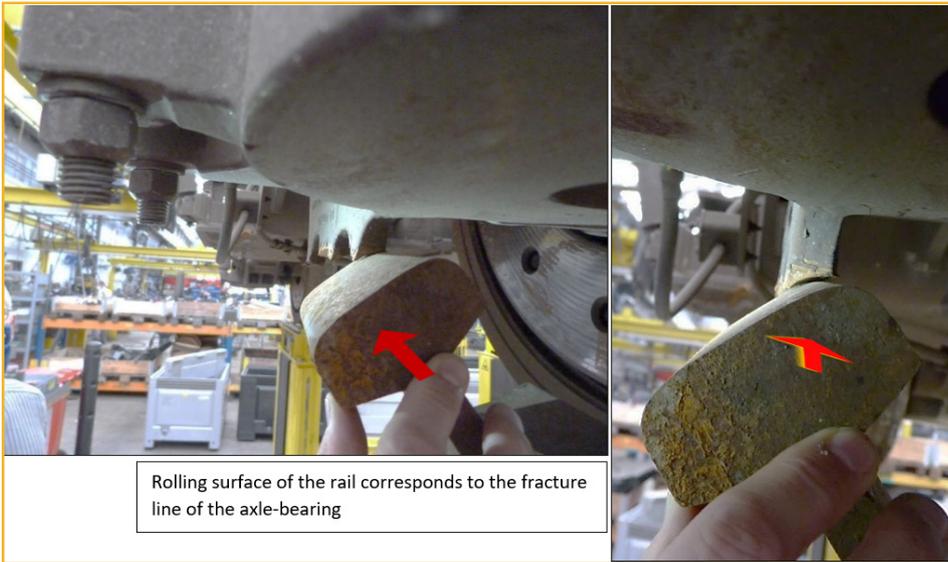
At the level of the first bogie of the train, the first damage to an axle-bearing can be observed. Later, when inspecting the rolling stock during the technical investigation, a piece of rail can be used to simulate that the course of the fracture line of the axle-bearing corresponds to the profile of the running surface.

Rolling surface of the rail corresponds to the fracture line of the axle-bearing

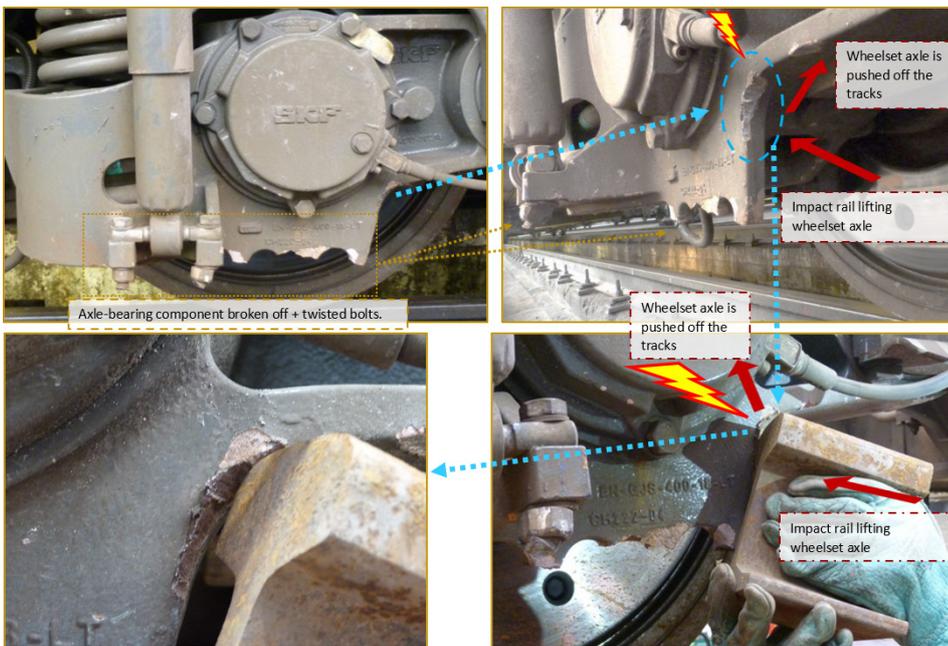
A component of the axle-bearing was also broken off at the level of wheel number 21. The bolts at the level of the primary suspension are twisted in the direction that corresponds to when they come into contact with a rail while in motion.

Where the component of the axle-bearing is curved, an impact is observed. A piece of rail can be used to simulate that the damage could originate from a collision with a rail.

Wheelset axle A50910-000541-5 with wheel numbers 21 and 22 is the derailed wheelset axle and, bearing in mind the impact damage, the hypothesis is plausible that a collision with the head of a rail actually occurred at this location and that, as a result of the impact, the wheelset axle was lifted and pushed off the tracks.

Axle-bearing component broken off + twisted bolts.

Wheelset axle is pushed off the tracks

Impact rail lifting wheelset axle

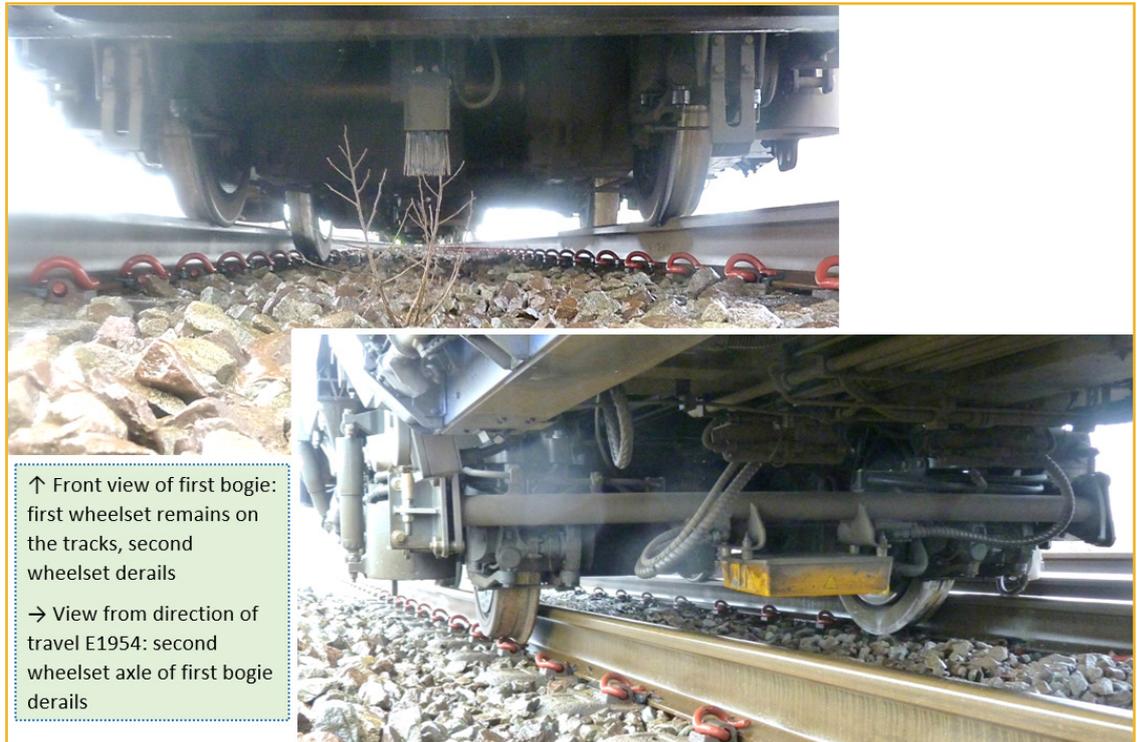
A component of an axle-bearing collides with a cut rail lying in the six-foot way, lifting the first wheelset axle and pushing it off the tracks. The wheels of the second wheelset axle end up to the left of the rails of L27 track A on which the train ran, and the derailment is a fact.

The **direct cause** of the derailment is the collision with a rail that, after being cut, encroaches on the clearance gauge.

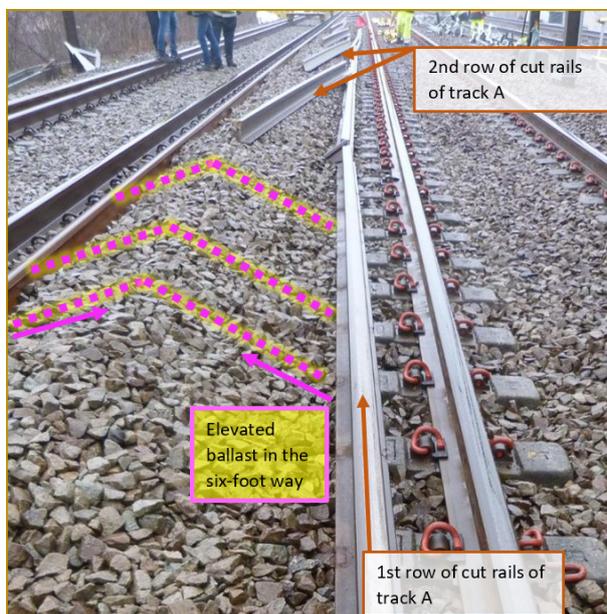
After being cut, the rails lie on the ballast in the six-foot way. Despite the fact that levelling works would have been carried out earlier, the ballast in the middle of the six-foot way is remarkably higher. This elevated ballast has contributed to the risk of cut rails lying on it encroaching on the clearance gauge. In its specifications, the infrastructure manager states: *“Equipment, tools, and materials must not cause a nuisance where they are placed, nor be left in an unstable condition.”*

A **first contributing factor** to the derailment is the encroachment of a cut rail on the clearance gauge.
