Derailment of a passenger train due to the collision with a metal object in the track.

Thursday 4 March 2021 at 6:35 p.m.

Line 161A, Germoir station (Ixelles), platform II, kilometre marker 7.465.

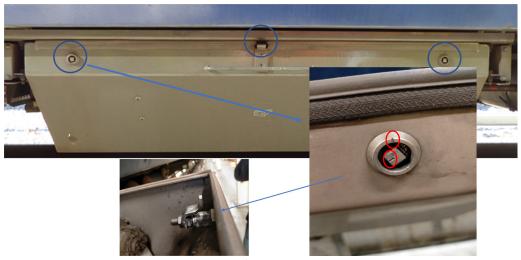
The metal object could be identified as the box containing the emergency coupling of an AM08 "Desiro" motor coach: it comes from train E2189 which passed through Germoir station a few minutes earlier.

Normal situation

Situation on the day of the accident

Opens like a drawer

Locking system
