Summary Safety Investigation Report

Derailment of a passenger train
Germoir (Ixelles) - 4 March 2021

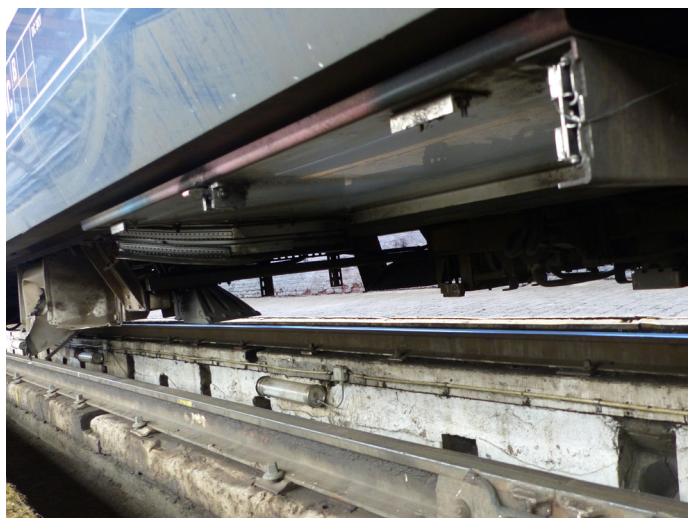
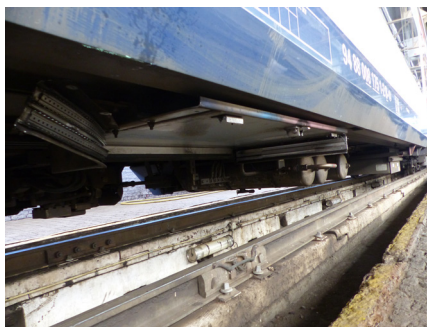
At 6:29 pm, as train E2189 passes through the Gerموir unmanned stopping point (in the municipality of Ixelles), it loses the emergency coupling box located under the rear coach of the train. Both the box itself and its contents are found in the track near the platforms of the Gerموir unmanned stopping point.

View of the damage underneath AM 8175 (photos taken at the Schaerbeek workshop): box missing, slide bar bent, damaged elements.

After its investigation, the Investigation Unit concludes that the direct cause of the derailment of passenger train E3289 is the collision of this train with an emergency coupling in the track. The presence in the tracks of the emergency coupling of an AM08 Desiro motor coach is the contributing factor identified by the investigation. This is due to the untimely opening of the coupling box located at the rear (in the direction of movement) of the second AM08 Desiro motor coach making up train E2189 and its impact on the edge of the platform at Gerموir unmanned stopping point.

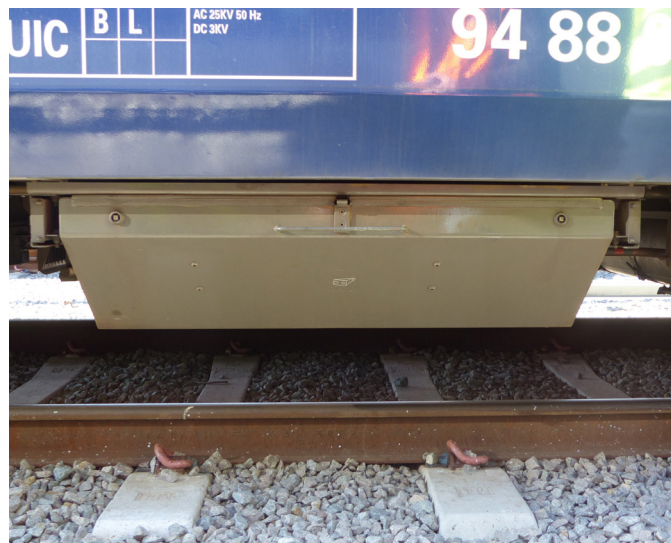
During their inspection of the rolling stock in the workshop, the investigators of the IU find that, in order to effectively close and lock the box, the following operations must be scrupulously followed:

- Push the box as far down as possible,
- Ensure that the centre pawl is correctly positioned in front of the retaining stop,
- Turn the two side locks with a key so that
 - the locking flap of each lock is positioned behind the corresponding retaining stop;
 - the lines on the locks are aligned opposite each other.

Coupling box closed and locked.

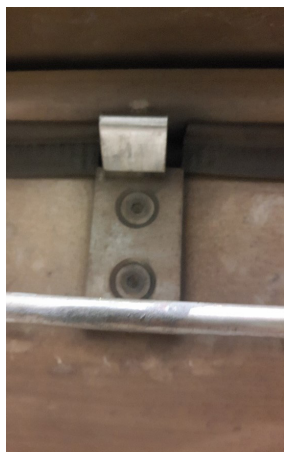
Central latch without extra safety system.

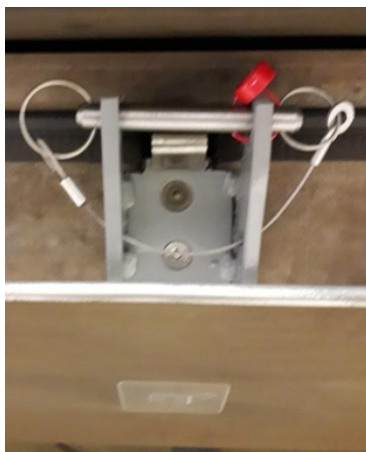
Central latch with extra safety system..

The extra safety system on the central latch allows:

- to make it impossible to lift the retaining latch by vibration, which is prevented by the added locking rod that blocks up the opening of the box,
- to add a visible sealing that confirms that the box has been closed properly and that if the sealing is missing, the box has been opened,
- to reduce the number of times the box is opened and closed during maintenance, and the associated inherent risks: sealing present and sealed = box not opened and emergency coupling not used.
