Summary
Safety Investigation Report
Collision with a person on the track
by a passenger train
Ruisbroek - 27 February 2021

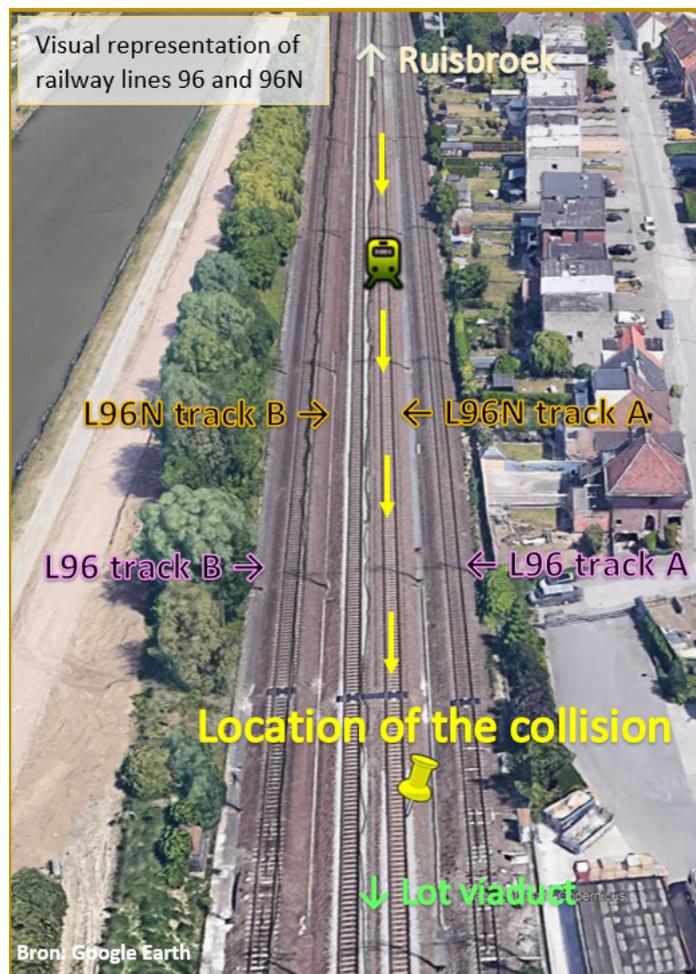
The works start in Buizingen and continue through Lot towards Ruisbroek. Up to Lot station, L96 and L96N run parallel to each other. Beyond Lot station, both tracks of L96 continue on level ground, while both tracks of L96N go up a viaduct. Beyond the Lot viaduct, both tracks of L96N run between tracks A and B of L96.

The width of the six-foot way between track A of L96 and track A of L96N, and that between track B of L96 and track B of L96N is more than 4.50 metres. According to the regulations of the infrastructure manager and the safety and health plan of the project supervisor, no additional safety measures have to be applied in this situation. The contractor shall consider the possibility and necessity of indicating the boundary line if the distance exceeds 4.50 metres, and shall review the risk analysis related to railway activity and the general risk analysis, taking into account the circumstances of the accident.
