Safety Investigation Report

Derailment of a wagon of a freight train

Bressoux - 29/08/2022

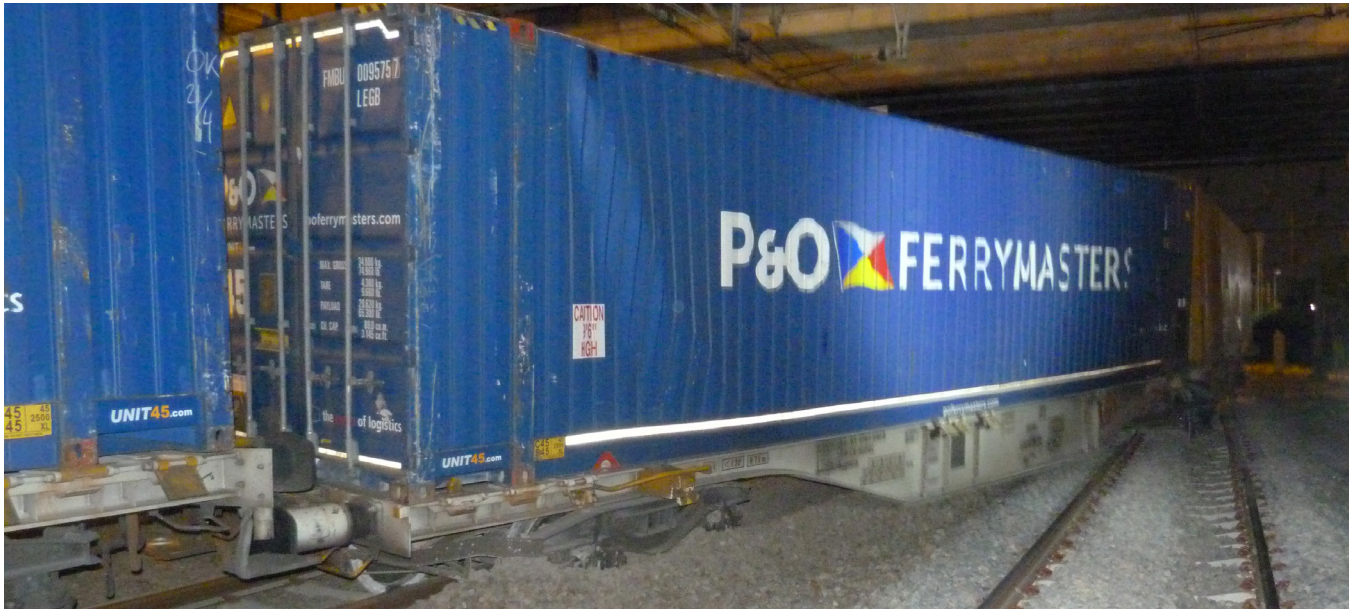
Shortly before 1:00 a.m., the train runs on track A of line 40. About 20 metres after entering the Froidmont tunnel near Bressoux, the right-hand wheels of the first bogie of the seventh wagon of the train lift and then fall back off the rails.

The train continues its journey towards Bressoux, causing damage to the track.

Approximately 2 kilometres after the Froidmont tunnel, at the entrance to the Bressoux station, the train runs over a switch: the first part of the train up to the sixth wagon continues its journey on track A of line 40, while the second part of the train (from the derailed wagon onwards) moves to the lead track of the Bressoux fan of sidings. The two parts of the train separate and the brake pipe ruptures. This rupture causes an emergency braking, bringing both parts of the train to stop.

There are no casualties, but the accident caused extensive damage::

- to the track over a distance of around 2 km
- to the sixth and seventh wagons.

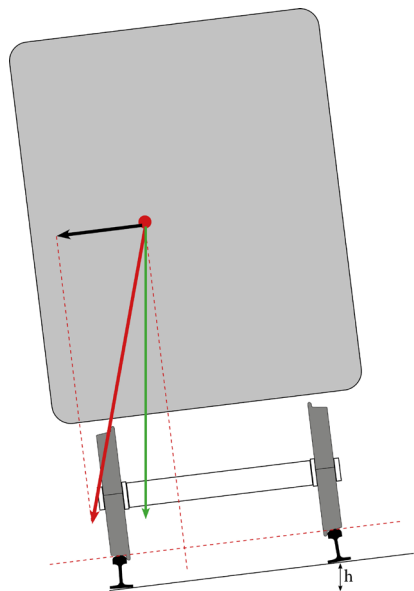
In a curve, a wagon is pushed by the centrifugal force towards the outside of the curve, causing an imbalance between the wheels on the inside of the curve and those on the outside. To counteract this, a curved track is generally laid at an angle that depends on the radius of curvature: the outer rail is raised sufficiently so that each rail supports approximately the same wheel load. The difference in level between the two rails is called the "cant". The cant is calculated for a specified design velocity.

In the Froidmont tunnel, the curved track was laid with a cant (h) calculated for a design velocity of 90 km/h.

When running at low speed with a load not centred laterally (the cellulose bales are positioned on the left against the wall of the container):

- centrifugal force is not as high
- the resultant of the forces involved is directed towards the inside of the curve.

It is assumed that the incorrect positioning of the load of cellulose bales in the container contributed to the centre of gravity moving towards the inside of the curve. Consequently, the resultant of the forces caused the offloading of the right-hand wheels on the first bogie of the wagon, lifting the wheels and causing them to derail.
