Summary  
Safety Investigation Report  
Near-collision between an empty passenger train and  
another passenger train  
Denderleeuw - 11/07/2023

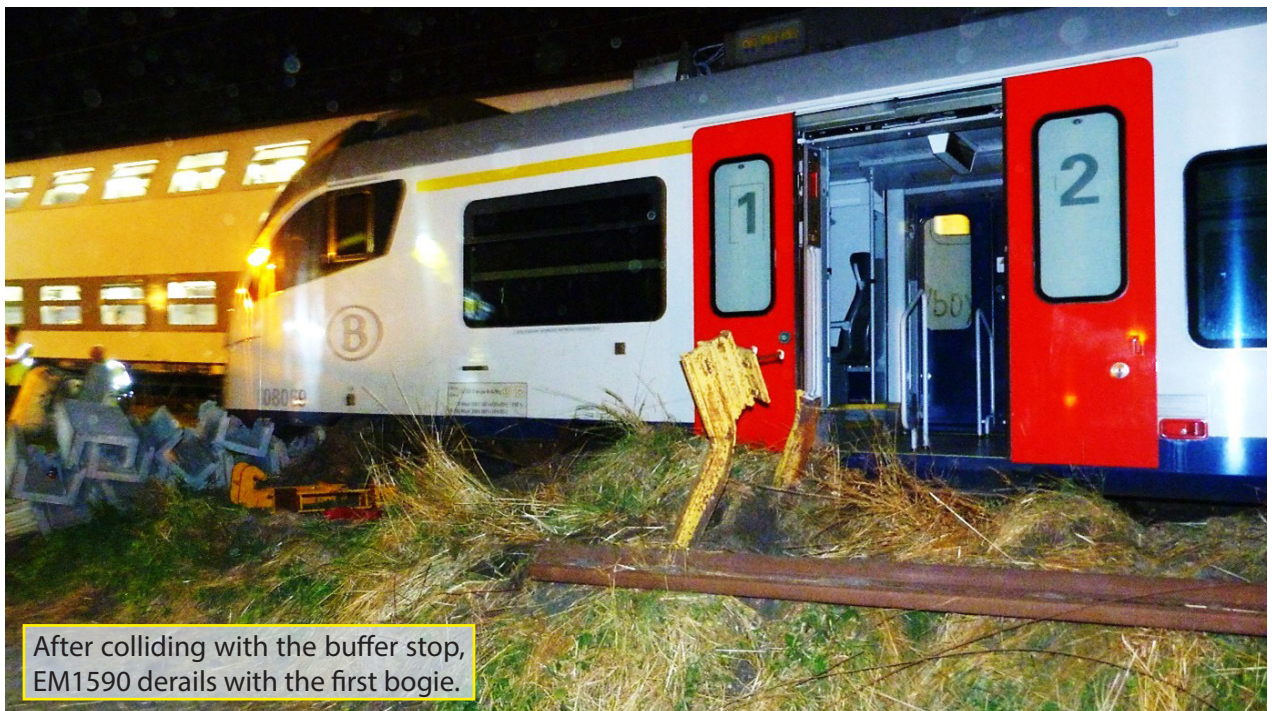
The end of the dead-end track is indicated by a buffer stop with a marker board that must be visually observed by the train driver. From the moment the distance between a buffer stop and the front of a train is less than 200 metres, the train driver must limit the speed to a maximum of 20 km/h. On the day of the accident, the train driver is driving at a speed of about 28 km/h until he reaches the end of the dead-end track and hits the buffer stop. As a result, the train derails with the first bogie over a distance of 17 metres in the direction of the adjacent track A of line 89 which is parallel to the dead-end track. Consequently, the train encroaches on the clearance gauge of this track. The collision also causes part of the buffer stop to land on track A of line 89.

The empty passenger train (EM1590) collides with the buffer stop at a speed of about 28 km/h. At the end of dead-end track 091, there is no more track and the train derails in the direction of the clearance gauge of the adjacent track A of the line 89.

The first contributing factor is that due to the lack of attention to the shunting movement, the train driver does not see the buffer stop with marker board at the end of the dead-end track 091, causing him to neither slow down nor brake.

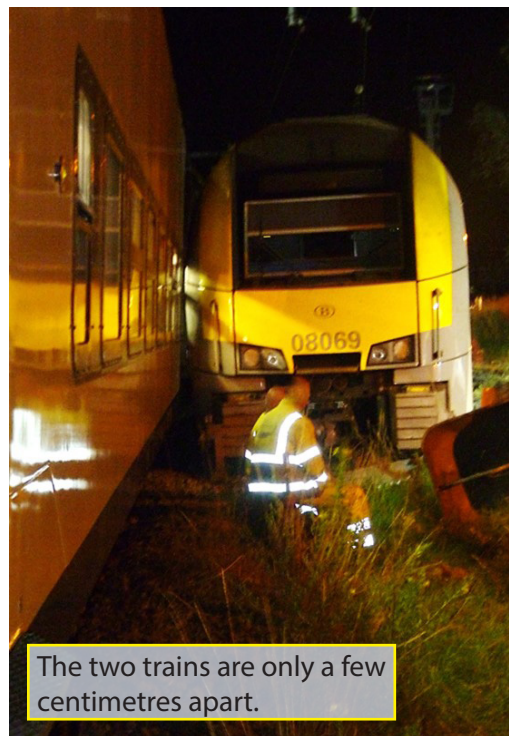
About one kilometre in advance of Denderleeuw station, at the level of the derailed train, the passenger train hits a piece of the buffer stop after which the train driver brings the passenger train to a standstill. The passenger train passes right next to the derailed train; both trains are only a few centimetres apart.

The near-collision by passenger train E5141 is caused by the encroachment of the empty passenger train EM1590 on the clearance gauge of track A of line 89.

The two trains are only a few centimetres apart.
