A subcontractor's worker hit by an SNCB/NMBS train.

27/10/2023 - 01:27 a.m.

Bleret (Waremme), on line 36 (~ kilometre marker 77.807)

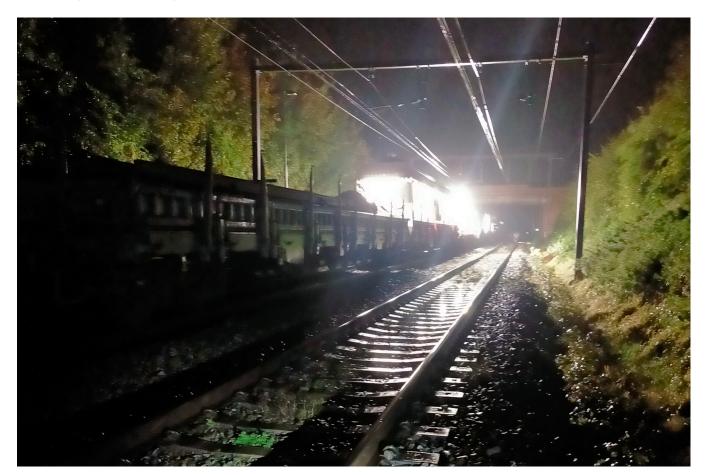
During the night of Thursday 26 to Friday 27 October 2023, works are carried out on track B of line 36 at Bleret: these works are carried out by the subcontractor Mobix and involve placing catenary supports outside the track. Track A is not affected by these works and traffic is not interrupted.

Just before 01:27 a.m., a worker of the team finds himself in the gauge of track A for a reason yet to be determined by the investigation.

At around 01:27 a.m., an SNCB/NMBS train runs on track A and hits the worker: seriously injured, he is taken to hospital by the emergency services.
