Collision between an empty passenger train and a railway crane causing the passenger train to derail.

Significant accident which, under slightly different circumstances, could have led to a serious accident.

12/03/2024 around 11:21 p.m.

Line 59 track A at kilometre marker 27.662.

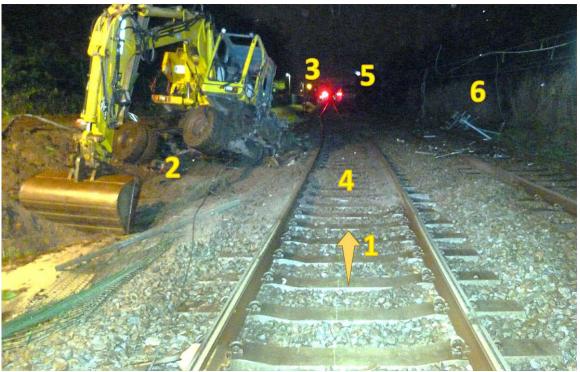
1. Line 59 track A, direction of travel of train EM2772	2. Railway crane
3. Train EM2772	4. Location of the collision between train EM2772 and the railway crane; lateral distortion of the track
5. Train E1822 on line 59 track B	6. Damage to catenary

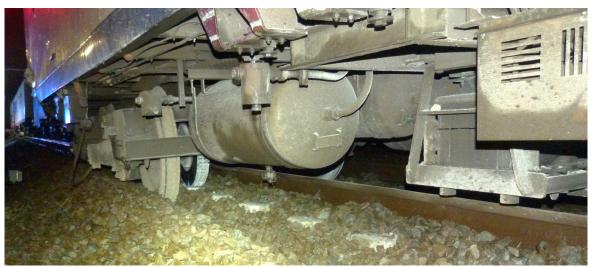
Photo: Front of train EM2772
