# Summary Safety Investigation Report

Collision between an empty passenger train  
and a railway crane  
Belsele - 12/03/2024

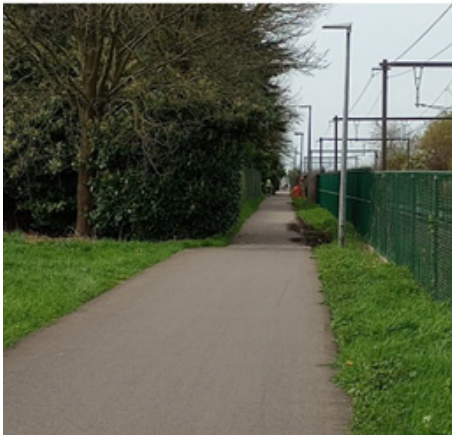
He chooses cycle highway F4, which runs alongside line 59, as the route to LC38 to get to the other side of LC35. Initially, the concrete cycle highway is wide enough for the railway crane. Further on, however, the cycle highway narrows and additionally an overhanging hedge vegetation restricts passage. Passing the narrowing, the railway crane enters the verge with its right wheels. Due to the rainy weather conditions, the ground is soggy and insufficiently stable to support the heavy weight, causing the crane to sink into the clearance gauge of track A. Shortly afterwards, the empty passenger train EM2772 hits the crane.

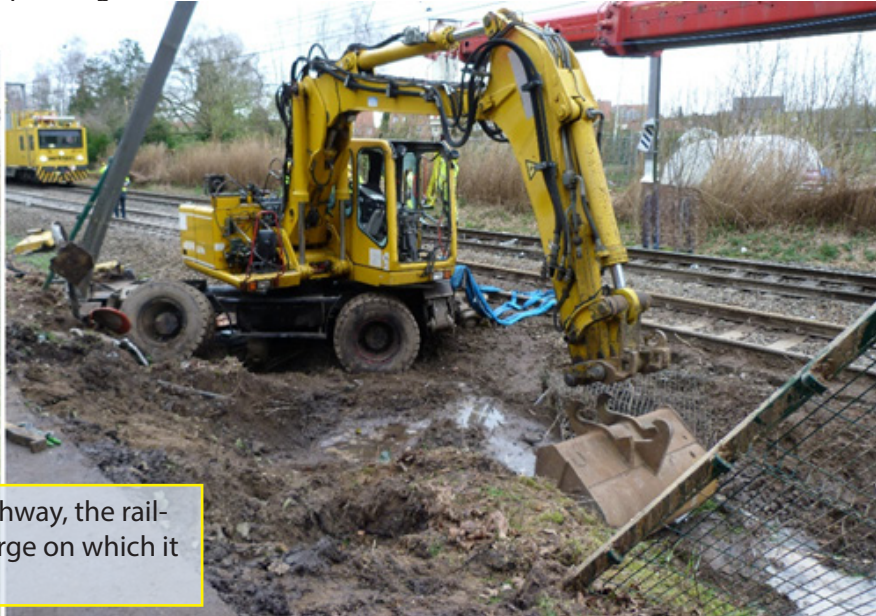
Due to a narrowing of the cycle highway, the railway crane deviates to the soggy verge on which it then slides away towards the track.

The direct cause of the collision of the railway crane by the train is the sliding of the railway crane into the clearance gauge of the track, due to the subsidence of the surface of the cycle highway on which the railway crane was travelling.

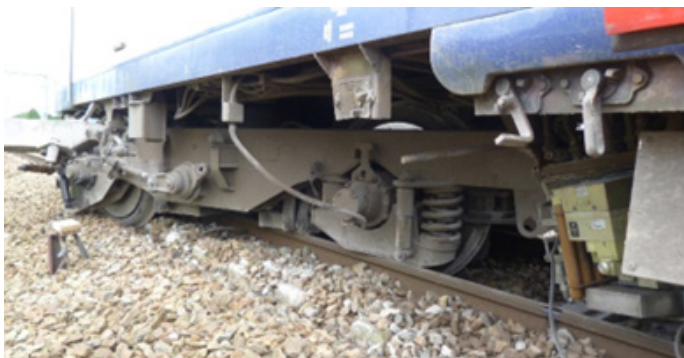
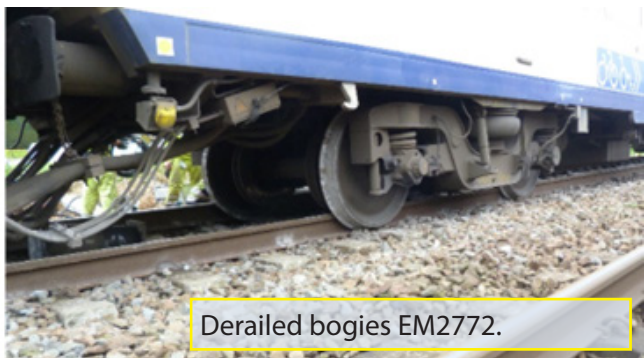
This impact causes the empty passenger train to derail.

Derailed bogies EM2772.
