Safety Investigation Report

Collision of a shunting locomotive
with an empty, parked passenger train
Schaerbeek Marshalling yard R - 13/05/2024

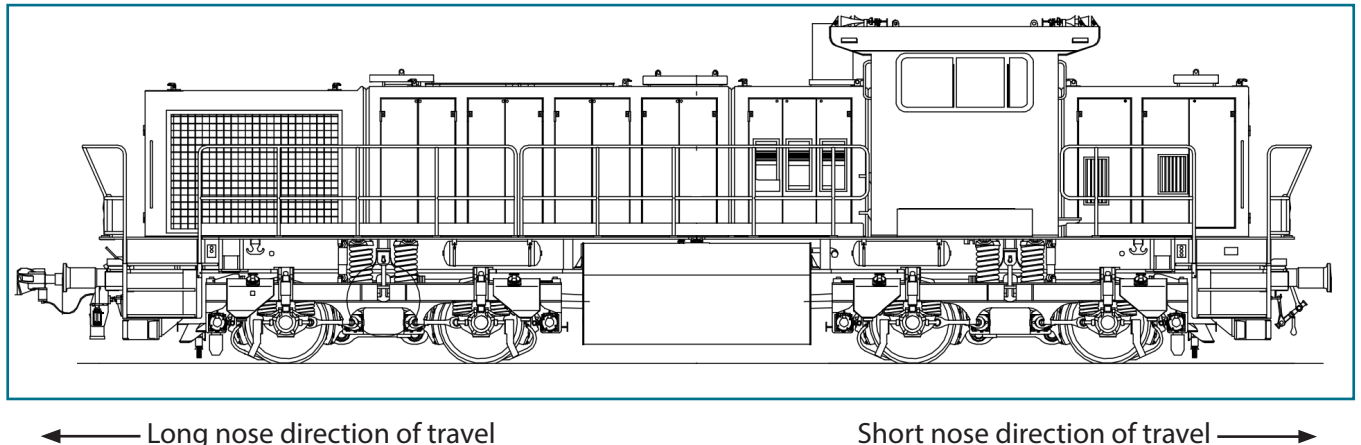
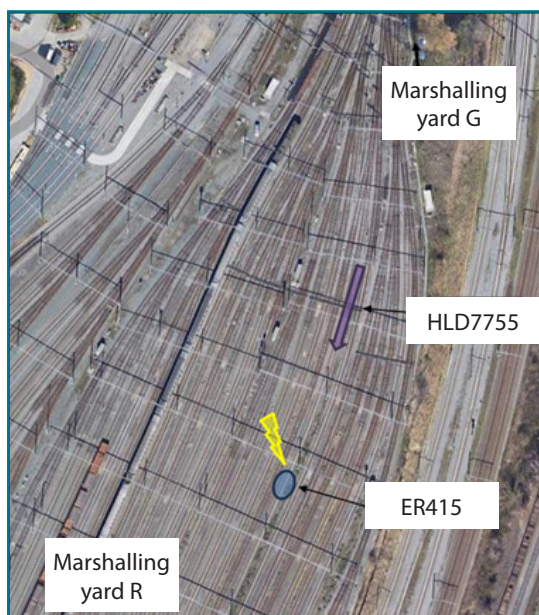
During his shift, the driver performs several shunting operations with the shunting locomotive HLD 7755, both in the direction of travel with the short nose at the front and in the direction of travel with the long nose at the front. In these shunting operations, First Assistants Operations support the movements.

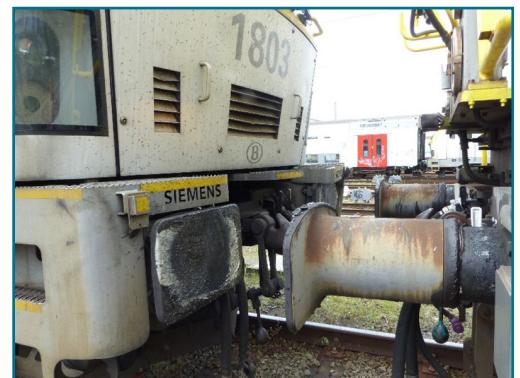
At about 11:12 a.m., the shunting locomotive collides with the head of the empty, parked passenger train on track 727 during the shunting operation. As a result, the two First Assistants Operations and the train driver are injured. Furthermore, there is damage to the passenger train: the buffers of the locomotive are completely compressed.
