# Bulletin of General Information

## Train mistakenly shunted onto an occupied track Zeebrugge Pelikaan fan of sidings - 20/08/2024

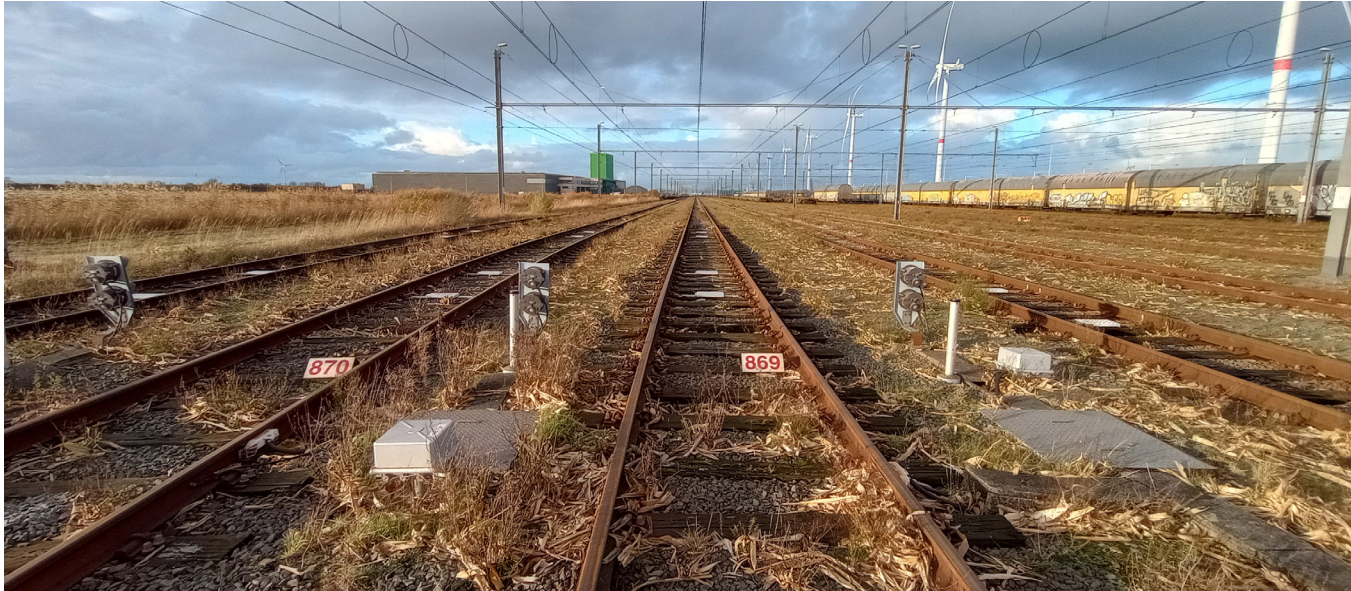
On Thursday 20 August 2024 at 01:58 p.m., E47576 (Recklinghausen Ost – Zeebrugge Pelikaan fan of sidings, Lineas, 23 wagons) arrives at track 869 in the Zeebrugge Pelikaan fan of sidings, and the train driver notices several wagons on the track. The train driver performs an emergency braking and can thus avoid a collision. The train driver continues by driving at a walking pace in order to clear level crossing 6 and comes to a standstill 5 metres in rear of the wagons involved.

The train driver contacts Block 7 Brugge. The wagons appear to be from Z65902 (Crossrail).
