Bulletin of General Information

Derailment of 2 tank wagons during a hump shunting operation Antwerpen-Noord fan of sidings - 31/10/2024

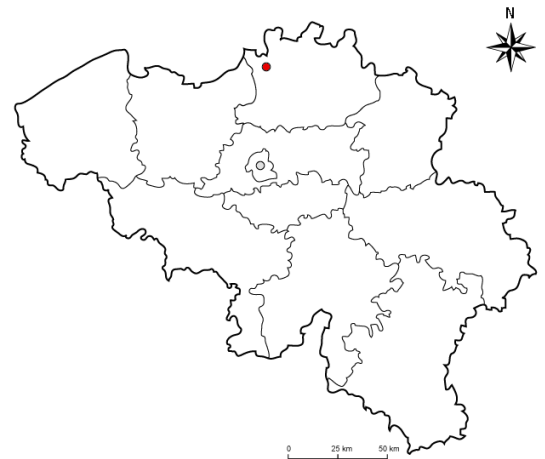
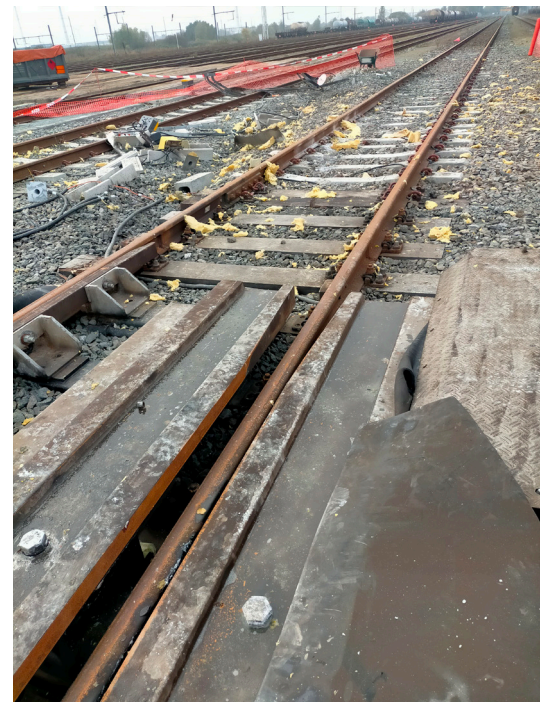
On 31 October 2024, at 5.10 p.m., during a hump shunting operation in the Antwerpen-Noord C2 fan of sidings, two wagons derail on track 222 at the level of the rail brake.

The wagons overturn, partly on the adjacent track 221. The tank of the first wagon is pierced during the derailment: a large quantity of toluene (a highly flammable dangerous good) leaks out, causing pollution and requiring the intervention of the specialist fire brigade of BASF.

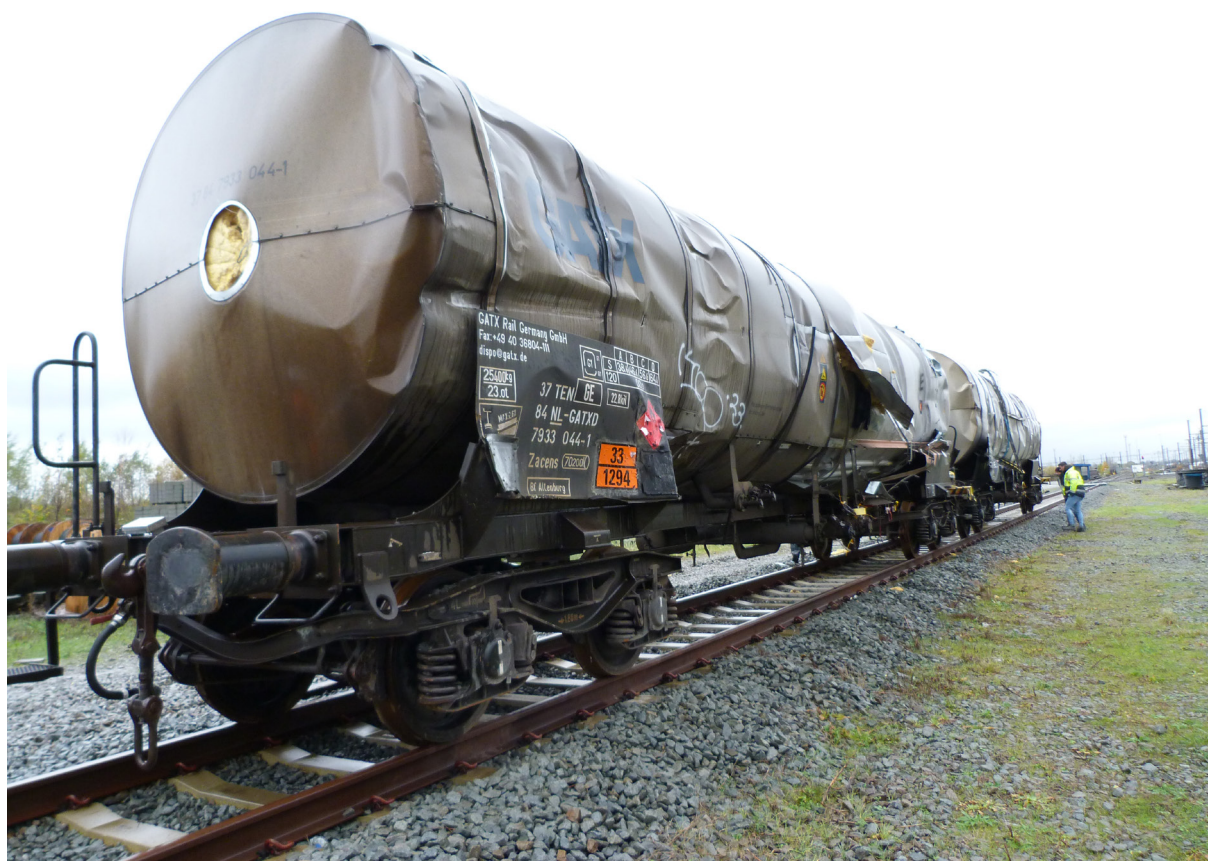
Photo of the wagons that were rerailed after the accident
