## Safety Investigation Report

Derailment of 2 tank wagons  
during a hump shunting operation  
Antwerpen-Noord fan of sidings - 31/10/2024

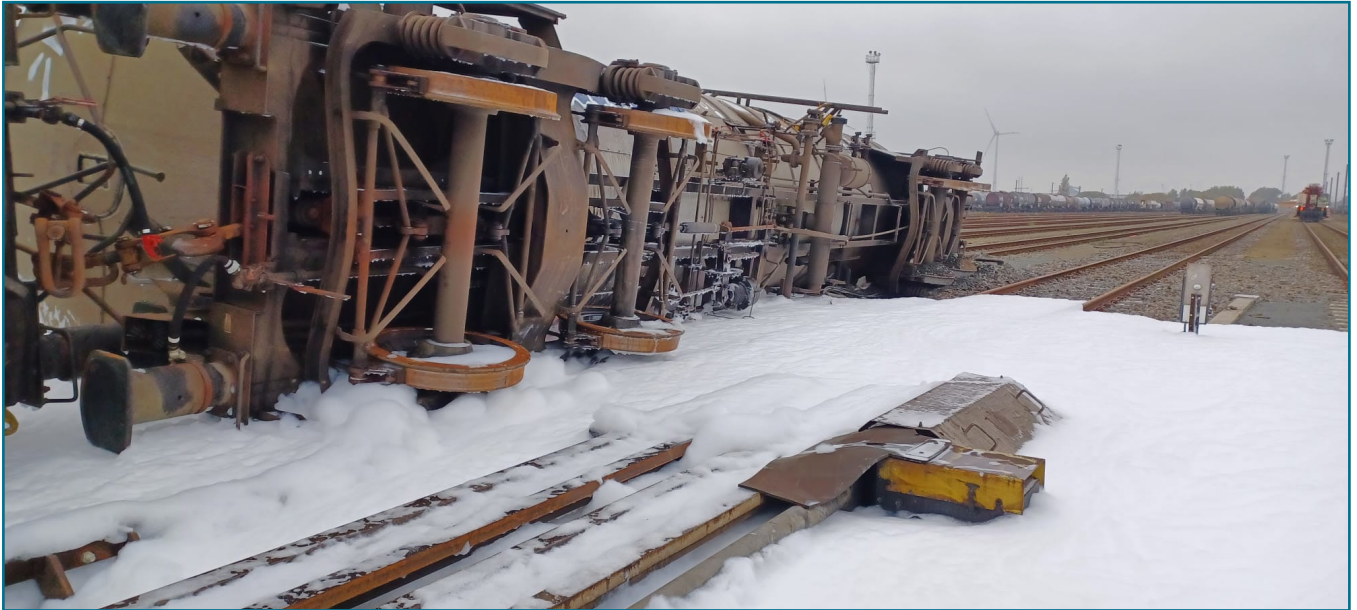
When the two wagons reached the classification retarder of shunting track 222, they derailed and overturned, partly onto the adjacent track 221.

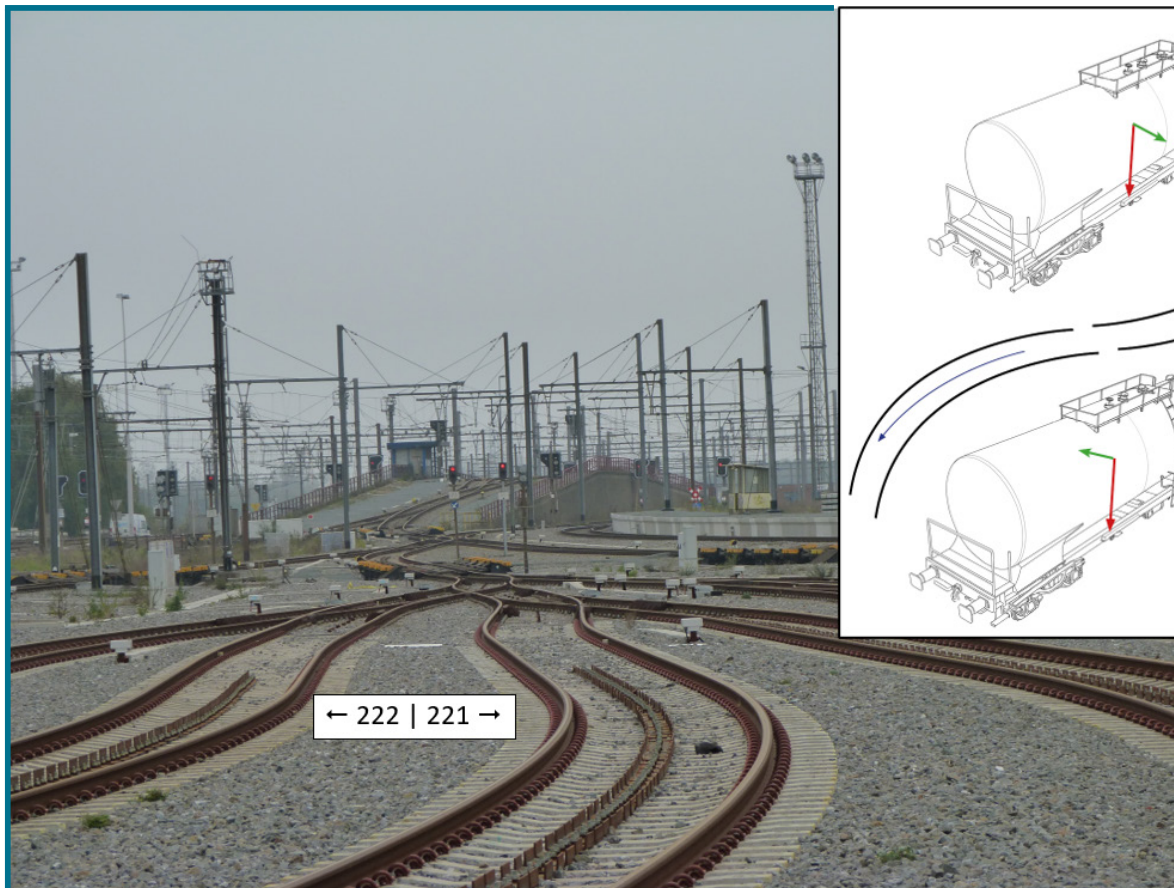
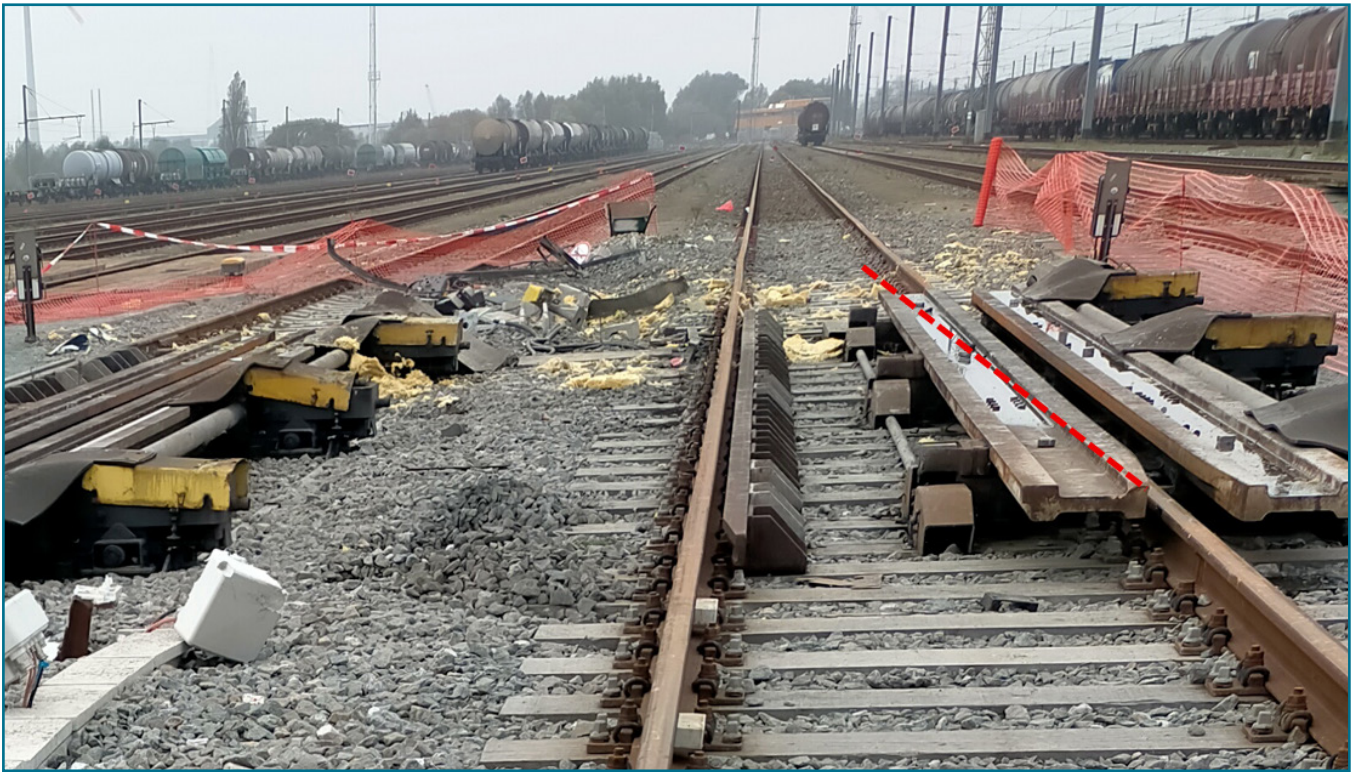
The IU assumes that the derailment of the first wagon is due to a combination of factors: the speed of the wagons after the main retarder, combined with the layout of track 222, may have generated forces acting on the wagons; the right-hand wheel of the first axle of the leading wagon is believed to have mounted on the classification retarder brake bar, the position of which was found during the investigation to be abnormal.

The investigation revealed that the bolts securing the classification retarder brake bar were loose: this may have caused the bar to move into an abnormal position following braking while the preceding wagons were passing.

During the investigation, the infrastructure manager took improvement measures. At the close of the investigation, these measures are extended and planned, while others are identified, implemented or planned:

1. Functional tests and modification of the “basic parameters” of the automatic shunting installation of the C fans of sidings ;
2. Check and adjustment of the “user parameters” of the automatic shunting installation of the B fans of sidings ;
3. Close monitoring of the maintenance and technical condition of the automatic shunting installation at Antwerpen-Noord ;
4. Functional tests and measures for putting shunting track 222 back into service ;
5. Close monitoring of all incidents and anomalies during automatic shunting at Antwerpen-Noord by the I-CBE.14 investigation team ;
6. Installation of a CCTV network at Antwerpen-Noord to visually assess the dynamic behaviour of wagons and cuts.
