## Safety Investigation Report

Runaway of a passenger train  
Mechelen - 24/05/2024

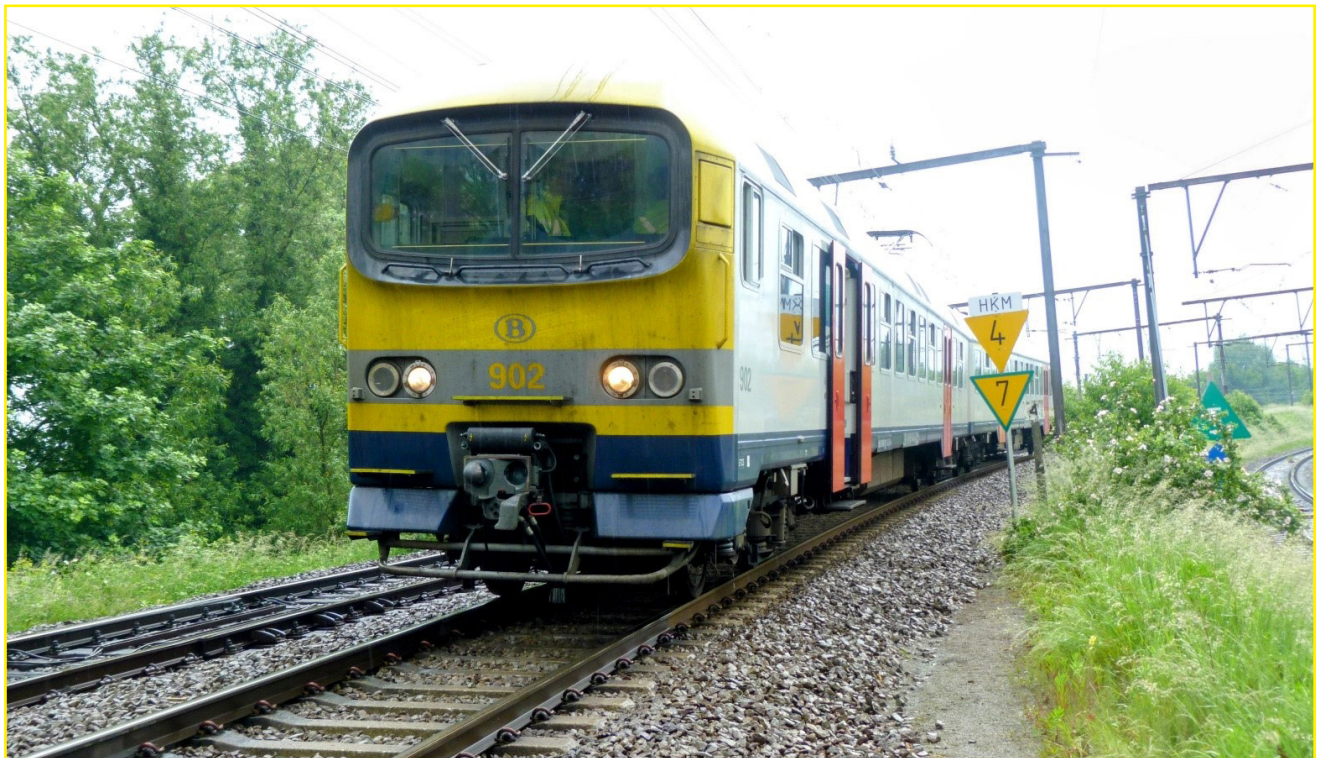
The runaway railcar runs through a switch on track B of line 53 and comes to a standstill after a train passenger actuates the emergency signal.

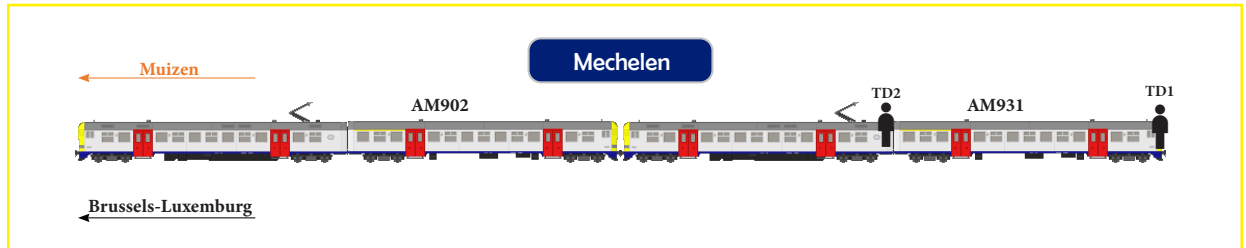
The situation prior to the uncoupling on arrival in Mechelen:

TD1: the train driver arriving in Mechelen with the convoy; after uncoupling, he would leave with AM902.  
TD2: the train driver performing the uncoupling; he was due to leave an hour later with AM931.
