# Bulletin of General Information

## Face to face between two freight trains

### Witte Molen (Antwerpen-Noord) - 13/10/2025

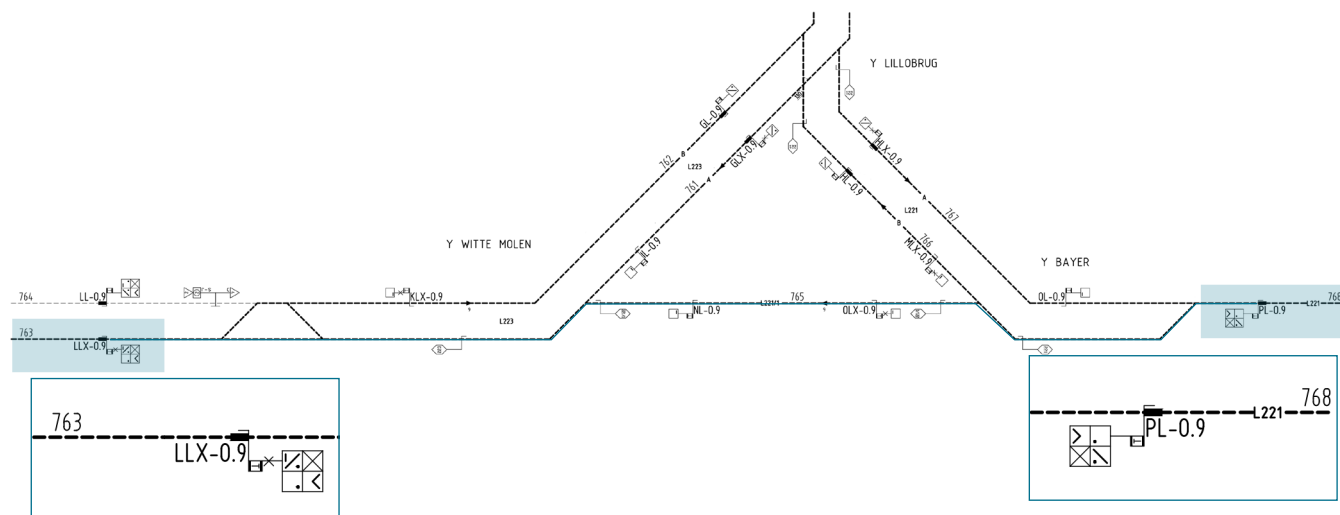
Around 12.15 p.m., the driver of train Z32235 reported by telephone that his train was at signal PL-O.9 on track 768. The signal was open and the itinerary for train Z32235 was traced towards track 763.

At 12.27 p.m., the drivers of the two trains realised that they were traveling towards each other on the same track 763 and they responded. After braking, their trains were 200 meters apart.
