# Safety Notice

Catenary hit by a lorry  
Lokeren - 26/05/2026

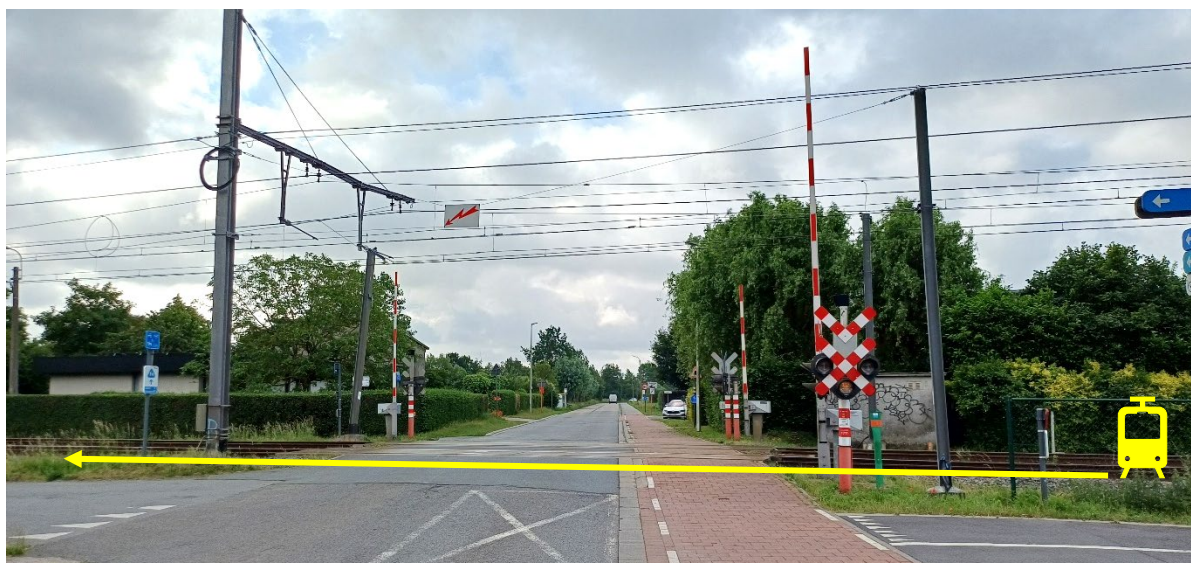
*Illustration: LC 60 as seen from the direction of travel of the lorry*

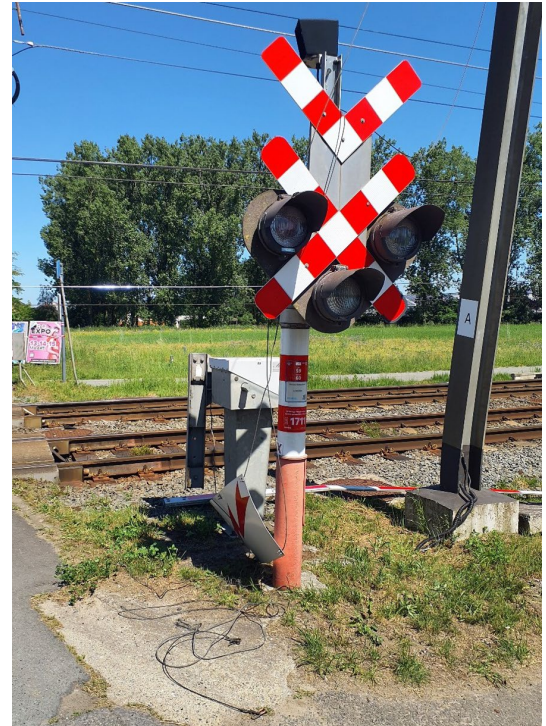
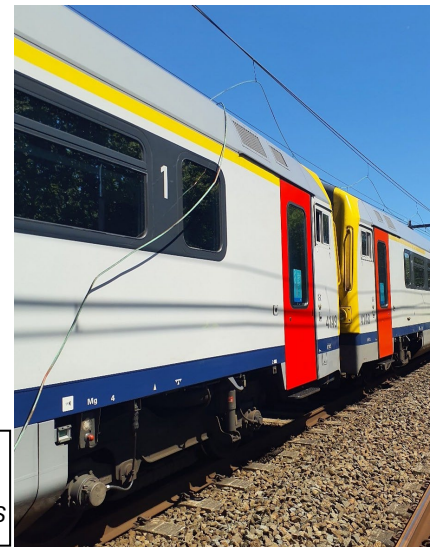
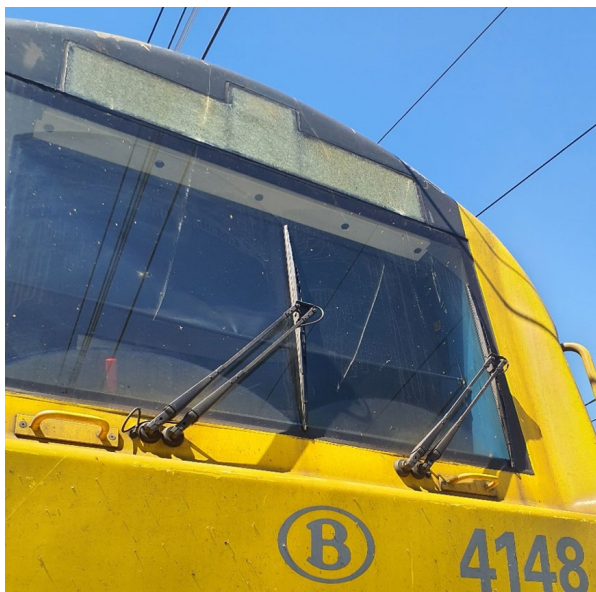
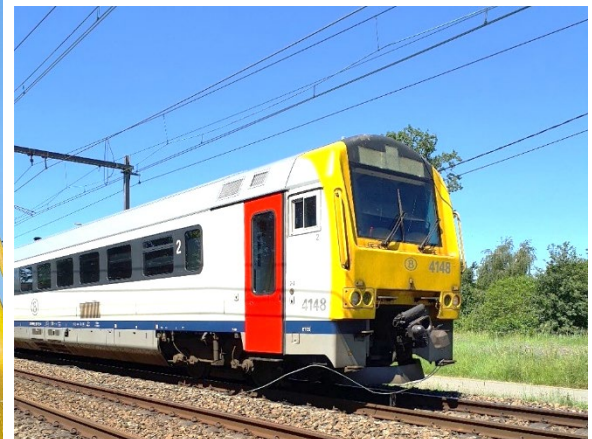
- On the catenary damage has been identified to
  - support cables and contact wire (1);
  - suspension and fixing components such as hangers, clamps and brackets;
  - cables and electrical connections;
  - support constructions and fixing points.
- A barrier needs to be replaced (2)

- Damage to the 1st railcar:
  - The windscreen of driver's cab 2 is scratched (3);
  - The front glass of the destination indicator is broken (4);
  - The coupling (type GF) is damaged (5), as are several electrical cables;
  - The flexible air hoses are damaged;
  - A bracket of the ABS sensor (sensor that measures the rotational speed of the wheels for the braking system) is bent;
  - There is minor lacquer damage to the front (driver's cab) and along the entire right-hand side (as viewed in the direction of travel of train Z658).
- Damage to the 2nd railcar:
  - There is minor lacquer damage on the right-hand side.
