# Safety Notice

Accident at a level crossing  
Estaimpuis – 21/05/2026

On 21 May 2026, at around 07:03 a.m., the driver of SNCB/NMBS train E3227 (Ath – Kortrijk) noticed a car on the tracks at level crossing 11 on line 75A in Estaimpuis.

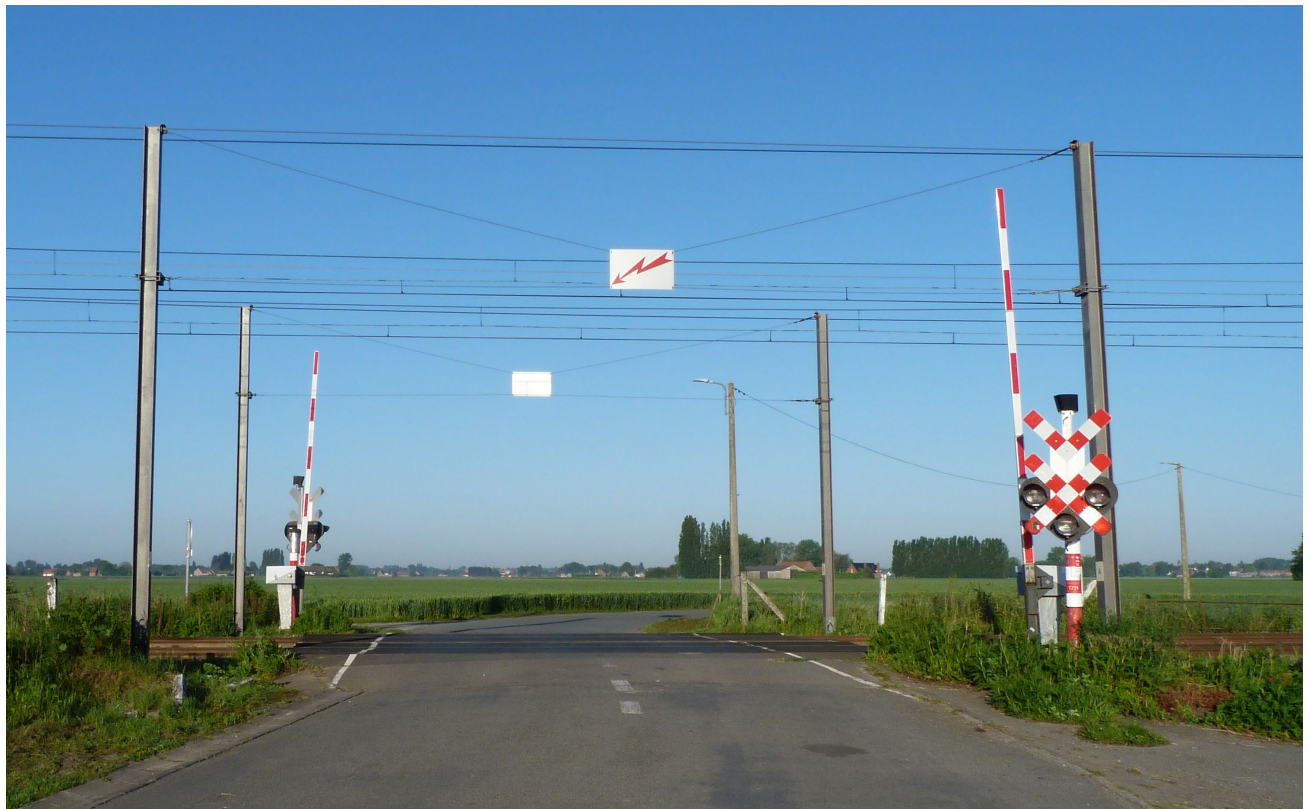
Level crossing 11 on line 75A is fitted with active signalling with two half-barriers.

*Illustration: view of level crossing 11 from Rue de Tournai*

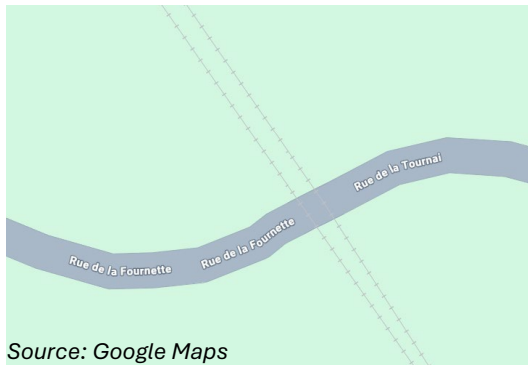
Source: Google Maps

Rue de la Fournette and Rue de Tournai lead to the level crossing.

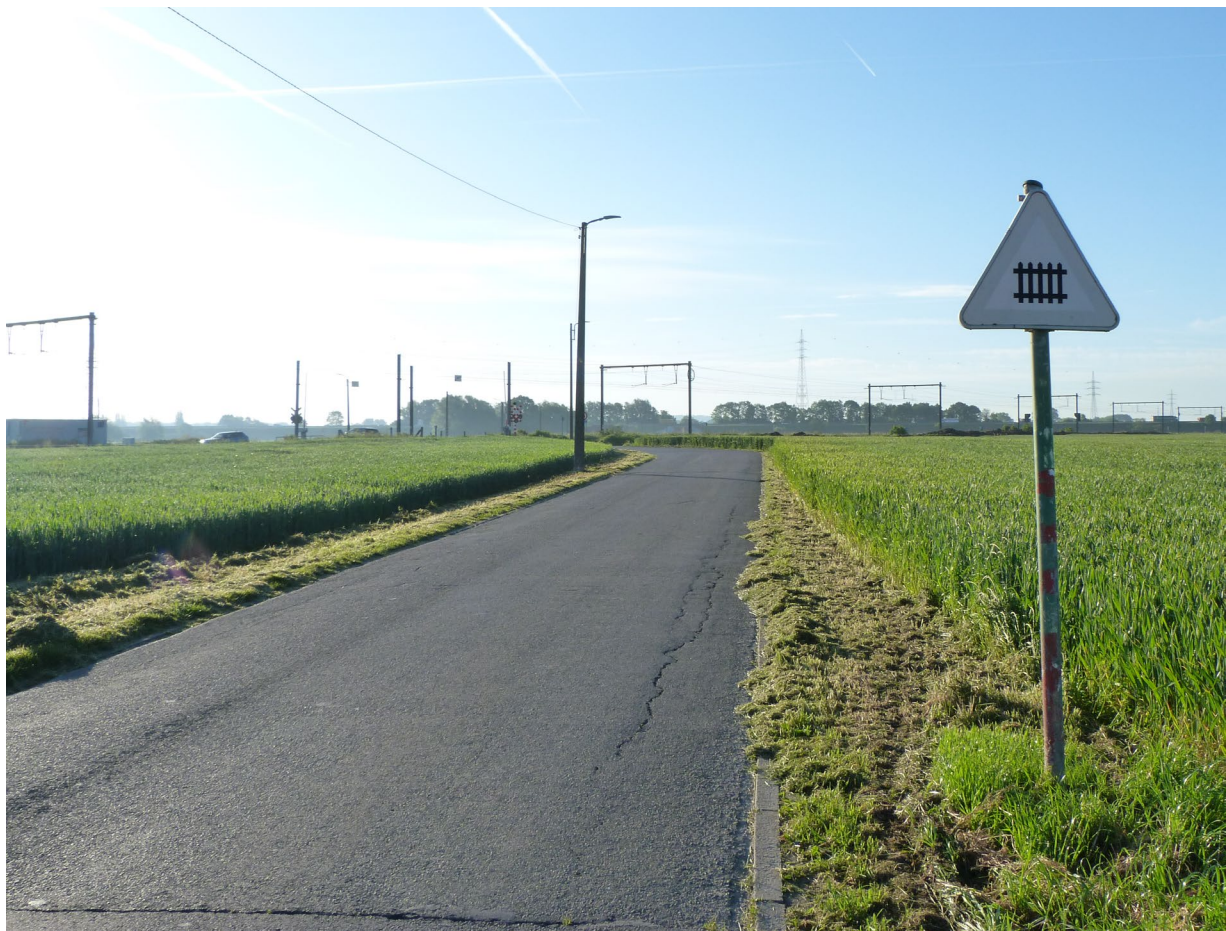
The A41 warning signs indicating the level crossing with barriers can be found on Rue de la Fournette and Rue de Tournai. The red colour of the border of the A41 sign on Rue de la Fournette has faded.

*Illustration: general view of the approach to level crossing 11 via Rue de la Fournette, along which the A41 warning sign is positioned approximately 150 metres from the level crossing (visible in the background of the photo, along with the electrical installations of the railway line)*

During his on-site investigation the day after the accident, the investigator from the Investigation Unit observed the presence of the A41 warning sign indicating the presence of the level crossing approximately 150 metres in advance, both on Rue de la Fournette and Rue de Tournai. However, the red colour of the border of the sign on Rue de la Fournette has almost completely faded.

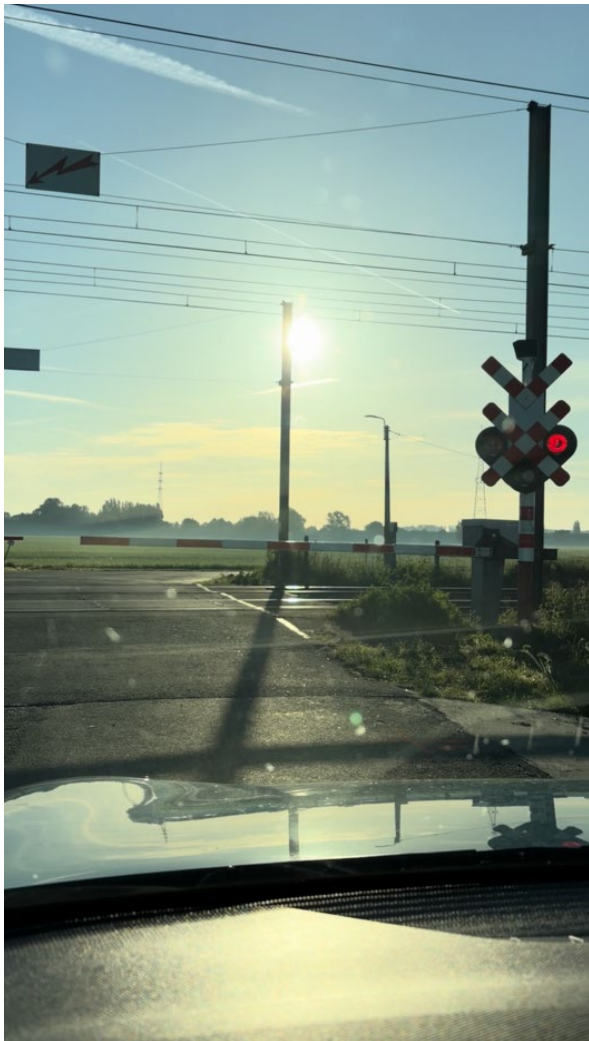
The photo shown here was taken under conditions similar to those on the day of the accident (time, weather, position of the sun), from inside a vehicle that was stationary in front of closed level crossing 11.
