# Safety Notice

Collision between a train and a road vehicle  
on a level crossing  
Elsegem - 19/06/2026

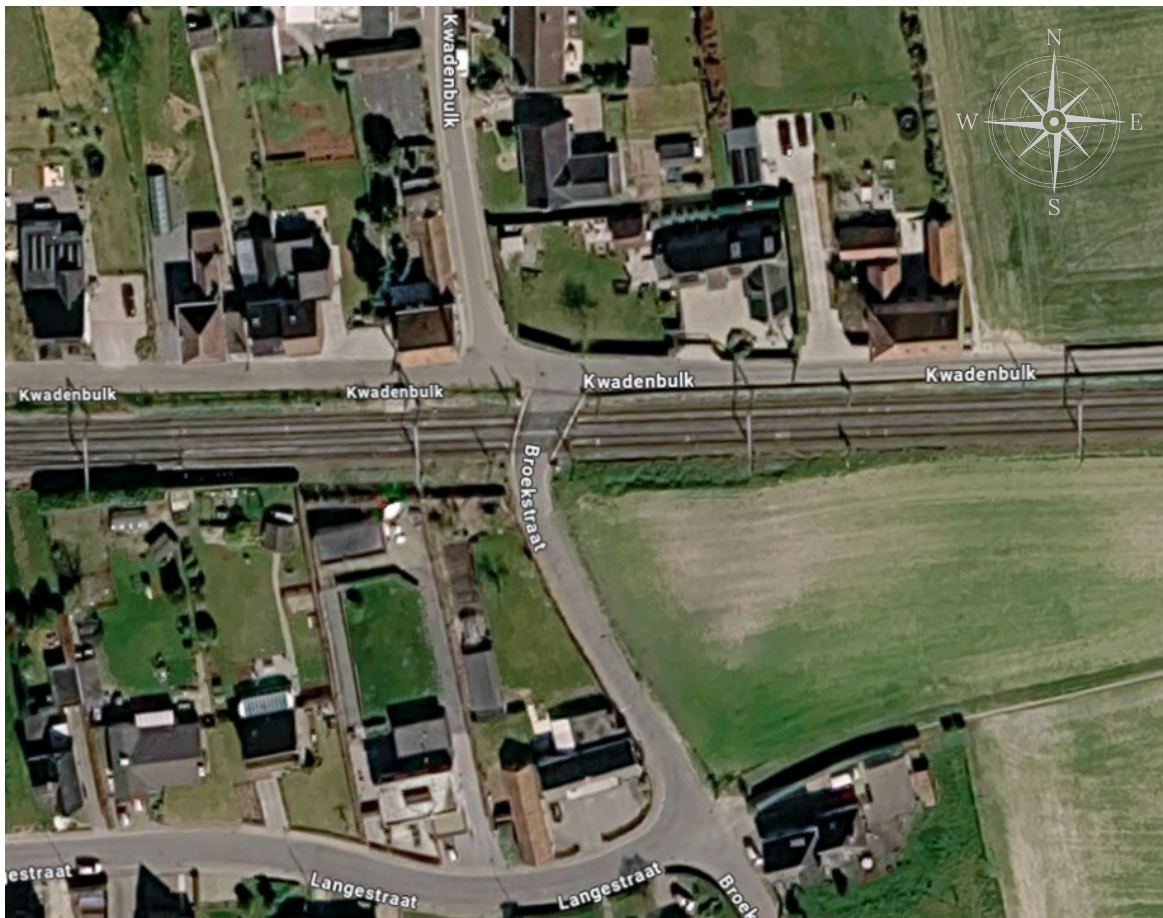
*Illustration: Aerial view of level crossing 96. Broekstraat crosses the railway line. Kwadenbult runs alongside the northern side of the railway line, with a western, an eastern and a dead-end branch. (Source: Google Maps)*

Broekstraat crosses railway line 89. Broekstraat runs up towards the level crossing from the south. For road users crossing the level crossing from Broekstraat, the junction with Kwadenbulk is immediately after leaving the level crossing.

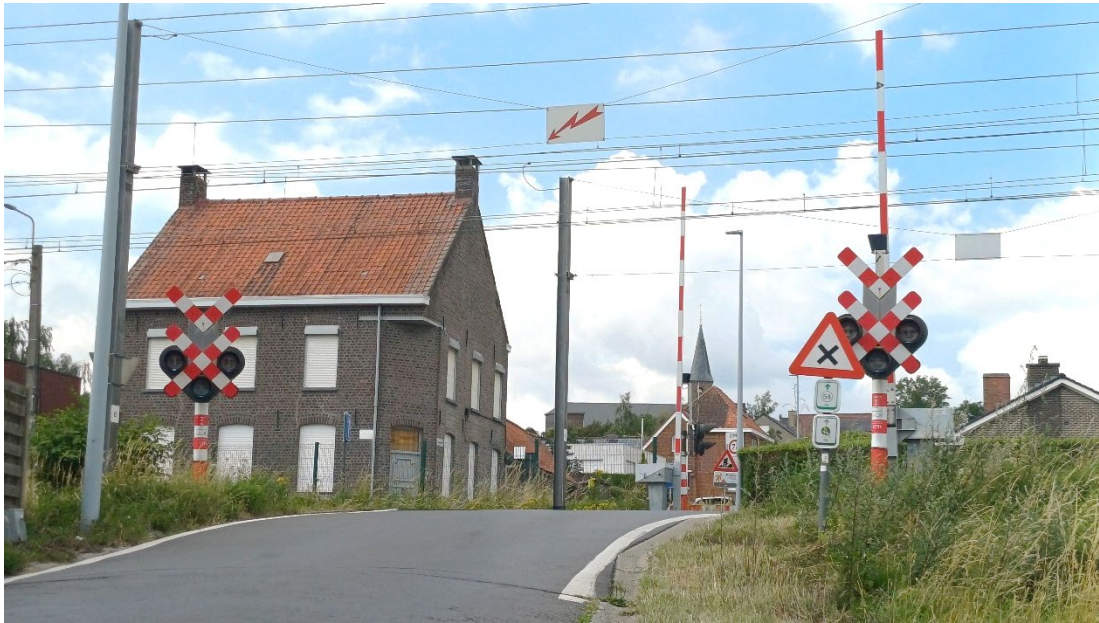
*Illustration: view from Broekstraat towards level crossing 96. The road runs up towards the level crossing. The B17 traffic sign indicates a junction where vehicles approaching from the right have right of way.*

The Investigation Unit does, however, find that the traffic situation in the immediate vicinity of the level crossing is complex.

The combination of a level crossing, a sloping approach, a nearby right-of-way situation and restricted visibility presents a risk factor for road safety.

- Only drive onto a level crossing if you are certain you can clear it completely.
- Bear in mind any junctions, right-of-way situations and stationary traffic just beyond the level crossing.
- Always observe the level crossing signalling. Do not drive onto a level crossing once the red lights are flashing, the audible signal is sounding or the barriers are closing.

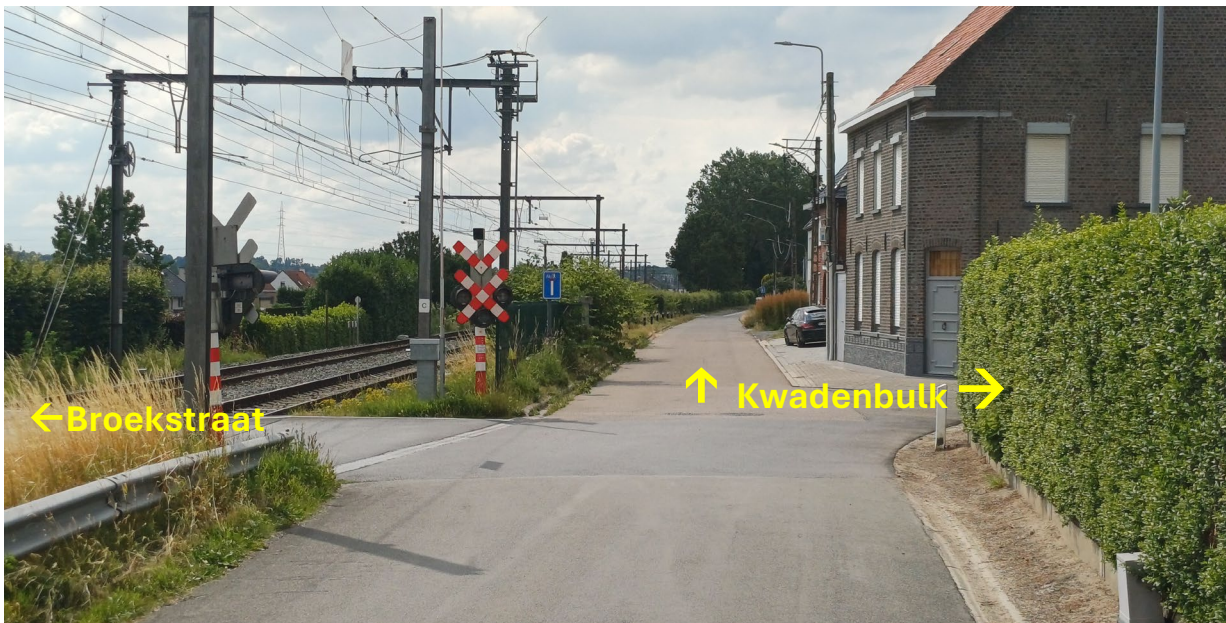
*Illustration: view from Kwadenbulk near level crossing 96. Broekstraat joins it on the left. Going straight on, Kwadenbulk comes to a dead end. Kwadenbulk continues to the right.*
