# Safety Notice

Collision between a passenger train and a  
motor scooter on a level crossing  
Hoboken - 22/06/2026

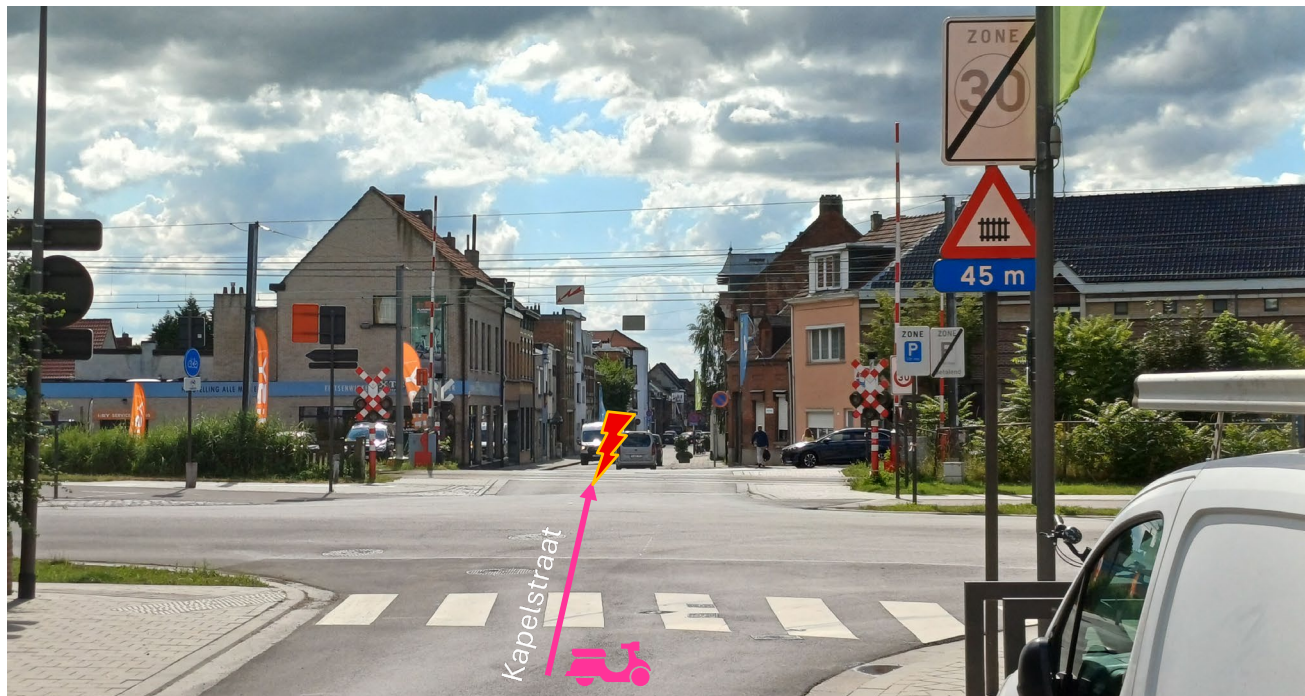
On 22 June 2026, at around 4:34 p.m., an SNCB/NMBS passenger train was approaching level crossing 10 on track B of railway line 52, located on Kapelstraat in Hoboken. The train driver noticed the presence of a motor scooter and rider on the level crossing and performed an emergency braking. Despite the emergency braking, a collision could not be avoided. After the collision, the train came to a standstill approximately 275 metres in advance of the level crossing.

*Illustration: the level crossing where the accident took place*

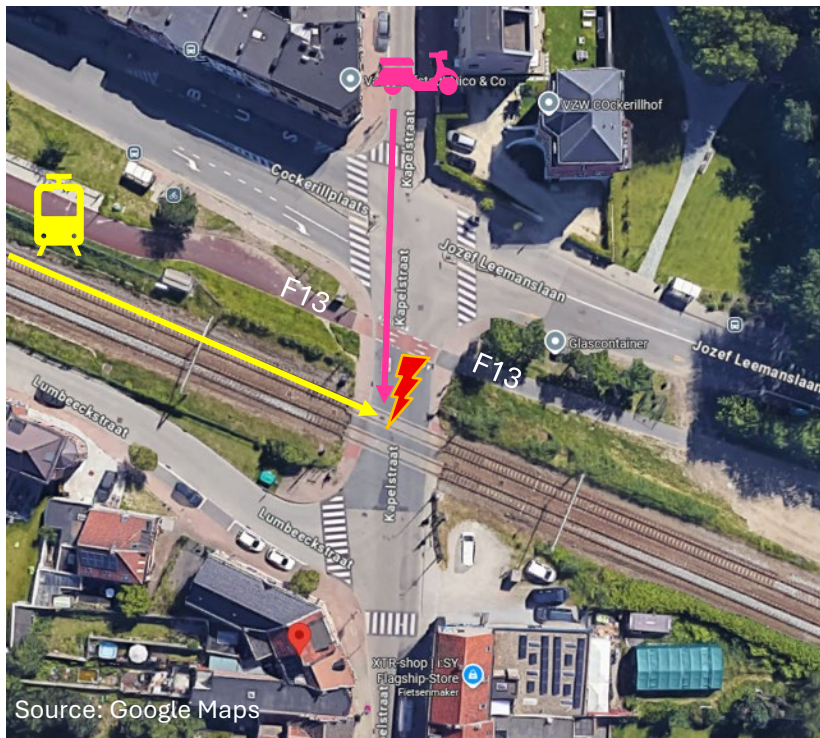
The level crossing on Kapelstraat is situated in the immediate vicinity of two junctions: on the one hand, the junction with Cockerillplaats and Jozef Leemanslaan, and on the other, the junction with Lumbeeckstraat.

Road users crossing the level crossing from Kapelstraat towards Lumbeeckstraat must yield to traffic coming from Lumbeeckstraat after the level crossing.

Road users crossing the level crossing from the opposite direction must yield to traffic coming from Jozef Leemanslaan after the level crossing.

The F13 cycle highway runs parallel to railway line 52. This cycle highway crosses Kapelstraat right next to the level crossing. Cyclists must give way to traffic crossing the level crossing there.

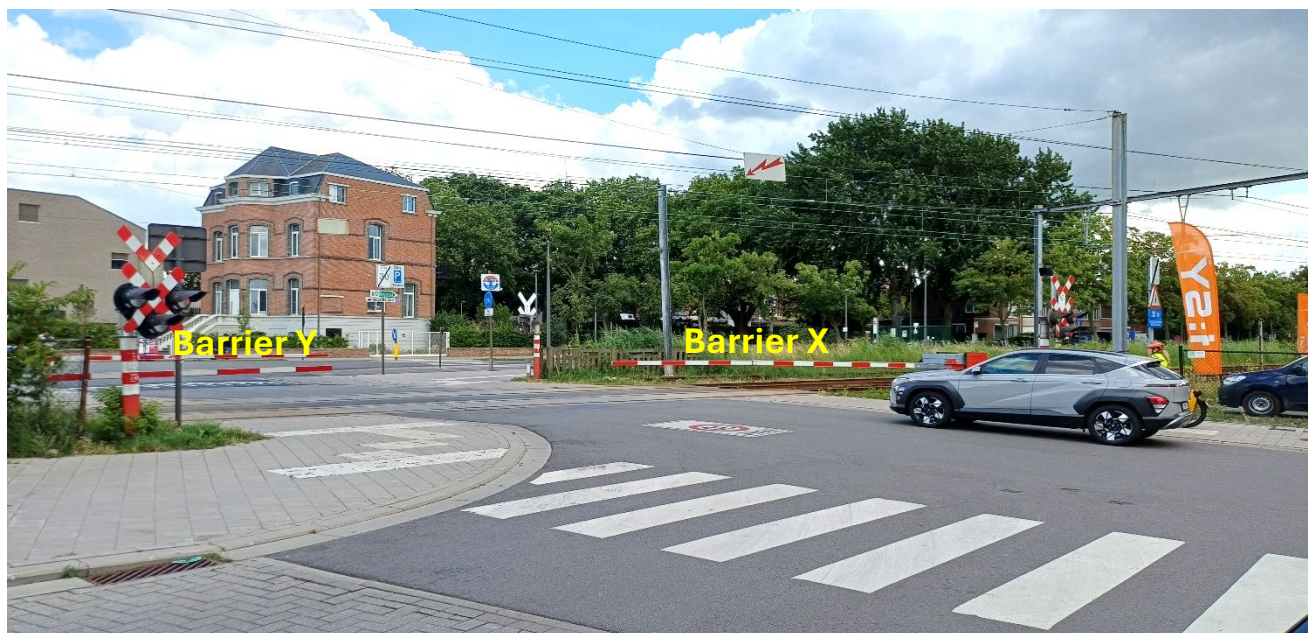
Level crossing 10 is a public level crossing with automatic active signalling with half-barriers and an additional barrier for pedestrians and cyclists.

On all five approach roads, there are A41 warning signs indicating the presence of a level crossing with barriers.

Over the past five years, level crossing barriers X and Y have been struck several times.
