# Safety Notice

Collision between a train and an agricultural vehicle  
on a level crossing  
Hasselt - 26/06/2026

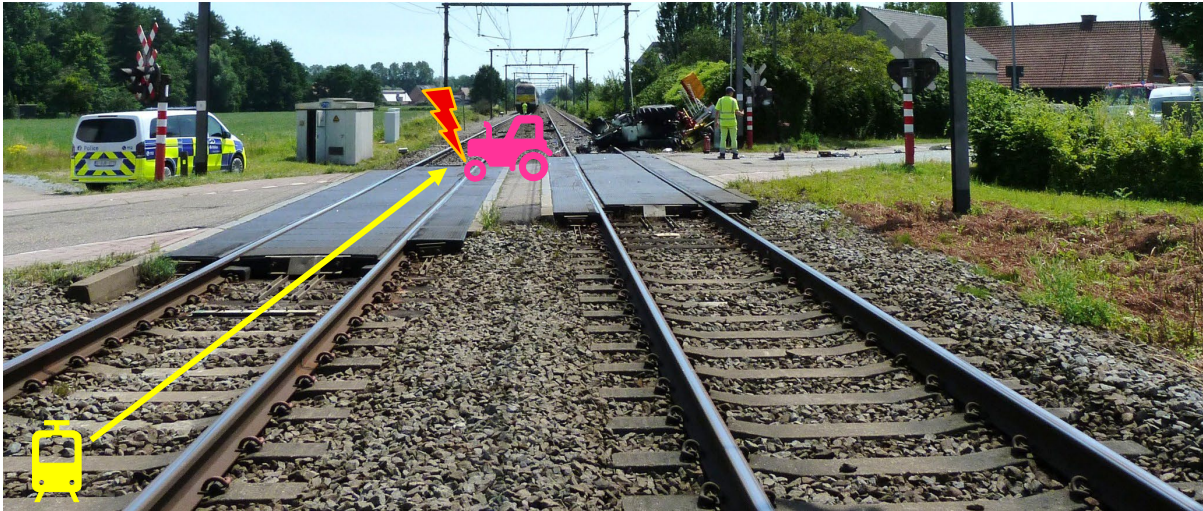
Despite the emergency braking, the train still passed the level crossing at a speed of around 95 km/h and collided with the agricultural vehicle. Upon impact, the first four-wheel bogie derailed. The train eventually came to a standstill 316 metres in advance of the level crossing.
