Railway Accident and Incident Investigation Unit

Safety Notice Derailment of a work train (ballast regulator) of the infrastructure manager Infrabel Tubize - 14 April 2020

December 2020

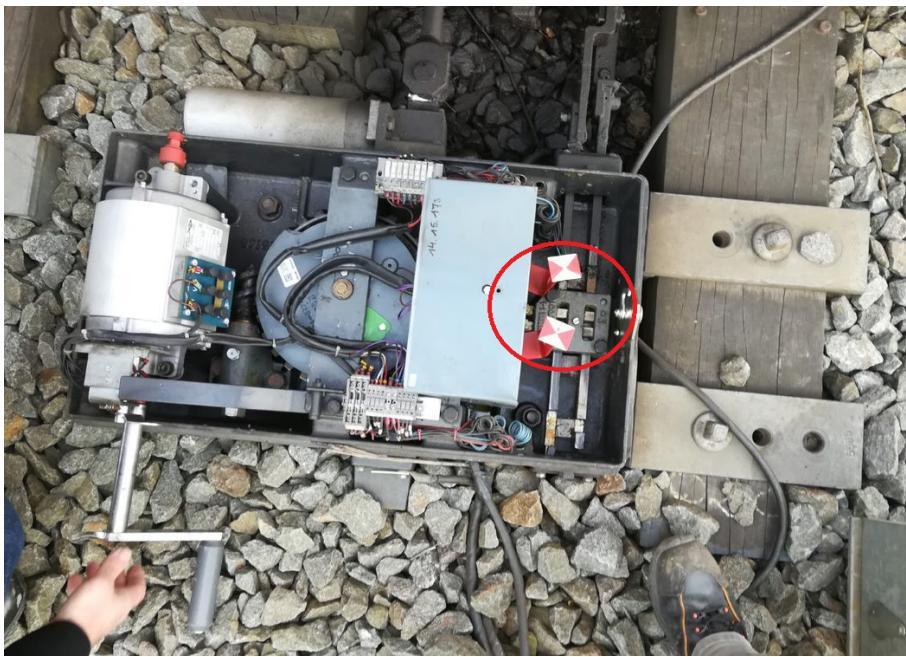
Illustration: Interior of the motor housing of the 02C switch. It is possible to see the diabolos in the red circle and the emergency crank in the bottom left of the picture.

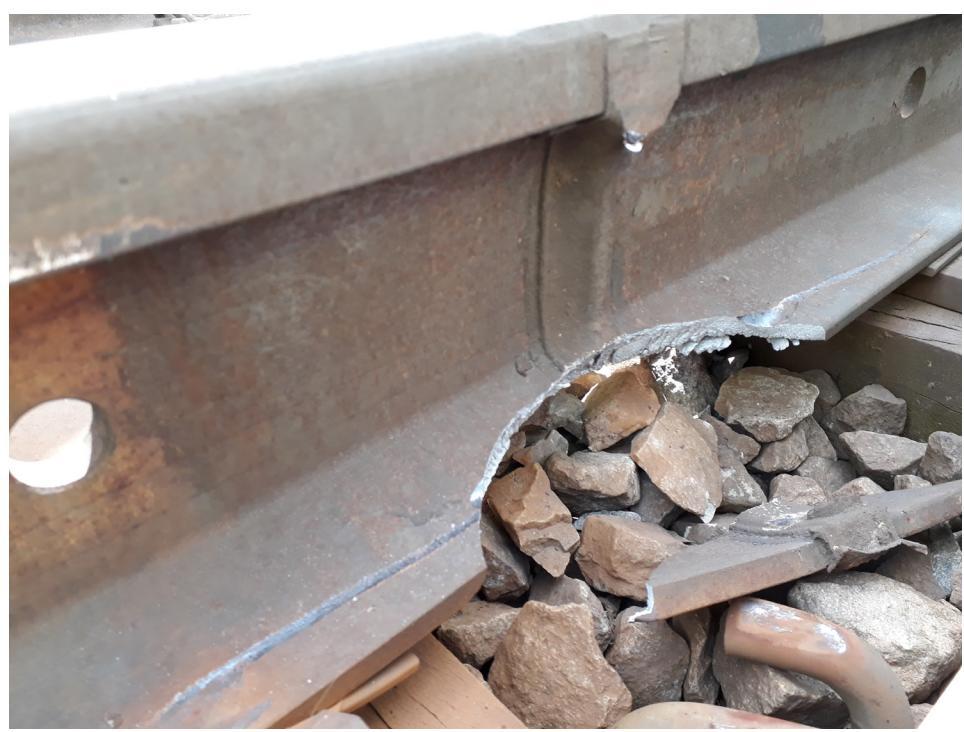
Switch 02C was damaged as shown in the illustration below.

Illustration: Damage observed on switch 02C on 14 April 2020 (source: Infrabel)

The necessary repairs were made to the damage to the crocodile box of signal FX-C.27.

Track A needed repairs following the derailment. The track remained out of service between switches 01C and 06C so that repairs could take place.

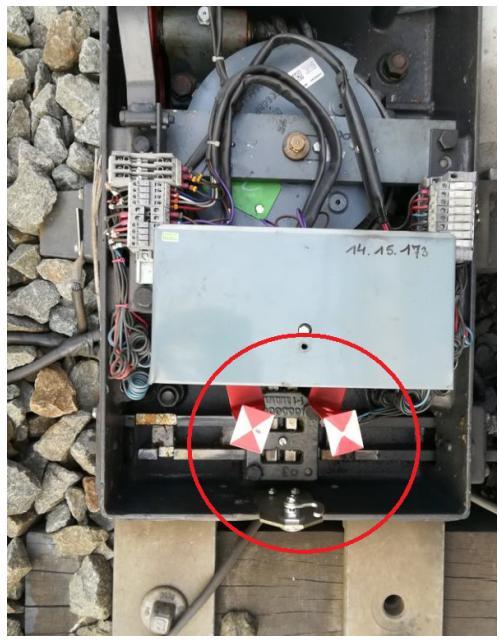
After lifting the switch motor housing cowl, the Investigation Unit investigator found that the diabolos were not in the expected position relative to the position to which the switch had been manoeuvred.

Infrabel's investigator found that the window on the cowl that allows the inside of the engine housing to be seen was dirty.

The dirty window made it difficult to check the position of the diabolos without lifting the motor housing cowl.

It was apparent from the investigation that the movement during the last manoeuvre before the ballast regulator derailed was not fully completed, as evidenced by the position of the diabolos after opening the engine housing cowl (see illustration below)⁷.

Illustration: In the red circle, the diabolos of the 02C switch in the position found by investigators after the accident.

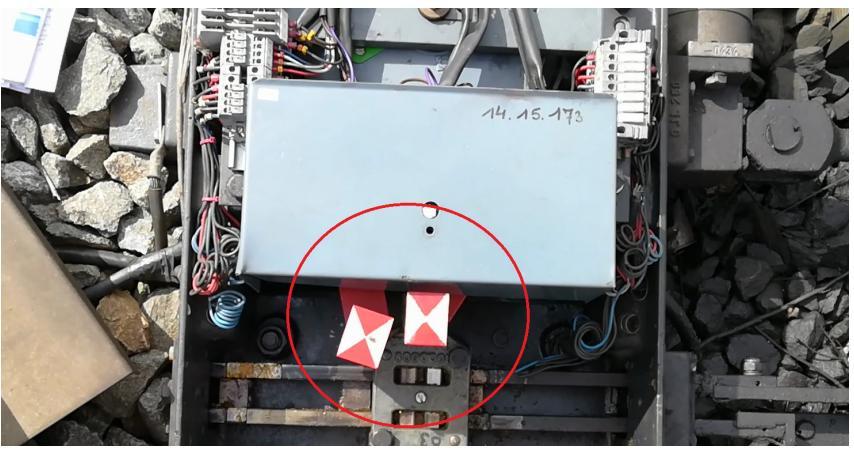
After requesting an emergency crank, the investigators manually operated the 02C switch and could see that the previous manual operation of this switch was not fully completed: the switch point was not fully to the right and the switch lock was not engaged.

Investigators were then able to complete this manoeuvre and obtain control to the right of the switch. The position of the diabolos confirmed the locking of the switch: they were in the axis of the window (see illustration below).

Illustration: In the red circle, the diabolos of the 02C switch in the position indicating control to the right of the switch.
