# Summary Safety Investigation Report Derailment of a Lineas freight train Aubange - 19 May 2017

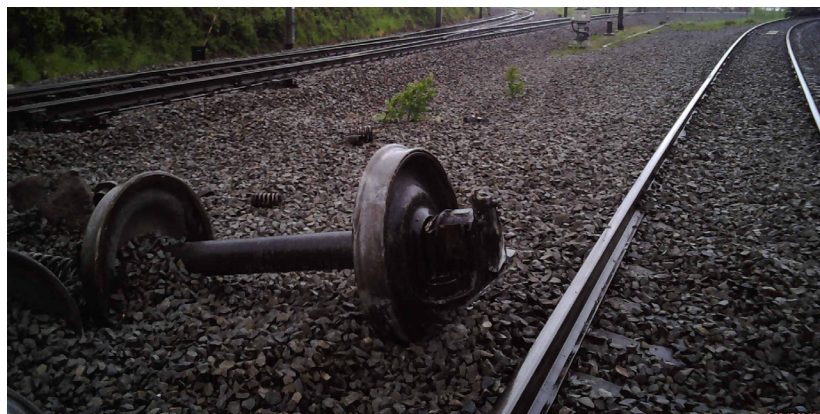
The derailment of the 24th wagon (n°3368 4952 072-9) is the result of the broken right wheel of the 3-3' axle of the wagon (see illustration below).

*Illustration of a Sggmrs-type wagon, showing the 3-3' axle.*

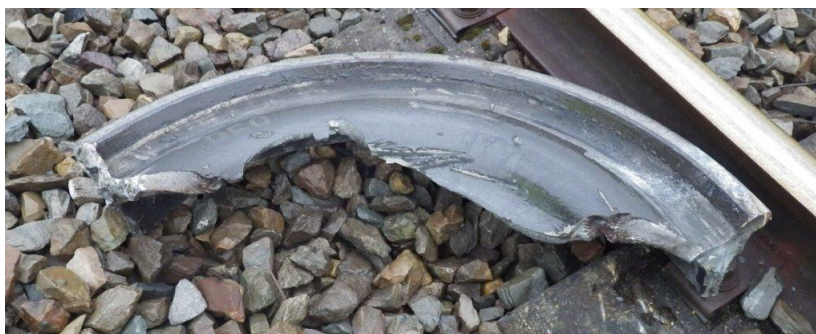
The inspection of the train by the driver reveals that the two last wagons of the train have derailed. The initial inspections of the rolling stock, of the tracks and of the area surrounding the tracks reveal that one of the wheels of the penultimate wagon broke some 17 kilometres from the train's stopping point, causing the derailment of the wagon.

Fragment n°	Borne Kilométrique (BK)	
1	127.800	
2	127.000	
3	124.000	
4	124.000

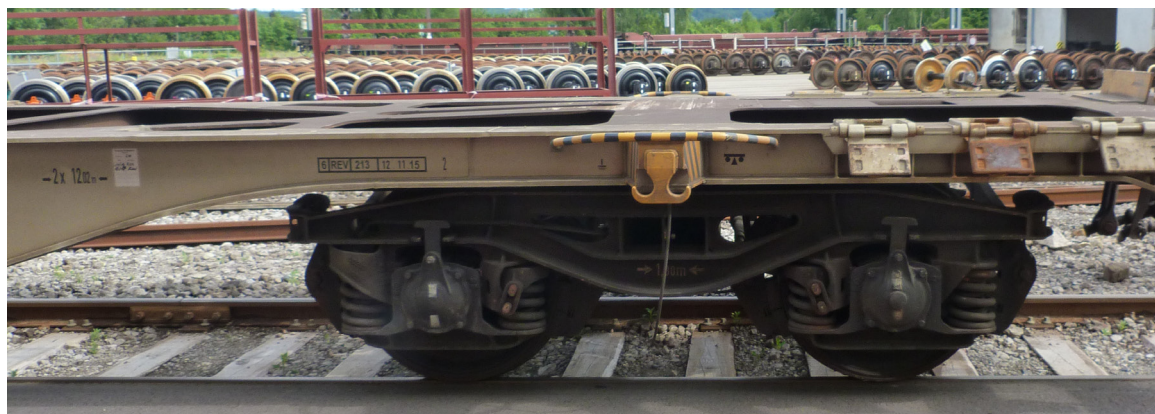
The wheel’s design does not facilitate its inspection: the following photo shows the visible portion of the wheel of a wagon of the same type as wagon 33 68 4952 072 9.
