Bulletin of General Information  
Near-collision between an empty passenger train  
and another passenger train  
Denderleeuw  
11 July 2023

Derailment of an empty passenger train followed by a near-collision between this empty passenger train and another passenger train.

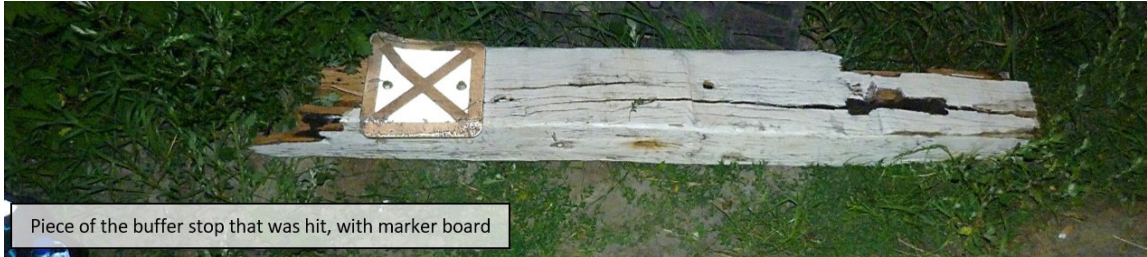
On 11 July at around 8:20 p.m., the empty SNCB/NMBS passenger train E1590 leaves Denderleeuw station to carry out a shunting movement on dead-end track 091. There is a buffer stop at the end of the dead-end track. Train E1590 runs to the end of track 091 and hits the buffer stop after which it derails with one bogie. This bogie derails in the direction of track A of line 89.
