# Safety Notice

Fire in a train  
Anderlecht – 19/03/2026

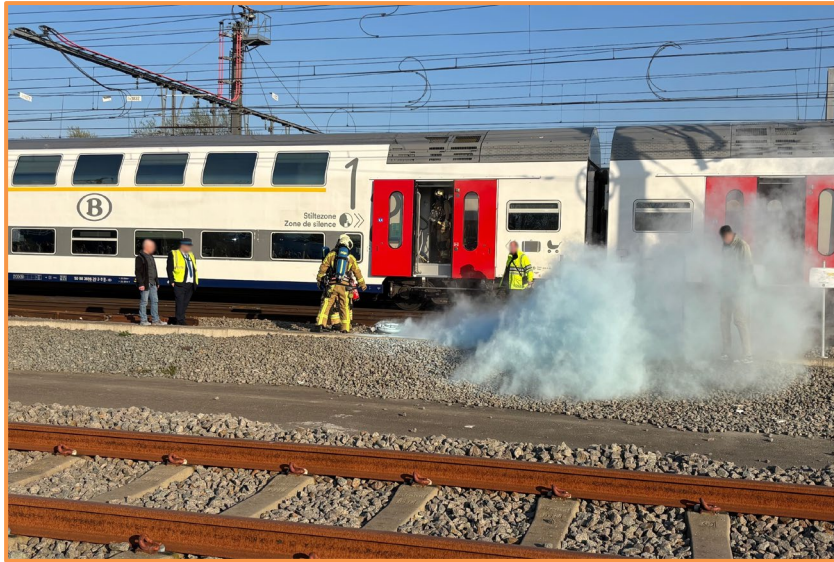
Source: SNCB/NMBS

On Thursday 19 March 2026, at around 4:33 p.m., the E1537 passenger train continued its journey towards Gent after departing from Bruxelles-Midi/Brussel-Zuid. In the second carriage, the battery of an electric monowheel caught fire, causing a significant amount of smoke. The fire alarm and several emergency brakes were triggered. The train came to a standstill at the Petite-Île/Klein-Eiland junction in Anderlecht. Train traffic in the area was suspended to allow passengers to be evacuated from the train, and the fire brigade was called to the scene.

The fire in train E1537 started when a passenger's electric monowheel caught fire on board the train. The battery was not charging at that moment.

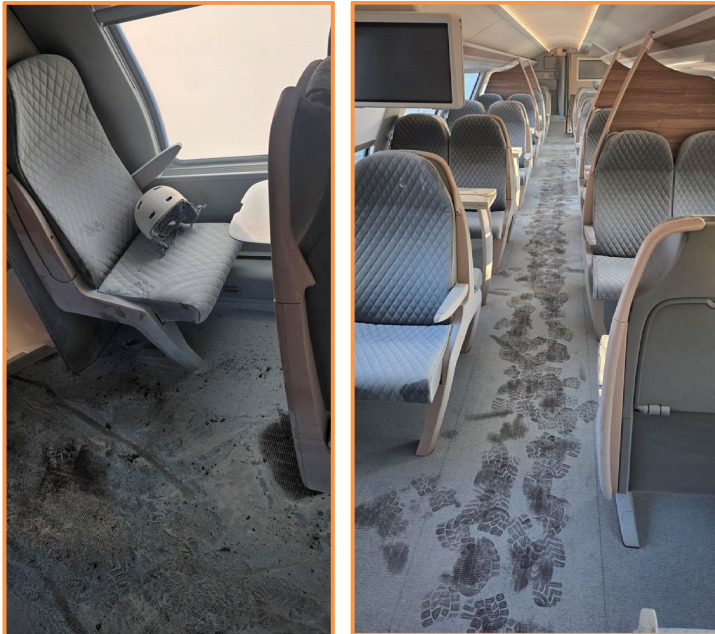
Source: SNCB/NMBS

There is damage to the interior of the second carriage, where the fire started. The railway undertaking had to carry out the following repairs:

- thorough cleaning of the interior following the use of various fire extinguishers;
- replacement of the emergency hammers, fire extinguishers and some seat covers;
- replacement of a window broken by a passenger.
