# Safety Notice

Person hit by a train  
Linkebeek – 29/04/2026

On 29 April 2026, at around 3:10 p.m., the driver of the passenger train E4514 passing through the Linkebeek unmanned stopping point noticed a person on platform 2. The person was standing close to the edge of the platform and was hit by the train.

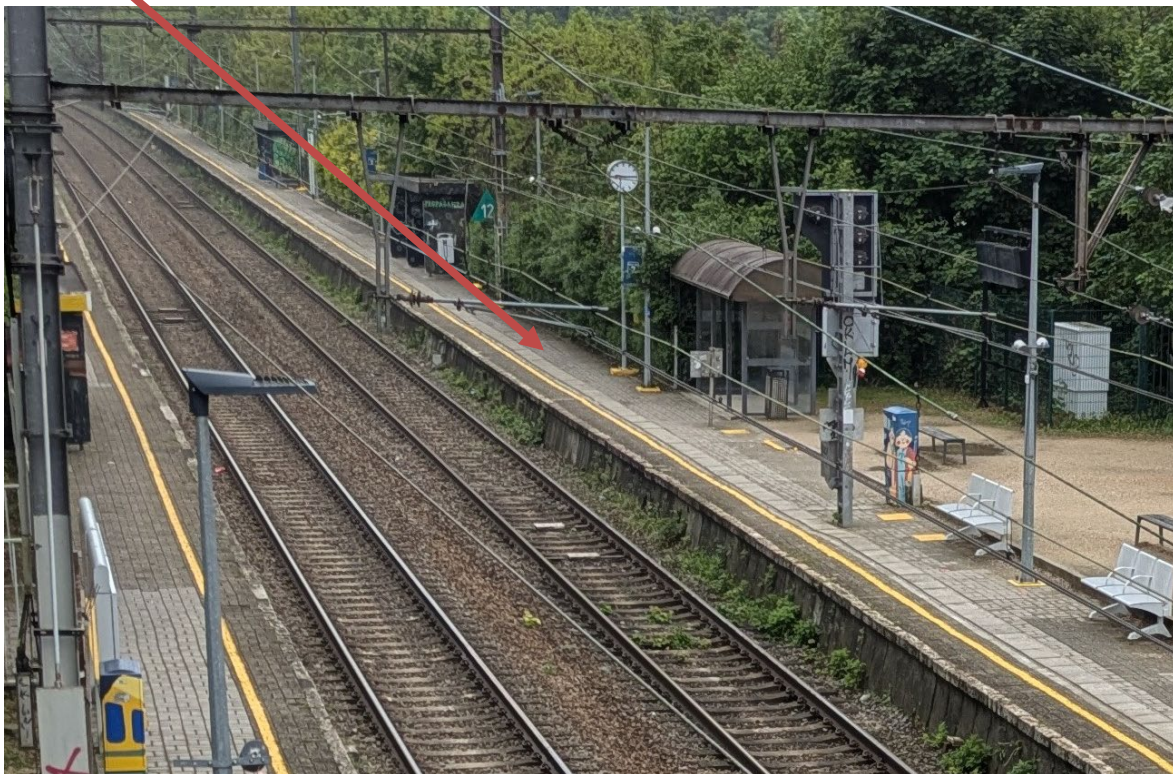
Source: RAIU

Line 124, track B.

Platform 2 at the Linkebeek unmanned stopping point. The maximum permissible line speed at this location is 120 km/h.

The yellow line, which indicates the minimum distance to be maintained, is clearly visible along the entire length of platform 2.

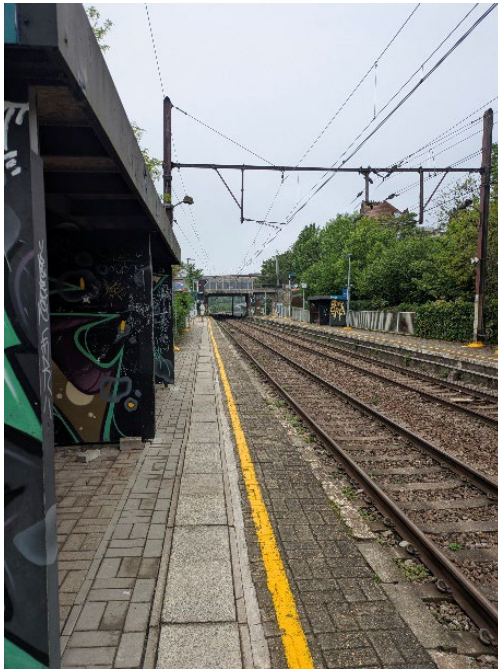
(1) Source: RAIU

The platform is narrow in places, particularly near the waiting shelters (1); however, these shelters provide sufficient space for passengers to wait. In other parts of the platform, the available width is reduced by overgrown vegetation (2). Furthermore, the platform is long enough (264 metres) to allow passengers to spread out.
