# Safety notice

Person hit by a train

Bruxelles-Nord / Brussel-Noord – 27/05/2026

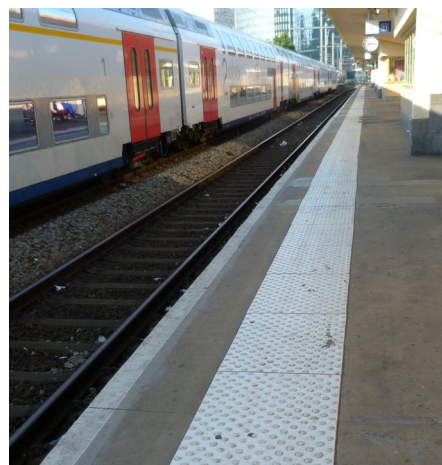
Line 25, platform 11 at Bruxelles-Nord / Brussel-Noord station. Podotactile paving, also known as detectable warning tiles, alerts passengers with a visual impairment to the proximity of the edge of the platform. The paving indicates the minimum safe distance from the edge of the platform for all passengers, just like the yellow line on the platform.

The passenger train was entering Bruxelles-Nord / Brussel-Noord station at platform 11 for a scheduled stop. At that moment, a person stepped into the area between the podotactile paving and the edge of the platform. The person lost their balance, was hit by the train and ended up between the train and the platform. The person was seriously injured and was taken to hospital.

- Stay behind the podotactile paving or the yellow line when a train is entering, passing through or calling at a station.
- Do not use the area between the safety markings and the edge of the platform as a waiting area.
