Safety Notice  
Side-on collision with a freight train  
by a runaway packing machine  
Gent-Sint-Pieters  
14 April 2019

Side-on collision with a freight train by a runaway packing machine of type Unimat 08.

Station Gent-Sint-Pieters at point switch AW61BK.

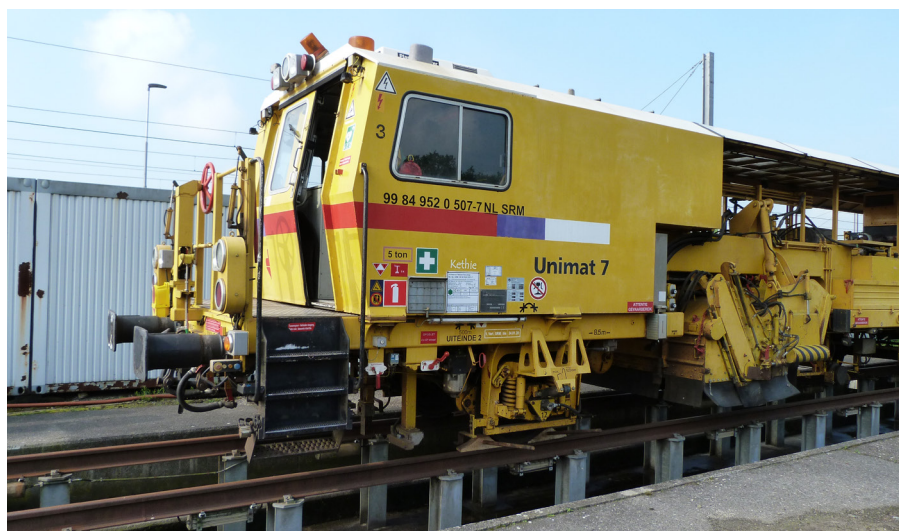
The runaway packing machine reaches point switch AW61BK at the moment freight train Z65902 is coming past and collides with it side-on. There are no casualties, but there is material damage to the infrastructure, 5 wagons and the packing machine. 1 wagon and the packing machine derail and are damaged.
