Bulletin of General Information

Derailment followed by a side collision

Walenhoek

6 February 2020

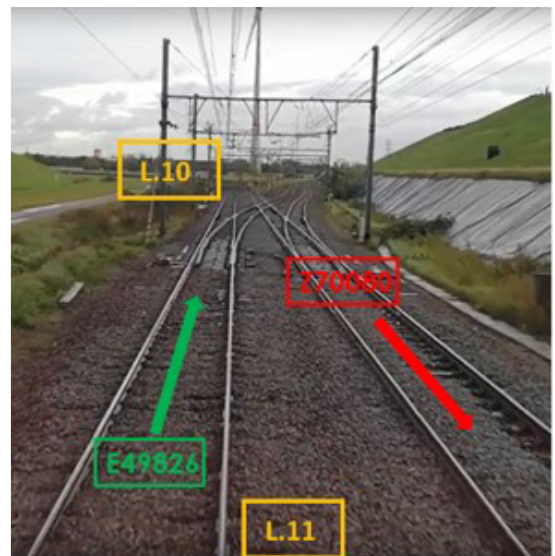
Derailment of 2 single engines of railway undertaking LINEAS followed by a side collision with a freight train, also of railway undertaking LINEAS.

- 2 derailed engines with considerable damage to the driver's cab and a leaked diesel tank.
- 6 derailed wagons of which 1 wagon overturned and began to leak and 2 wagons ended up in the verge.
- Damage to railroad infrastructure:
 - Damage to overhead wires;
 - Damage to rails;
 - Damage to point switches.
- Freight transport suspended for several days on L.10 and L.11.
