Safety Investigation Report
Infrabel agents hit in Morlanwelz, followed by a
collision with an SNCB/NMBS-train in Bracquegnies
caused by a runaway towed damaged railcar
27 November 2017

SUMMARY

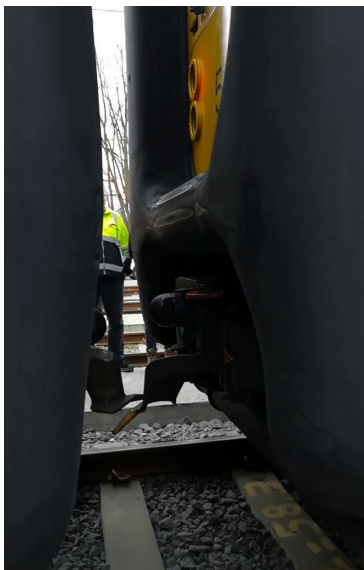
When two of these railcars are coupled, the rubber diaphragms compress against one another, thereby forming a seal. It is a specificity of this type of railcar that allows passengers and staff to pass from one railcar to the other.

The disadvantage of the presence of these rubber diaphragms pressed against one another is that they do not allow access to the manual uncoupling mechanism located on the couplers. Therefore, AM96 railcars feature a manual uncoupling command system in the driver's cabin: it is a hand crank used to transmit the effort to the mechanism through a cable and its sheath.

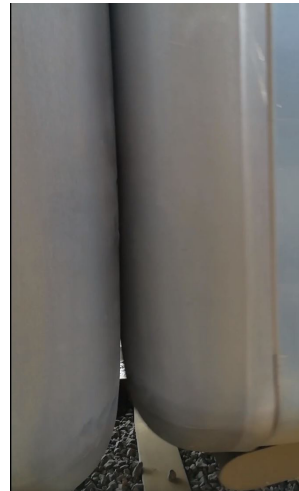
The applied force to uncouple two railcars is relatively important. The presence of rubber diaphragms pressed against one another generates a mechanical strain in the coupling mechanism: during normal operations, the automatic uncoupling procedure is initiated by opening a solenoid valve to slightly deflate the rubber diaphragms. This is why the procedures require the cranks to be operated simultaneously in both drivers' cabins, to cumulate the forces applied.

On the day of the accident, a first attempt at manual uncoupling using the crank in the driver's cabin was performed, before repeating the same operation in a synchronised manner in both drivers' cabins.

In normal operating conditions, indicator lights inform on the coupling state of the railcar (coupled/uncoupled). In the absence of electrical voltage powering the railcars after the accident, these indicator lights were non-operational. The driver and the first foreman attempted to confirm this state visually, but the rubber diaphragms forming the connection seal between both railcars did not provide access to the couplers connecting the two railcars. There is no other indicator informing on the coupling state of a railcar.

The uncoupling of the two railcars was not achieved.

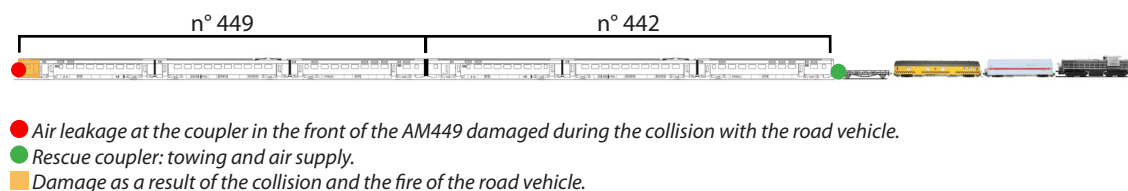
Because of the damage caused during the collision on the level crossing and the subsequent fire of that morning, the coupler in the front of the AM449 was leaking air: the crew of the re-railing train managed to solve this issue by closing the pneumatic valve supplying air to the damaged coupler of the AM449.

Despite a supply of compressed air at 5 bars, the brakes of the damaged railcar (n° 449) could not be released. It was therefore impossible to tow it away.

The crew of the re-railing train then decided to isolate the brakes, the purpose of this operation being to release the brakes and to allow the towed train to move. The consequence of isolating the brakes was that the damaged railcar (n° 449), at the rear of the convoy, was not braked. The damage caused by the morning's accident and subsequent fire made it impossible to couple another vehicle at the rear of the convoy.

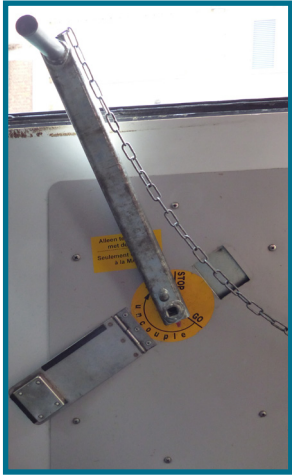
The manual uncoupling procedure is a “last resort” procedure and is not part of the practices generally implemented by drivers who, in most cases, use the automatic procedure.

The investigation highlighted that this last resort procedure is not well-known by drivers and instructors.

Inappropriate use of the crank causes irreversible damage to the sheath of the cable connecting the crank to the manual uncoupling system when a foot is used to apply greater force on the crank.

The damage caused to the cable sheath is only visible during workshop maintenance operations.

Once the “sheath + cable” system is damaged, rotating the crank no longer drives the correct motion of the internal parts of the coupler, bringing them to an intermediary and unstable position.

Based on these elements, the IB recommends that SNCB/NMBS analyses its training procedure so as to raise awareness of staff in terms of the risks identified.
