Summary of Security Investigation Report

DERAILMENT OF A FREIGHT TRAIN WETTEREN - 4 MAY 2013

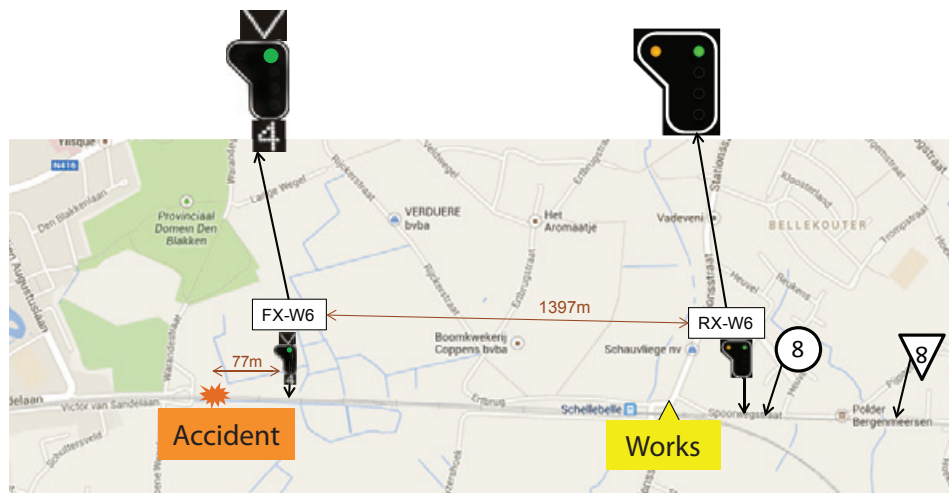
The driver encounters 9 consecutive green flashing signals. Then he encounters a green-yellow horizontal flashing warning signal (RX-W.6) that informs him of the aspect of the following signal (FX-W.6). In the absence of a speed indication (on the signal RX-W6) the train is permitted to travel at a restricted speed of 40km/h from the next dangerous point.

The driver continues along the works on the left side of the track and encounters the next signal (FX-W6) showing a flashing green light with 2 fixed illuminated indications: a white chevron "V" and a white digit "4". This indicates to the driver the change of regime, from the opposite track to the normal track, and recalls the instruction to limit the speed to 40km/h for changing regime.

Approximately one km from the zone of the maintenance works the driver encounters the signal FX-W.6. The speed of movement at the signal FX-W.6 is around 84 km/h.
