Safety Notice

Incident with numerous vehicles on a level crossing
Moelingen - 3 March 2020

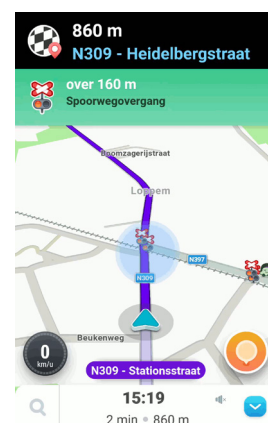
- Warning via navigation app: from 1 June 2020, Infrabel, with its Open Data platform, has worked with the navigation app Waze. If you approach a level crossing on a passenger line, you will see a warning sign in the shape of a Saint Andrew's Cross in Waze. This is intended to be an additional stimulus (on top of traffic signs, lights, barriers and audible signals) to be alert in the vicinity of level crossings. If it is a level crossing without barriers or not visible from 100 metres away, the driver will hear a notification. Around 1,200 level crossings are uploaded in the app as standard, and about 1.6 million drivers in Belgium use the app. The infrastructure manager does not rule out future collaborations with other similar companies or apps. (PUB, 2020).

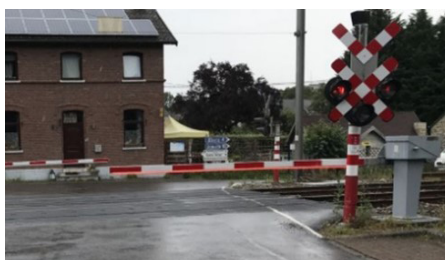
- **LED lighting on barriers:** to increase the visibility of the level crossing and the barrier, the barrier is equipped with LED lighting, red on the outside and blue on the inside.⁶⁰ On 14 July 2020, the LED system was put into service for the first time at the Comblain-la-Tour level crossing in Hamoir. (Giot, 2020).
