Railway Accident and Incident Investigation Unit

Safety Notice Derailment of a work train (ballast regulator) of the infrastructure manager Infrabel Tubize - 14 April 2020

December 2020

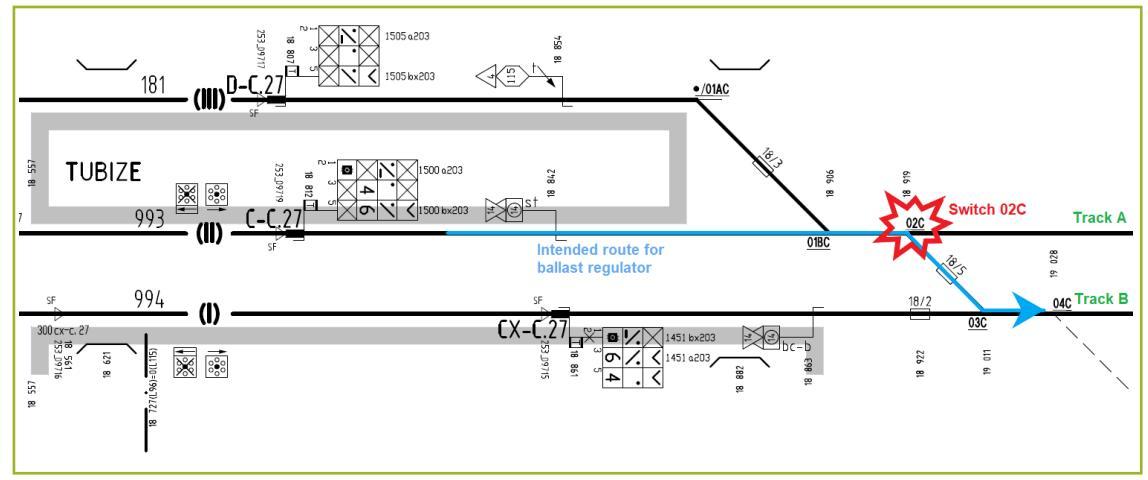
Illustration: Signalling plan (SSP) with indication of the intended train route

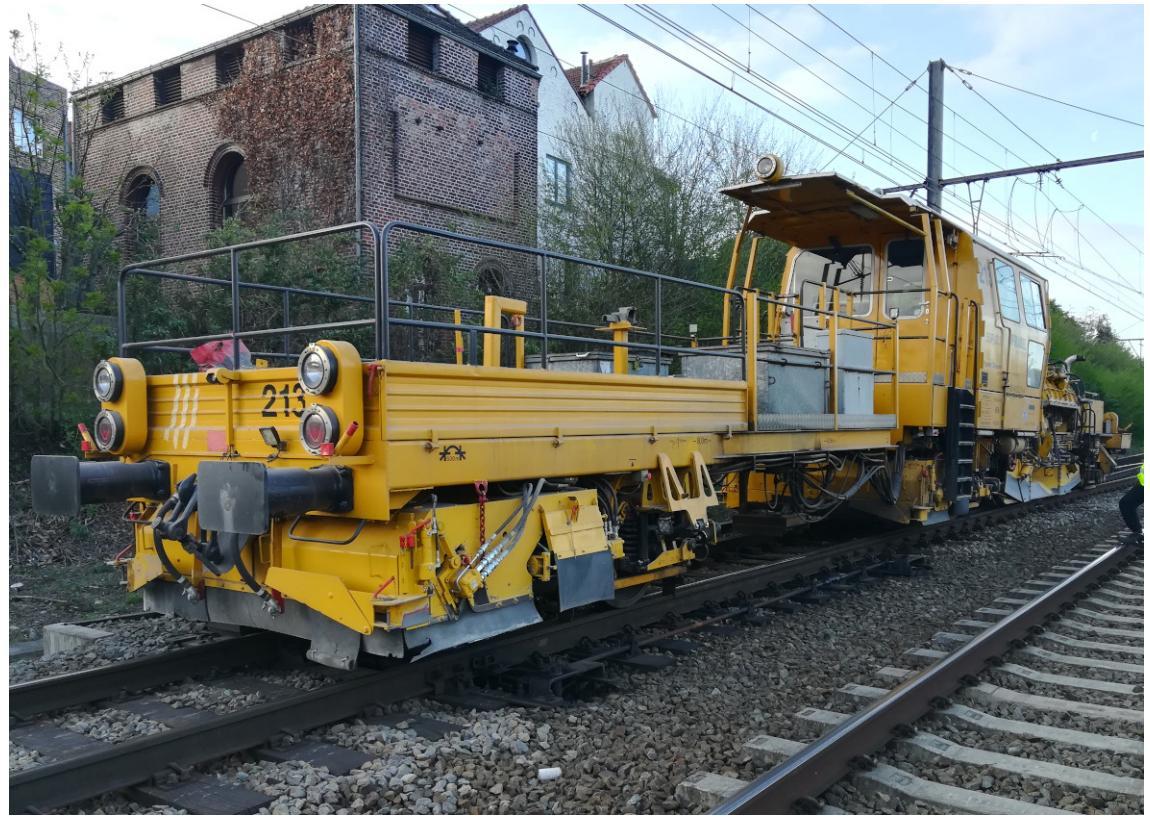
Illustration: ballast regulator no. 998894252134

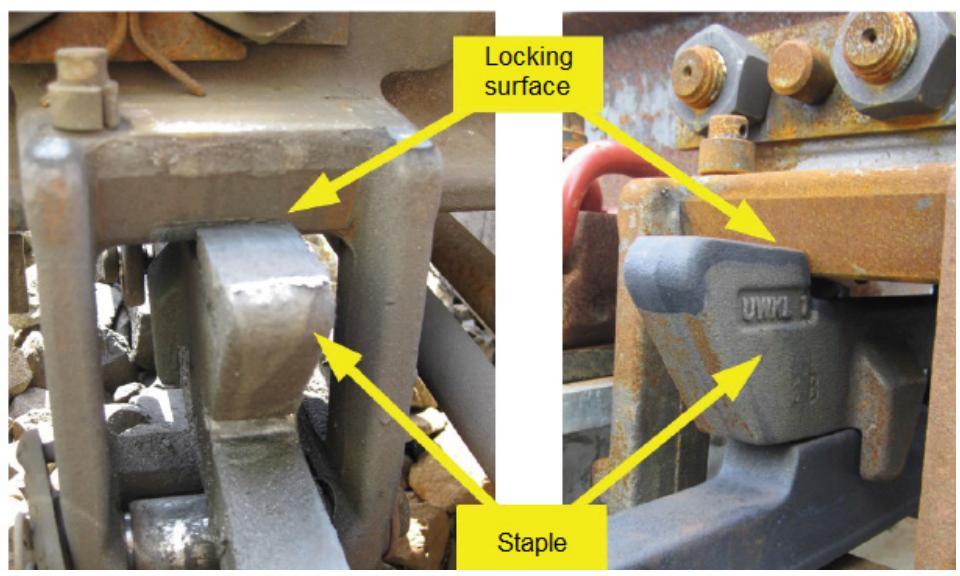
Illustration image: Vertical staple locking (source: Infrabel)

There is a significant risk of derailment if a switch is not properly locked. The vertical staple locking device is not sufficient to secure the switch points when a switch is traversed by a train at speeds in excess of 90 km/h³. These switches are thus equipped with an additional locking device.

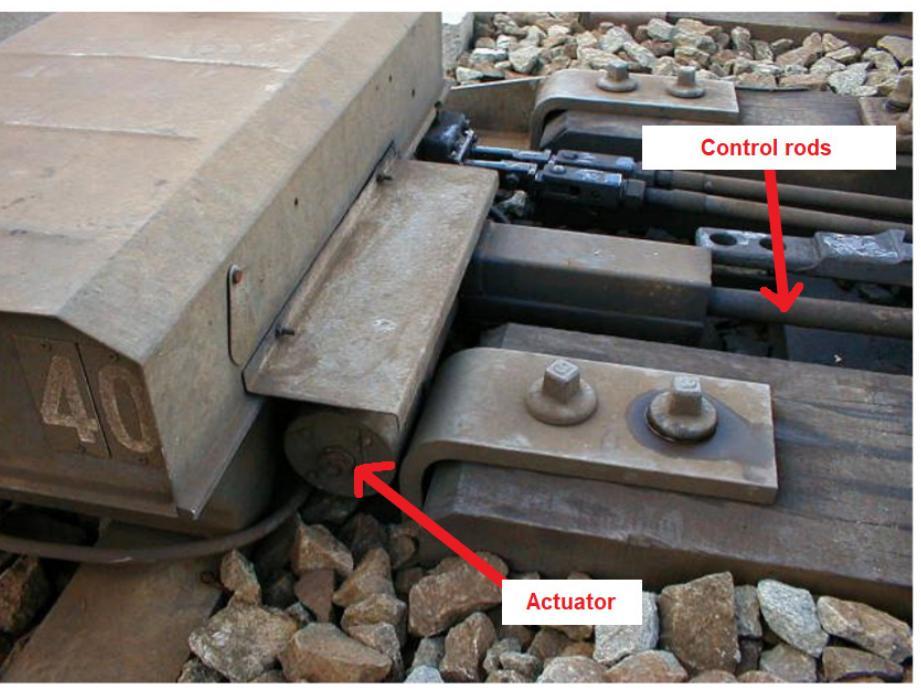
The additional locking device for the 02C switch is an actuator system. It consists of a rack and pinion that will rotate to allow the actuator rod to extend and engage in the notch provided for this purpose in the control rods. Once the actuator is engaged, the control rods and switch points will not be able to move.

Illustration image: Locking device for the motor rack and pinion (actuator) (source: Infrabel)

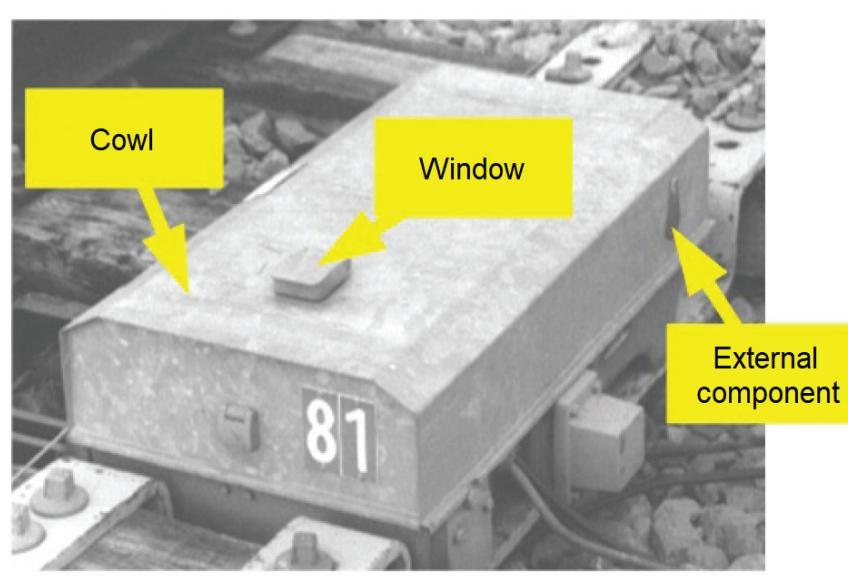
In the locked position of a switch, they are positioned in line with the window on the switch stand cowl and are therefore visible when the window is raised.

Illustration image: Motor housing of a switch (source: Infrabel)

On site, it was found that the window pane in the cowl of the motor housing of the 02C switch motor was dirty. It is through this window that the position of the diabolos can be checked without having to open the switch motor cowl.

- formalisation in the internal regulations (RGE/ARE 300) of an "insider agent authorised agent" role that assists personnel performing a critical safety task.
- adaptation of the training material, which serves as work instructions, for the A.R.E.T. training to include didactic elements (element films) aimed in particular at performing manual switch operations and locking of moving parts.
- creation of a work instruction detailing the application of RGE/ARE 741.1 and RGE/ARE 728.2 for the operation of switches within a track or an area that is out of service, with the integration of the requirements and procedures for delegating this task (excluding A.R.E.T. certified officers).
- adaptation of the instructions (checklist E12) for the execution of the periodic checks and maintenance of the switch stand (inclusion of the cleaning of the switch motor window).

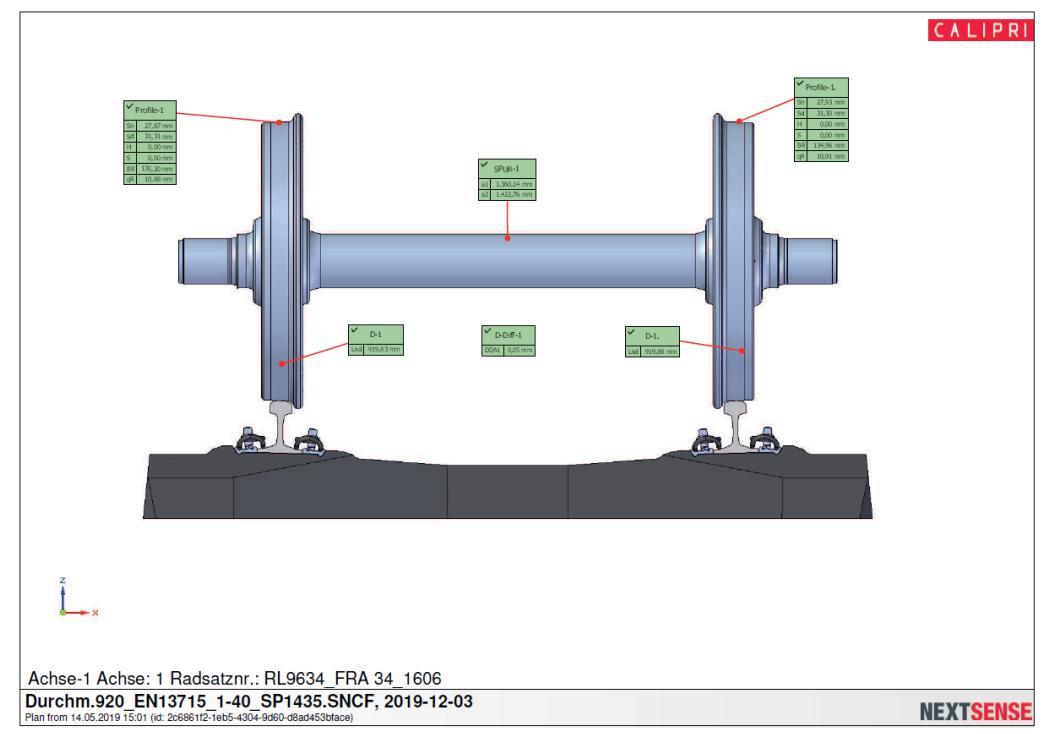
During the investigation, Infrabel informed the Investigation Unit that the axles of the ballast regulator had been replaced with new axles in December 2019.

Illustration: Profile and measurements of the new axles installed in December 2019 on ballast regulator no. 998894252134.
