Safety Investigation Report

Derailment of an SNCB/NMBS passenger train

Weerde - 28 January 2021

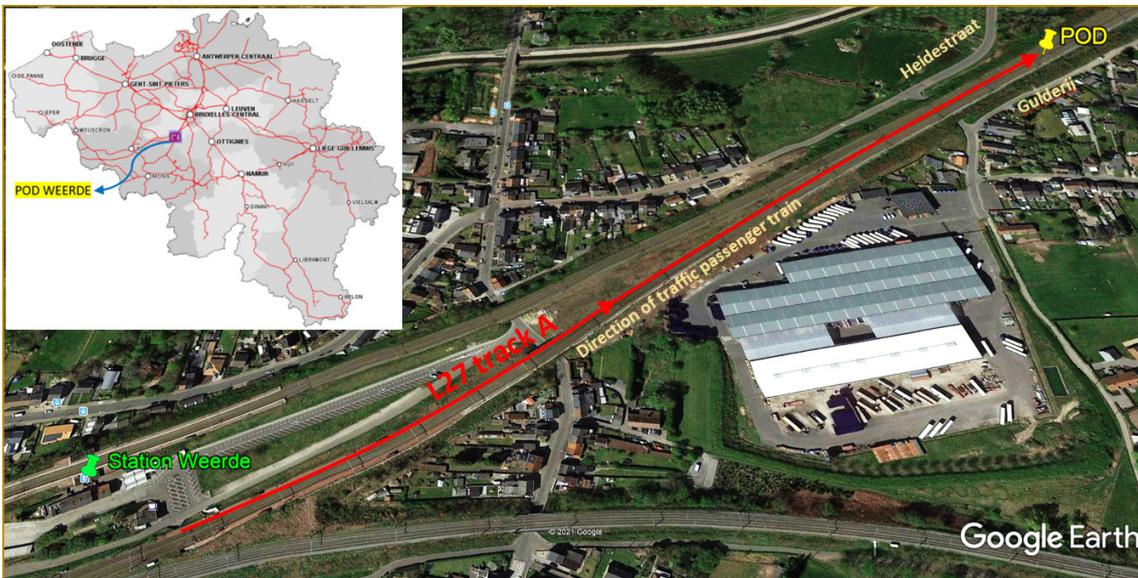
As a partial assignment within the framework agreement “renewal of main line rails Area North East” between the infrastructure manager Infrabel and the contractor Strukton Rail, the contractor carries out rail renewal works during six nights in the period from 19 to 27 January 2021. The works take place between Weerde and Mechelen on L27 track A. During the night of 27 to 28 January, clearance works are then carried out: the old rails are cut in the six-foot way so that they can be loaded and removed later. The rail cutting works are completed on time on 28 January, and the track is put back into service at around 05:00 a.m.

The SNCB/NMBS passenger train E1954 (Charleroi-Sud – Antwerpen-Centraal) departs from Weerde station towards Mechelen on 28 January at 06:12 a.m. E1954 is the first movement on L27 track A.

832 metres in advance of Weerde station, the passenger train derailed with the second wheelset axle of the first bogie. As a result of the shock, the train driver performs an emergency brake at 06:13 a.m. The speed of the train at that time is 85 km/h.

The train driver and the 15 passengers on board are unharmed. Between the location of the derailment and the place where the train comes to a standstill, damaged Pandrol clips, shifted concrete sleepers, and destroyed railway cabling can be observed. There are various impact and abrasion damages to the chassis of the first bogie of the passenger train.
