# Summary Safety Investigation Report

Collision between an empty passenger train  
and a railway crane  
Belsele - 12/03/2024

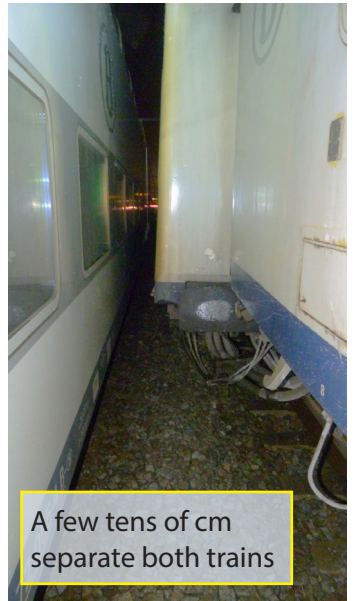
On Tuesday evening 12 March 2024 at around 11.21 p.m., a collision between an empty passenger train (EM2772) and a railway crane takes place in Belsele, on track A of line 59 between Sint-Niklaas and Lokeren. The collision causes the train to derail with four bogies. While derailling, it still covers about another 300 metres, leading to significant damage to the rolling stock, the rail infrastructure and the catenary. The operator of the railway crane manages to leave his cab before the collision and is not injured. The driver of train EM2772 and a colleague in the driver's cab are slightly injured. The second derailed carriage of the train is located in the six-foot way a few tens of centimetres from the clearance gauge of track B.

Passenger train E1822 is running in the opposite direction on track B. The train driver sees sparks at the level of the catenary and performs an emergency braking. During braking, this train runs a few tens of centimetres alongside the second carriage of EM2772.

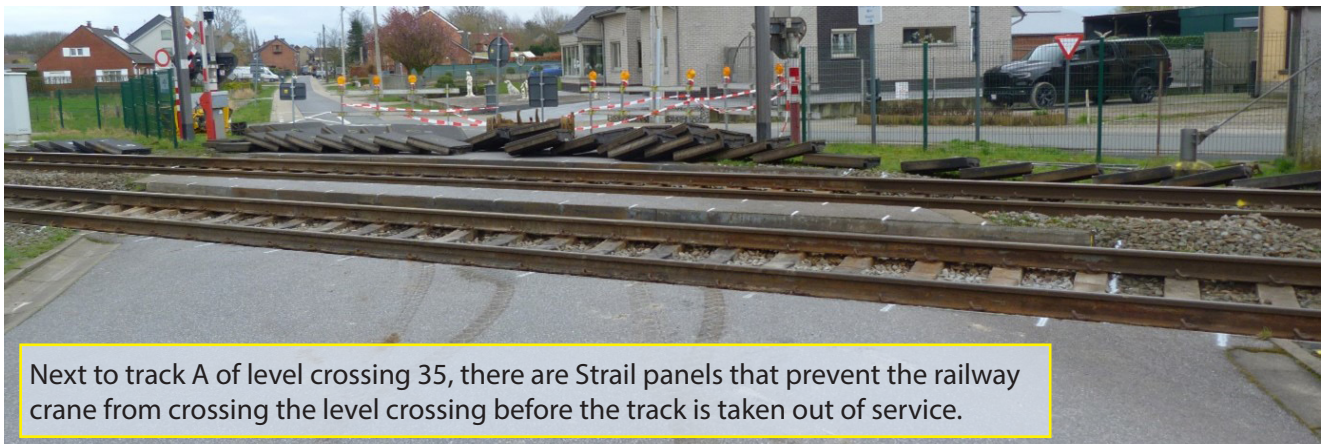
Rail renewal works are planned at level crossing 35 (LC35) on line 59 during the night of 12-13 March. These are performed from track B by two railway cranes. One of these cranes was delivered at LC35 on the track A side on 12 March. Due to previous works, the Strail panels have been removed from LC35, preventing direct passage for a railway crane to go from one side of LC35 (track A side) to the other (track B side) prior to the admission of the works.

A contributing factor is the relocation of the railway crane before the pre-job briefing and before the infrastructure manager's permission to start the works.

The operator of the railway crane arrives at LC35 before the scheduled taking out of service. He notices that his crane is not on the track B side and decides to move it before the official working hours (the suspension of train traffic), without informing the site manager.
