# ANNUAL REPORT OF THE INVESTIGATION BODY FOR RAILWAY ACCIDENTS AND INCIDENTS **2016**

Service public fédéral  
Mobilité et Transports

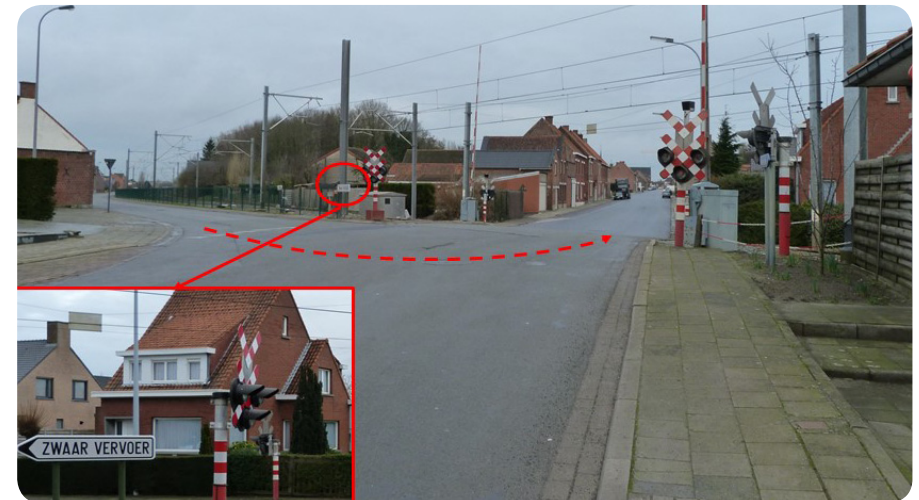
The cause of the accident is the presence of a stationary bus on a level crossing during the passage of the train at this crossing. Owing to a miscalculation, the bus turned onto the open level crossing - before the arrival of the train was announced - and became stuck against the level crossing signals.

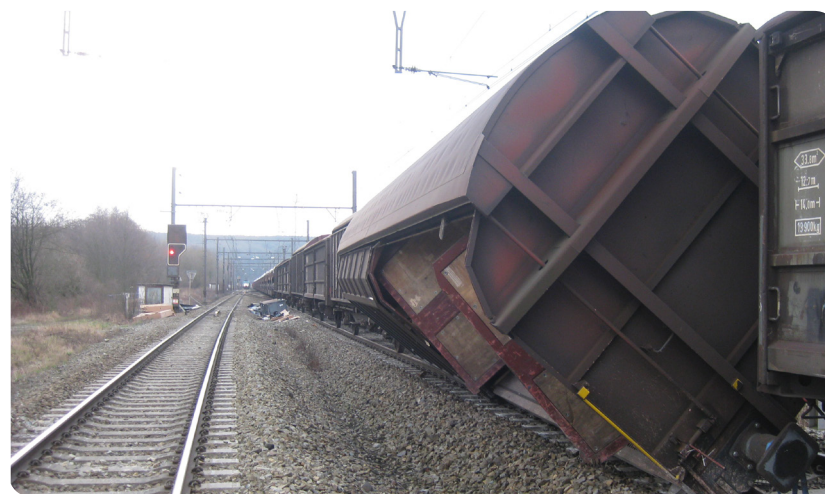
According to the theory retained by the investigation body, the direct cause of the derailment was the loss of contact between the rails and the wheels due to the “lifting” of the rear wheels of wagon 3.

The rapid deterioration of the geometry of the track was certainly noticed and reported in several consecutive routine inspections, but the deformations were not measured. In the inspections, the rail deflation, which was noted after the accident, was never observed or measured with a rail deflation measuring device to monitor the development.

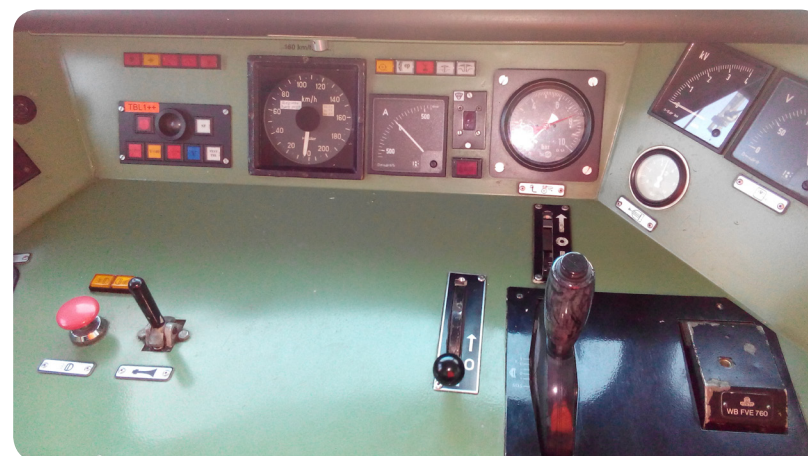
The direct cause of the running away of the train was the releasing of the brakes following sufficient pressure in the ABP after the driver had closed the pneumatic valve.

- non-compliance with the HLT procedure by the driver for stopping his train while he was inspecting it;
- the untimely movement of the lever of the pneumatic release valve allowed an air to escape from the main reservoir of one of the cars, resulting in a pressure drop in the ABP.

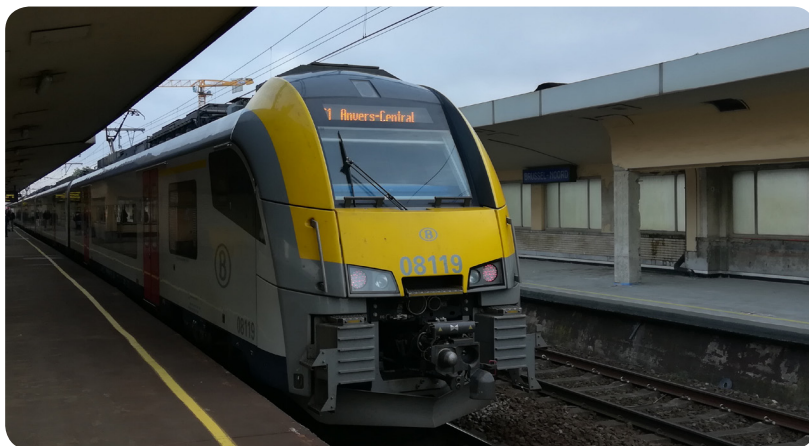
Since 2009 and in a more accelerated way since the Buizingen catastrophe in 2010, one of the measures taken by the sector in order to reduce the number of SPAD involves installing ATP systems (Automatic Train Protection) on the tracks and on board rolling stock.

The SNCB/NMBS committed itself to equipping all its vehicles with TBL1+ by the end of 2013, the planning has been respected.

At the level of its rolling stock (works trains), Infrabel was supposed to modify its own rolling stock: by the end of 2015, 99% of stock was equipped with the TBL1+ system (100% of special units and 99% of locomotives). At an infrastructure level, Infrabel had decided to accelerate the timetable of TBL1+ implementation. In December 2015, Infrabel had installed TBL1+ in the tracks as the IM had planned.
