# ANNUAL REPORT

of the Investigation Body for  
Railway Accidents and Incidents

# 2018

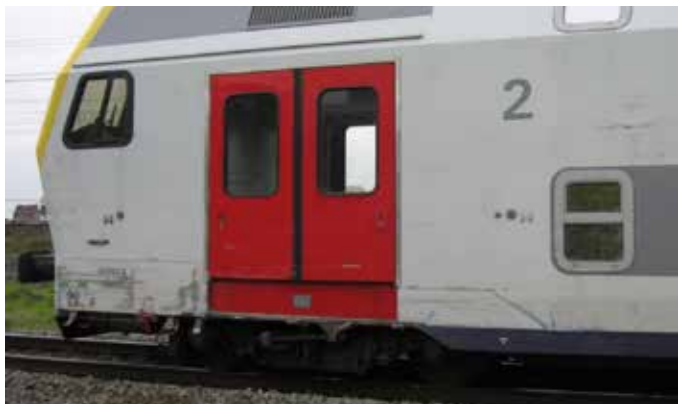
Bruxelles-Nord: 24 April 2018

On Tuesday 24 April 2018, following a defect, train E2178 comprised of two AM08 Desiro railcars (08118 + 08564) was declared in distress.

The two defective railcars were towed by three other AM08 Desiro railcars to the Brussels-North railway station.

The railcars passed through a switch and continued their route. They collided lightly with the side of train 17907 (a technical train with no passengers), only causing mild damage. The runaway railcars came to a halt around 800 metres from the platforms of Brussels-North.

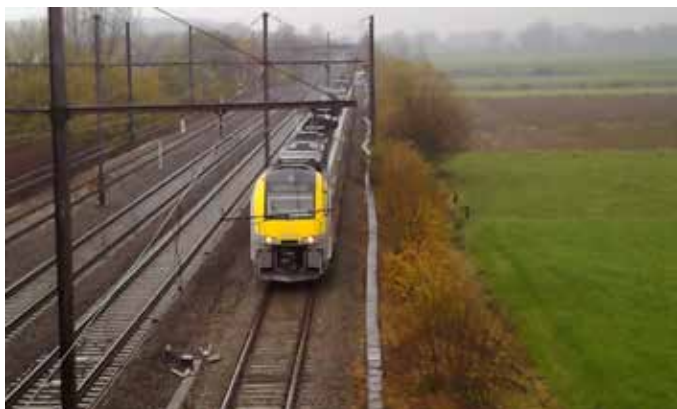
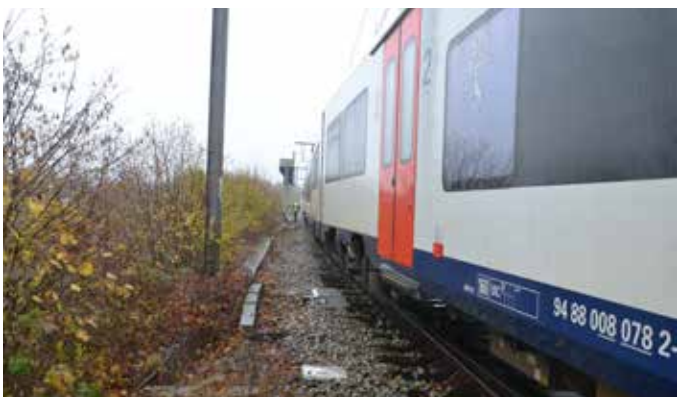
Neufvilles: 20 November 2017

The inspection of the train by the driver reveals that the two last wagons of the train have derailed. The infrastructure is severely damaged over a distance of 14 kilometres.

The initial inspections of the rolling stock, of the tracks and of the area surrounding the tracks reveal that one of the wheels of the penultimate wagon n° 3368 4952 072-9 broke some 17 kilometres from the train's stopping point, causing the derailment of the wagon. The wagon remained attached to the train, causing damage to the infrastructure. Four pieces of the broken wheel were found in the tracks.

The derailment of the 24th wagon (n°3368 4952 072-9) is the result of the broken right wheel of the 3-3' axle of the wagon, of cracks and thermal splitting which spread in the wheel.

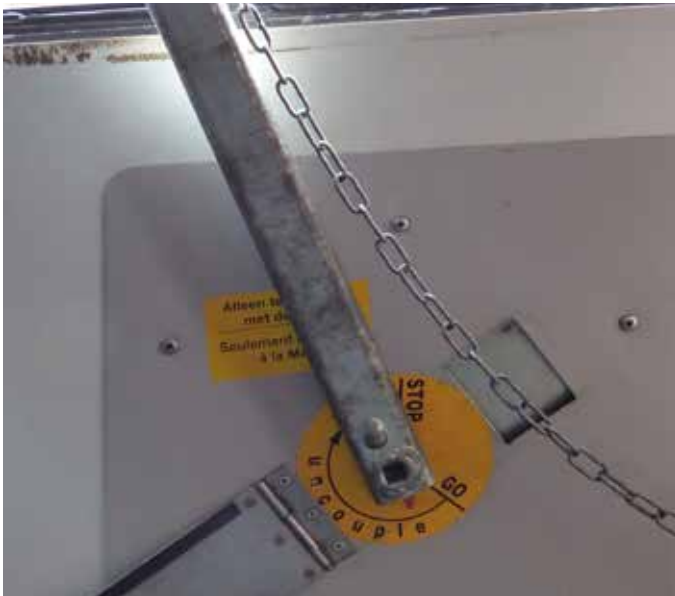
Around 1:07 p.m., a technical train ('re-railing train') E97708 comprising 1 diesel locomotive, a 10 ton crane and 2 technical carriages set off from Charleroi. Around 2:13 p.m., the E97708 train arrived from La Louvière-Sud at the 2 railcars of train E928 on track B of line 112.

The crane was detached from the re-railing train for the clearing intervention of the burned road vehicle.

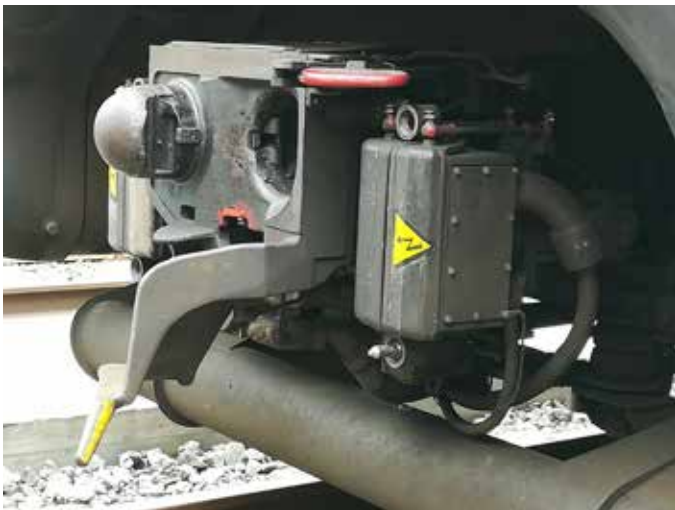
Bracquegnies / Morlanwelz: 27 November 2017

Without personnel or the driver of the re-railing train realising, the AM449 disconnected from the convoy during towing to Piéton, and the railcar rolled back down the sloping track towards Morlanwelz.

The railcar continued its drifting and passed by La Louvière-Sud before reaching line 118: the emergency procedures undertaken by the various Infrabel services did not manage to stop the escape.
