Safety Investigation Report

Train mistakenly shunted onto an occupied track
Zeebrugge Pelikaan fan of sidings - 20/08/2024

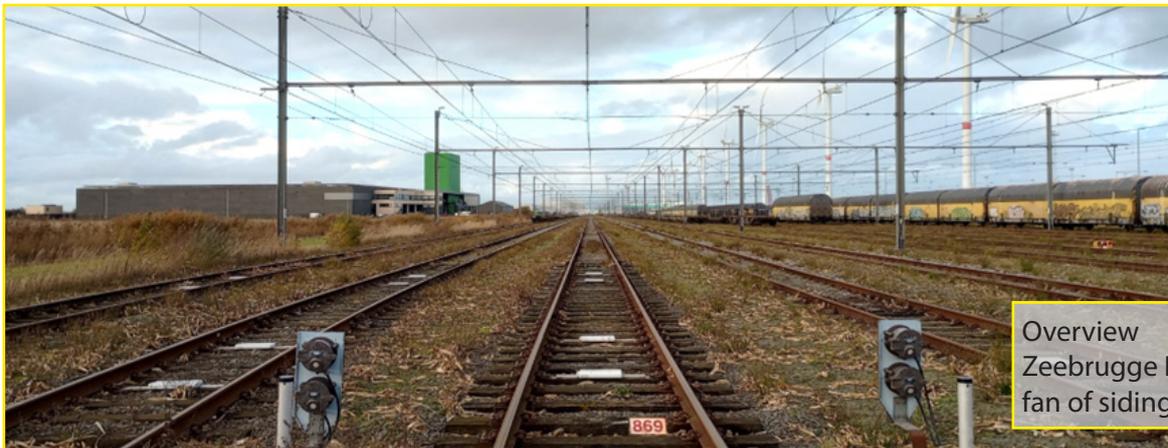
Overview
Zeebrugge Pelikaan
fan of sidings

The Pelikaan RMI/VRG fan of sidings is half-signalled which means there are no detection tools in the installation where the RMI/VRG holder is operating to determine the actual track occupation.
